RE: 2019 Inspection of Holtwood Fish Passage Facilities

Subject: Inspection of fishways at Holtwood Hydroelectric Project (FERC #1881) on May 22, 2019

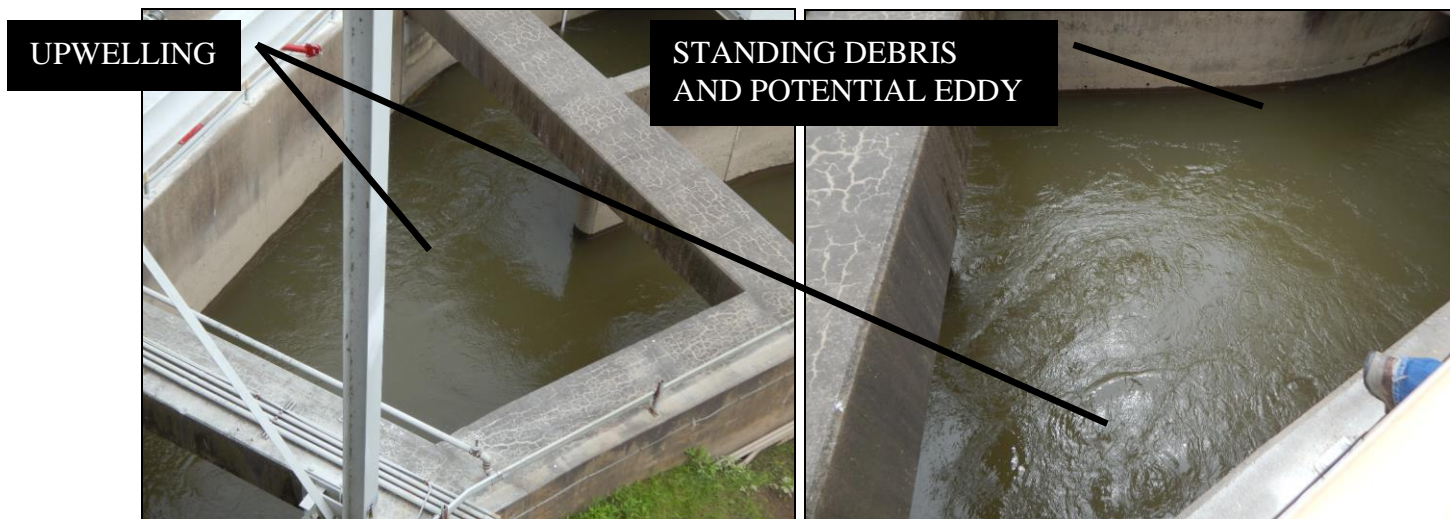
- Visible upwelling over AWS floor diffusers - During the site visit, Service staff identified a location within the Tailrace Channel where excessive hydraulic turbulence was visible from the walking platform (Figure 1). The force of a hydraulic upwelling (i.e., vertically oriented velocity vectors) was clearly extending from a channel floor diffuser, all the way up to the top of the water column. Floor diffusers are designed to introduce additional attraction flow into a fishway through an auxiliary water supply (AWS) system. The Service suspects that for whatever reason (e.g., pushing too much flow through the floor diffuser, or debris issues causing the diffuser to be partially blocked), flow velocities coming out of the floor diffuser were simply too high for this particular entrance channel. This unwanted hydraulic upwelling resulted in a noticeable interruption of the zone of passage inside the Tailrace Channel. In general, hydraulic upwelling should never be visible within the entire longitudinal profile of a well-maintained zone of passage for migratory fish. The Licensee should consider reducing the amount of flow going through the floor diffuser system to ensure visible upwelling is not occurring in the fishway.

- Hydraulic eddy and standing debris within the Tailrace Channel - Immediately upstream of the hydraulic upwelling over the floor diffuser, an apparent eddy was also identified by Service staff (Figure 1). A small amount of debris was seen floating in circles on the outer bend of the right side wall (looking downstream). This could be evidence of the presence of a hydraulic eddy. Hydraulic eddies could become physical interruptions to the zone of passage within a fishway, and could ultimately result in fish delays and/or fallbacks. Unwanted eddies should always be avoided in any successful fish passage facility. Any possible reduction in this condition through flow management through the fishway should be evaluated. Physical modifications to the channel may be required in the future to eliminate this issue if poor fish passage efficiency continues in the entrance channel of the fishway (as noted in telemetry studies).

Figure 1 - Visible upwelling and potential eddy within the fish lift's tailrace entrances' channel

- b. Visible Upwelling Over AWS Floor Diffusers - Flow going through the diffuser system should be reduced to ensure visible upwelling is not occurring in the fishway.

- c. Hydraulic Eddy and Standing Debris within the Tailrace Channel - Any possible reduction in this condition via flow management through the fishway should be evaluated. Physical modifications to the channel may be required in the future to improve fish passage efficiency in the entrance channel of the fishway.

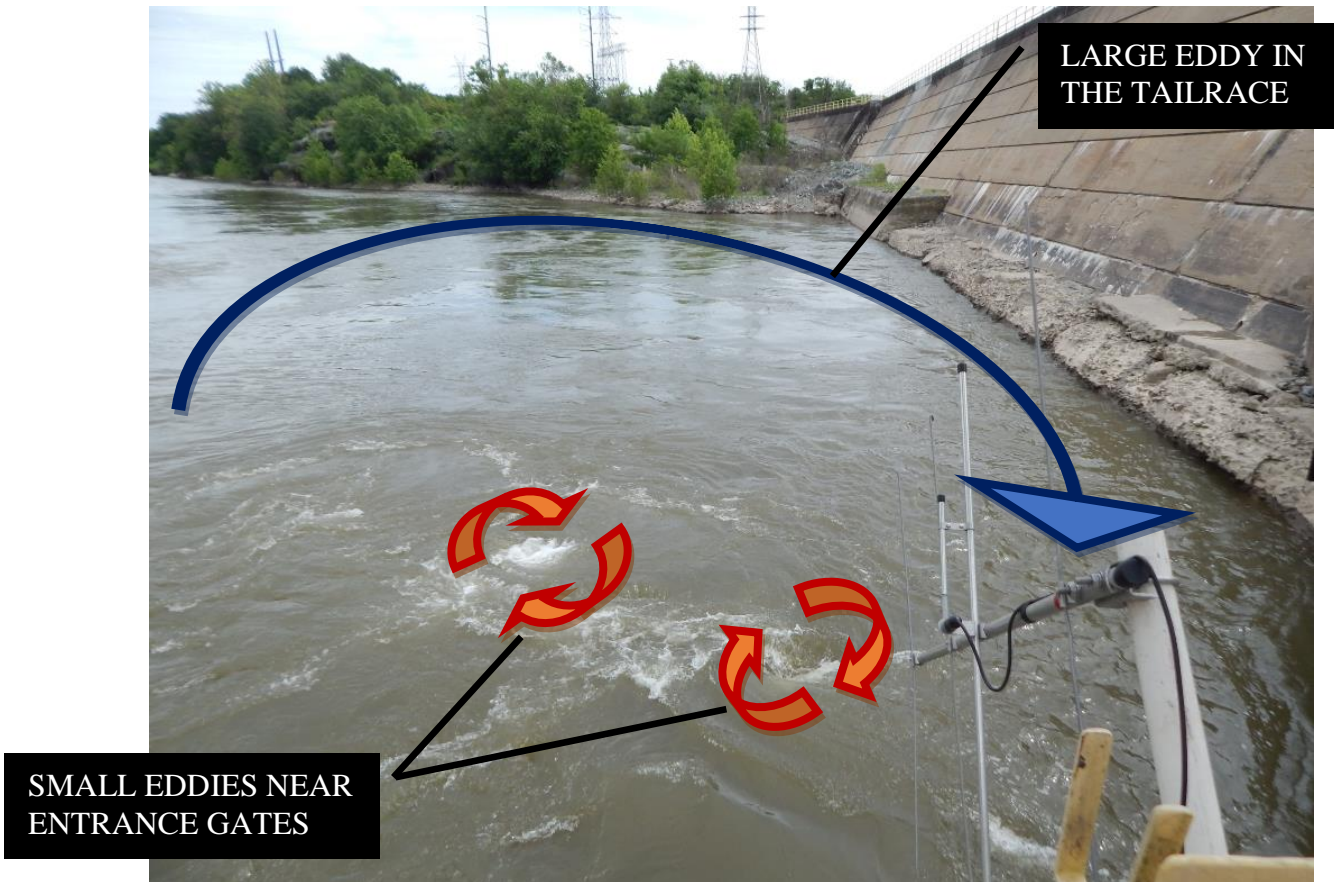
- Continual eddies downstream of tailrace entrance gates - Service staff identified multiple small eddies (Figure 2) that would continuously form in the path of the fish attraction jet flow coming out of entrance Gates A and B (i.e., Tailrace Channel). The Service suspects that a much larger

eddy in the tailrace of the powerhouse (Figure 2) that causes flow to move upstream along the retention wall on the right bank of the tailrace might be the culprit for these smaller eddies within the zone of passage. When the flow from the large eddy moves in the upstream direction towards the entrance gates, it appears to interact with the fish attraction flow coming out of entrance Gates A and B in the downstream direction, resulting in these unwanted smaller eddies. On the day of the site visit, not all of the powerhouse units were generating. The large eddy might or might not be present during other powerhouse operational schemes. Any successful fish passage facility should avoid these type of hydraulic eddies within the dedicated zone of passage for migratory fish. Any possible reduction in this condition through flow management through the fishway and using powerhouse generation should be evaluated. Physical modifications to the tailrace or fishway entrances may be required in the future if poor fish passage efficiency occurs at the entrance of the fishway (as noted in telemetry studies).

Figure 2 - Visible large eddy in tailrace and smaller eddies near entrance gates

- d. Continual Eddies Downstream of Tailrace Entrance Gates - Any possible reduction in this condition via flow management through the fishway combined with powerhouse generation should be evaluated. Physical modifications to the tailrace or fishway entrances may be required in the future to improve fish passage efficiency at the fishway entrance.

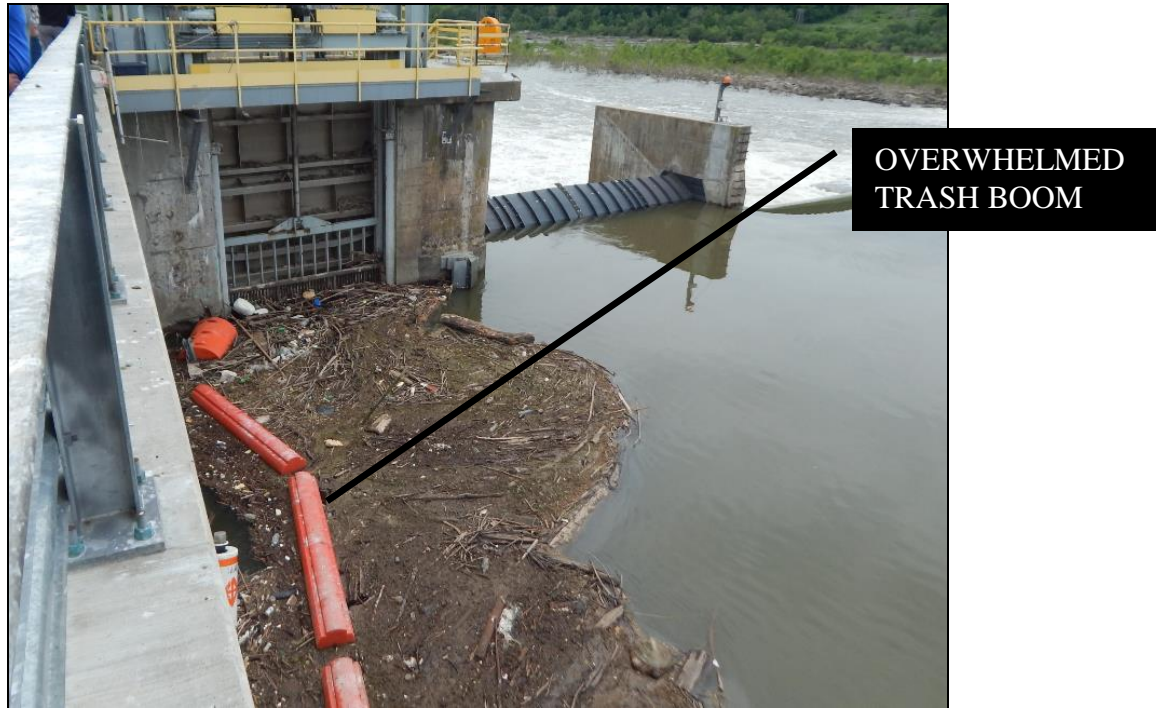
- Broken trash sluice gate - The trash sluice gate system, located inside the fish lift exit channel, was experiencing mechanical issues and was not working on the day of the site visit. A significant amount of debris was accumulated against the exit channel upstream gate. The Project operators had no way of removing it, or sluicing it out, because the trash sluice gate was broken. A floating trash boom intended to keep the exit channel free of debris was visibly overwhelmed by the amount of trash, and became detached from its connection point near the Obermeyer gates (Figure 3). Fish exiting the fishway after being lifted would then be required to swim underneath all the accumulated debris before they could continue their upstream migratory journey. Any successful fish passage facility should maintain its exit channel upstream gate free

Figure 3 - Debris accumulation in the vicinity of the exit through trash rack

of debris during the fish migratory season. Please verify the status of this repair of the trash sluice gate and reattachment of the trash boom.

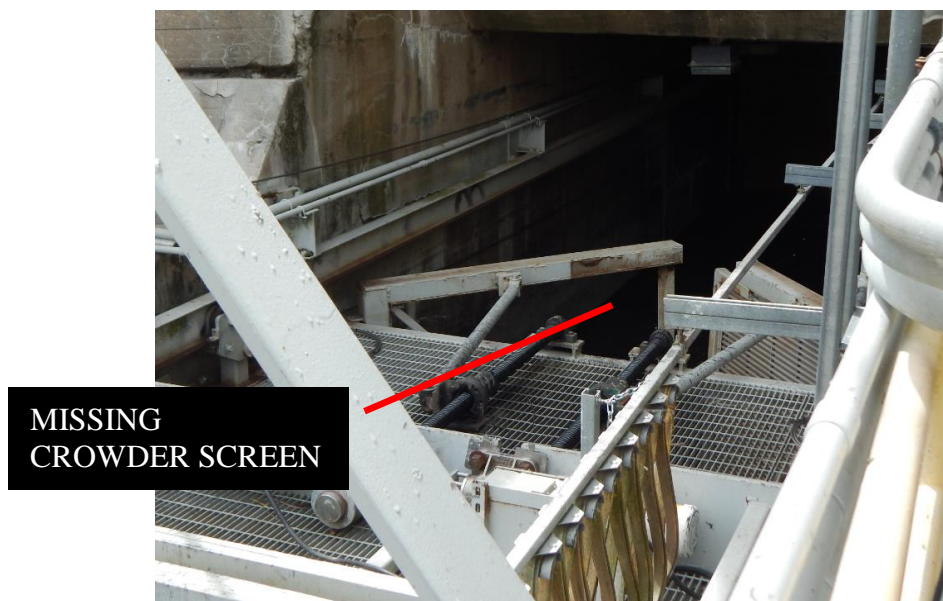
- Missing crowder screen - One of the crowder wings (right wing looking downstream) in the Tailrace Channel was missing its metal screen (Figure 4). If the fish can move freely through the crowder during a lift cycle, then a high rate of fish fallbacks, even after reaching the holding pool, should be expected. The crowder screen should be in good condition during the migratory season so that the fish can be effectively crowded onto the lift hopper. Please verify the status of the repair of the screen.

Figure 4 - Crowder screen missing

- a. Missing Crowder Screen - Please verify the status of the repair of the screen.
- 4. Additional Observations
 - a. Gap in Crowder Wings - Modifications to crowder operation, including reducing the gap in the crowder wings should be evaluated to improve fish passage efficiency in the entrance channel.
 - b. Spillway Channel Eddies - Any possible reduction in this condition via flow management through the fishway should be evaluated. Physical modifications to the channel may be required in the future to improve fish passage efficiency through the entrance channel.
 - c. Bolt Protrusion - Please ensure there are no protruding objects in the fish's path of travel within the fishway that may injure the fish.

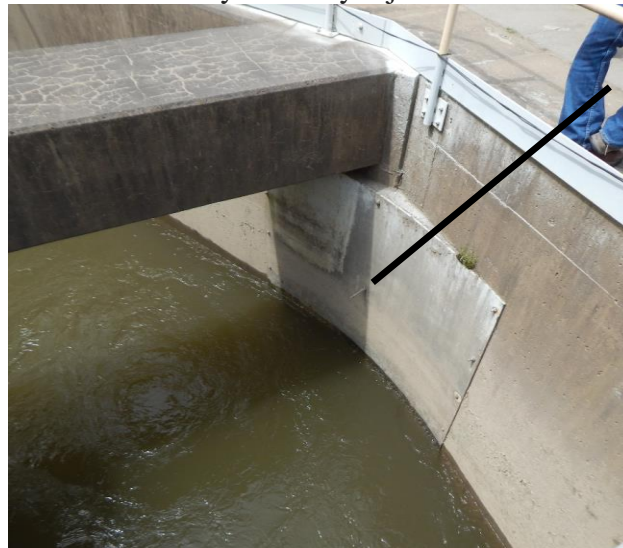
- A protrusion into the tailrace channel was identified during site visit. A long bolt (Figure 5) can be seen protruding into the fish lift channel inside a bend. The bolt was above the water surface, but there might be more of these underwater that were just not visible from the walking platform. Fish passage channels should be free of any sharp corners or protrusions that may injure the fish at any stage within the zone of passage. Please ensure there are no protruding objects in the fish's path of travel within the fishway that may injure the fish.

BOLT PROTRUDING INTO THE ZONE OF PASSGE
