RE: 2019 Inspection of York Haven Fish Passage Facilities

Subject: Fishway Inspection at the York Haven Hydroelectric Project (FERC #1888) on May 21, 2019

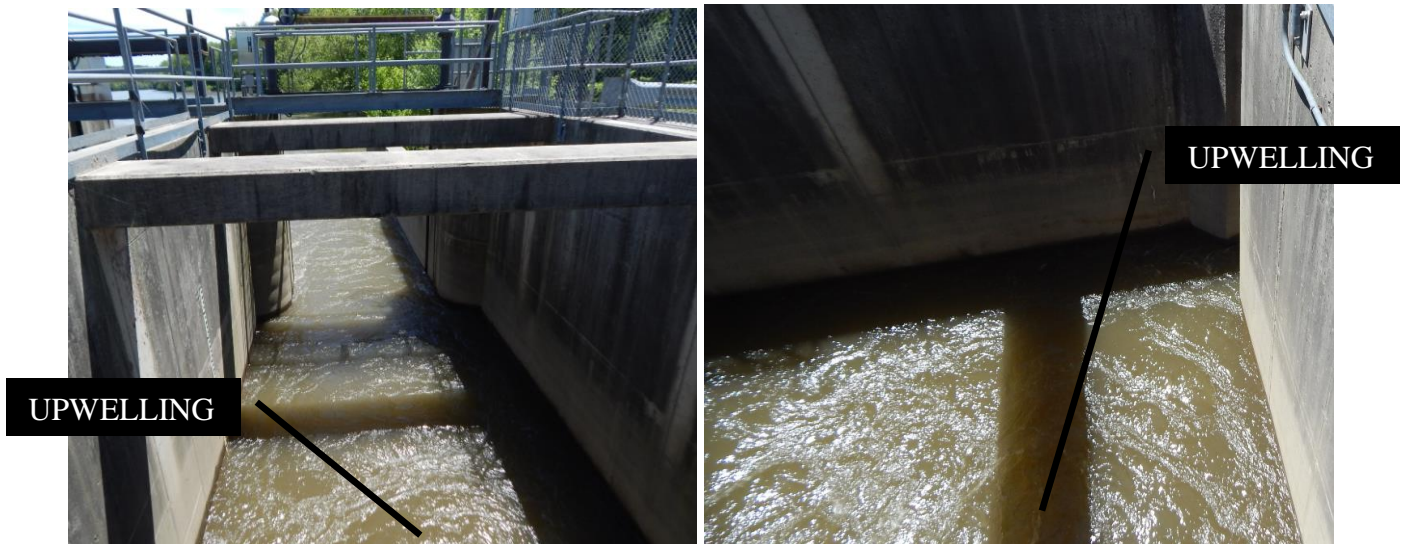
- Upwelling probably caused by discharge from the AWS floor diffuser - During the site visit, Service staff identified a location within the fish ladder entrance channel that showed indications of excessive hydraulic turbulence. A hydraulic upwelling (i.e., vertically oriented flow velocity vectors) was visible from the walking platform where visitors were standing (Figure 1). The force of this upwelling was clearly extending all the way up to the top of the water column, in the area of the entrance channel right over a floor diffuser. Floor diffusers are designed to discharge attraction flow from an auxiliary water supply (AWS) system to be combined with the internal fish ladder flows. The Service suspects that for whatever reason (e.g., pushing too much flow through the floor diffuser, or debris issues causing the diffuser to be partially blocked), flow velocities coming out of this floor diffuser are too high for this particular entrance channel. This unwanted upwelling could result in an interruption of the zone of passage inside the fishway.

Generally, a hydraulic upwelling should never be visible within the entire longitudinal profile of a well-maintained zone of passage for migratory fish. The Licensee should consider reducing the amount of flow going through the floor diffuser system to ensure visible upwelling is not occurring in the fishway.

Figure 1 - Visible upwelling within the fish ladder's entrance channel

1. Upwelling in the Entrance Channel - Please reduce the amount of flow going through the diffuser system to ensure visible upwelling is not occurring in the fishway.

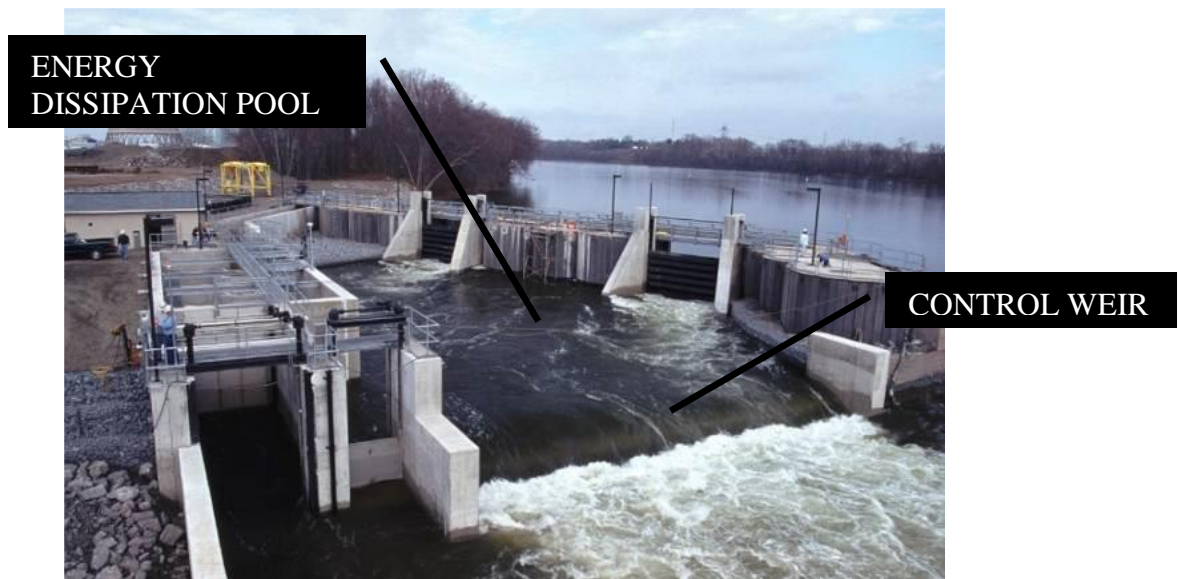
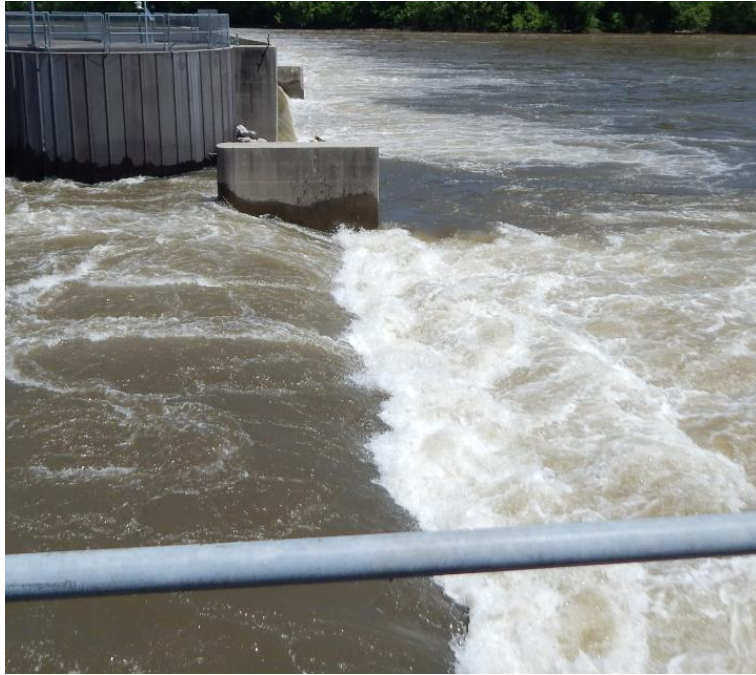
- The energy dissipation pool is accessible for upstream migrants - The hydraulic control weir at the downstream boundary of the energy dissipation pool (Figure 2) is frequently submerged by the water surface elevation of the tailrace. This submerged condition produces a control weir that is technically passable to some target species, making the energy dissipation pool accessible for potential upstream migrants. Once inside the energy dissipation pool, these migrants do not have a safe or effective way to continue their upstream migration. No corrective action is recommended at this time to address this particular issue.

Figure 2 – Energy dissipation pool downstream control weir is submerged by tailrace pool

2. Downstream Control Weir and Access to the Energy Dissipation Pool - This possible issue is noted in this report, but the Service is not recommending corrective action at this time.

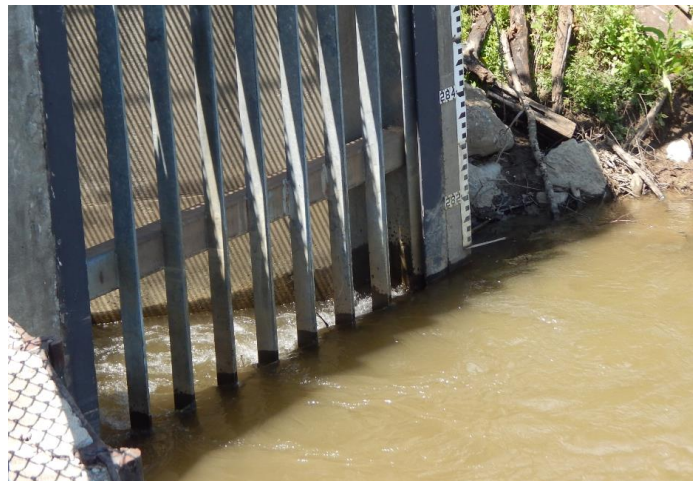
- At the time of site inspection, fish counting was still not required because the trigger to initiate the American shad upstream passage operating season (i.e., 1,000 American shad passed by the Safe Harbor Dam Fishway) had not been reached. For this reason, the fish counting window had not yet been cleaned for the season. No corrective action is recommended at this time to address this particular issue.
- During the time of the site inspection, debris accumulation against the upstream face of the fish ladder's exit channel trash rack was creating a head differential of approximately 3 inches between the upstream headpond and the water surface elevation inside the fish ladder channel (Figure 3).

Figure 3 - Head differential at the exit channel trash rack caused by debris accumulation

4. Debris Accumulation at the Fishway Exit Trash Rack - Per the FOP, the trash rack at the fishway exit is checked and cleaned daily during the shad passage season, but frequency of cleaning during the resident fish passage season is not specified in the FOP. During the resident fish passage season, general inspections, including debris removal at this rack, should occur at least twice per week. Additional inspections of the fishway during the resident fish passage season may also be needed after storms or high flow events to ensure debris is not accumulating at the fishway exit.
