SUSQUEHANNA RIVER
BASIN COMMISSION

Juniata River Subbasin Small Watershed Study: Morrison Cove

*A Water Quality and Biological Assessment,
April 2005 - February 2006*

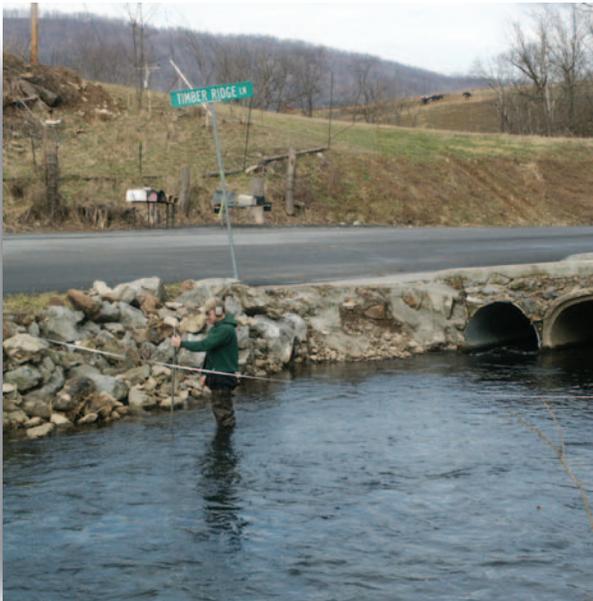
Taking a flow measurement in Plum Creek.

Flow at stream locations and in tributaries from large springs was measured using a Scientific Instruments pygmy or AA meter according to the USGS methods (Buchanan and Somers, 1969). At smaller springs and tributaries, where it was impossible to use a flow meter, a bucket with a known volume and a stopwatch were used to estimate flow. Numerous tributaries and springs were dry at different times during the sampling period due to below normal precipitation during the summer and fall.

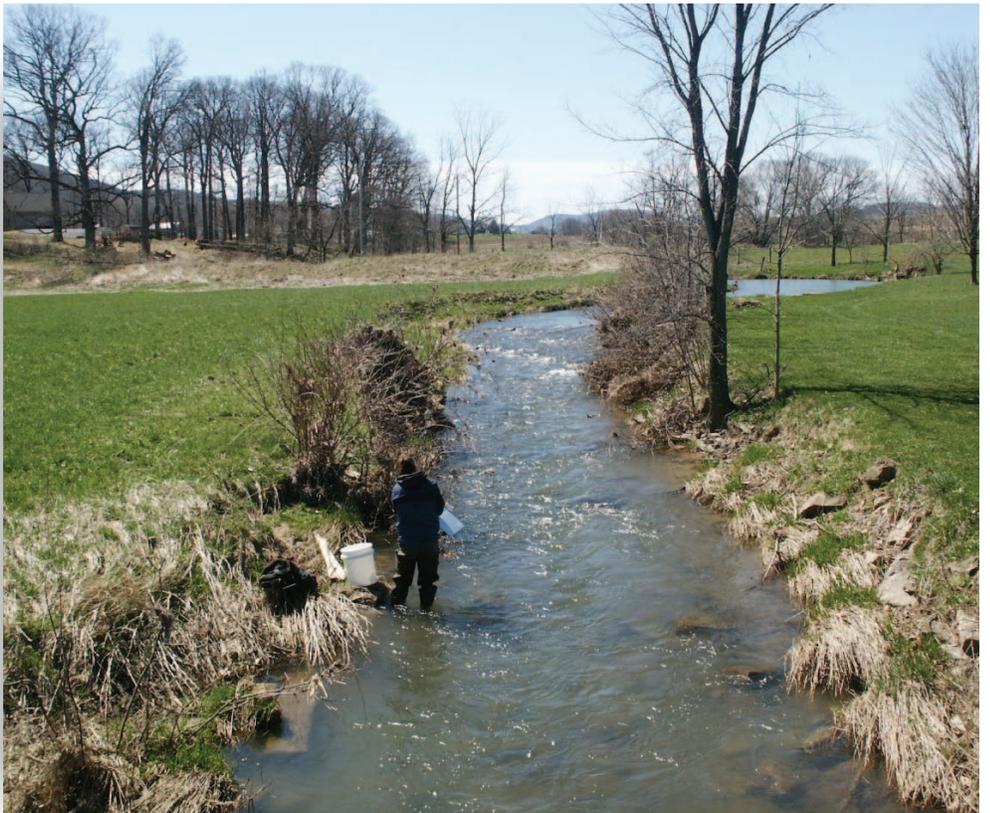
Collecting macroinvertebrates in the upstream reaches of Clover Creek.

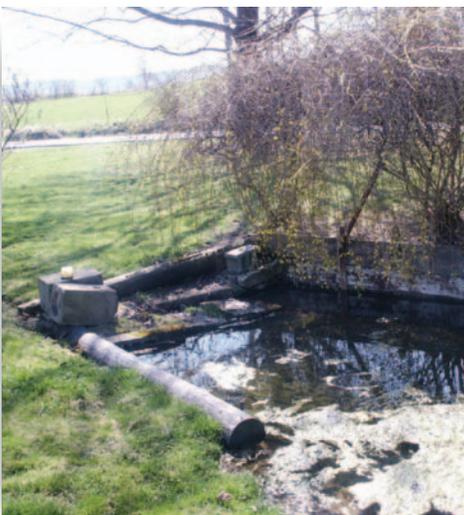
Large spring (S10) flows into Three Springs Run.

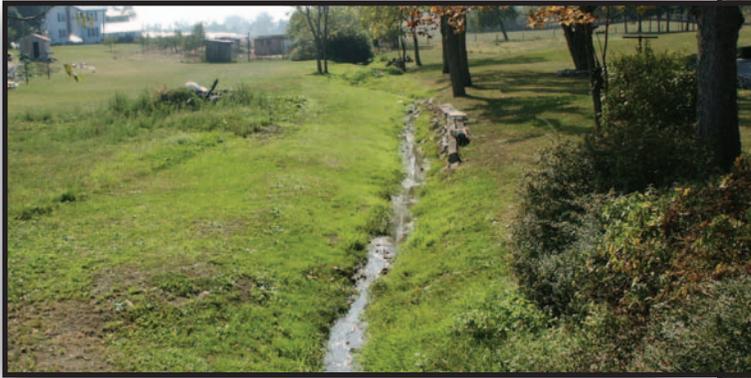
Headwaters of Halter Creek during low flows in October 2005.
