**ASSESSMENT OF INTERSTATE
STREAMS IN THE
SUSQUEHANNA RIVER BASIN**

Monitoring Report No. 20
July 1, 2005, Through June 30, 2006

*Watershed Assessment and Protection Division
Susquehanna River Basin Commission*

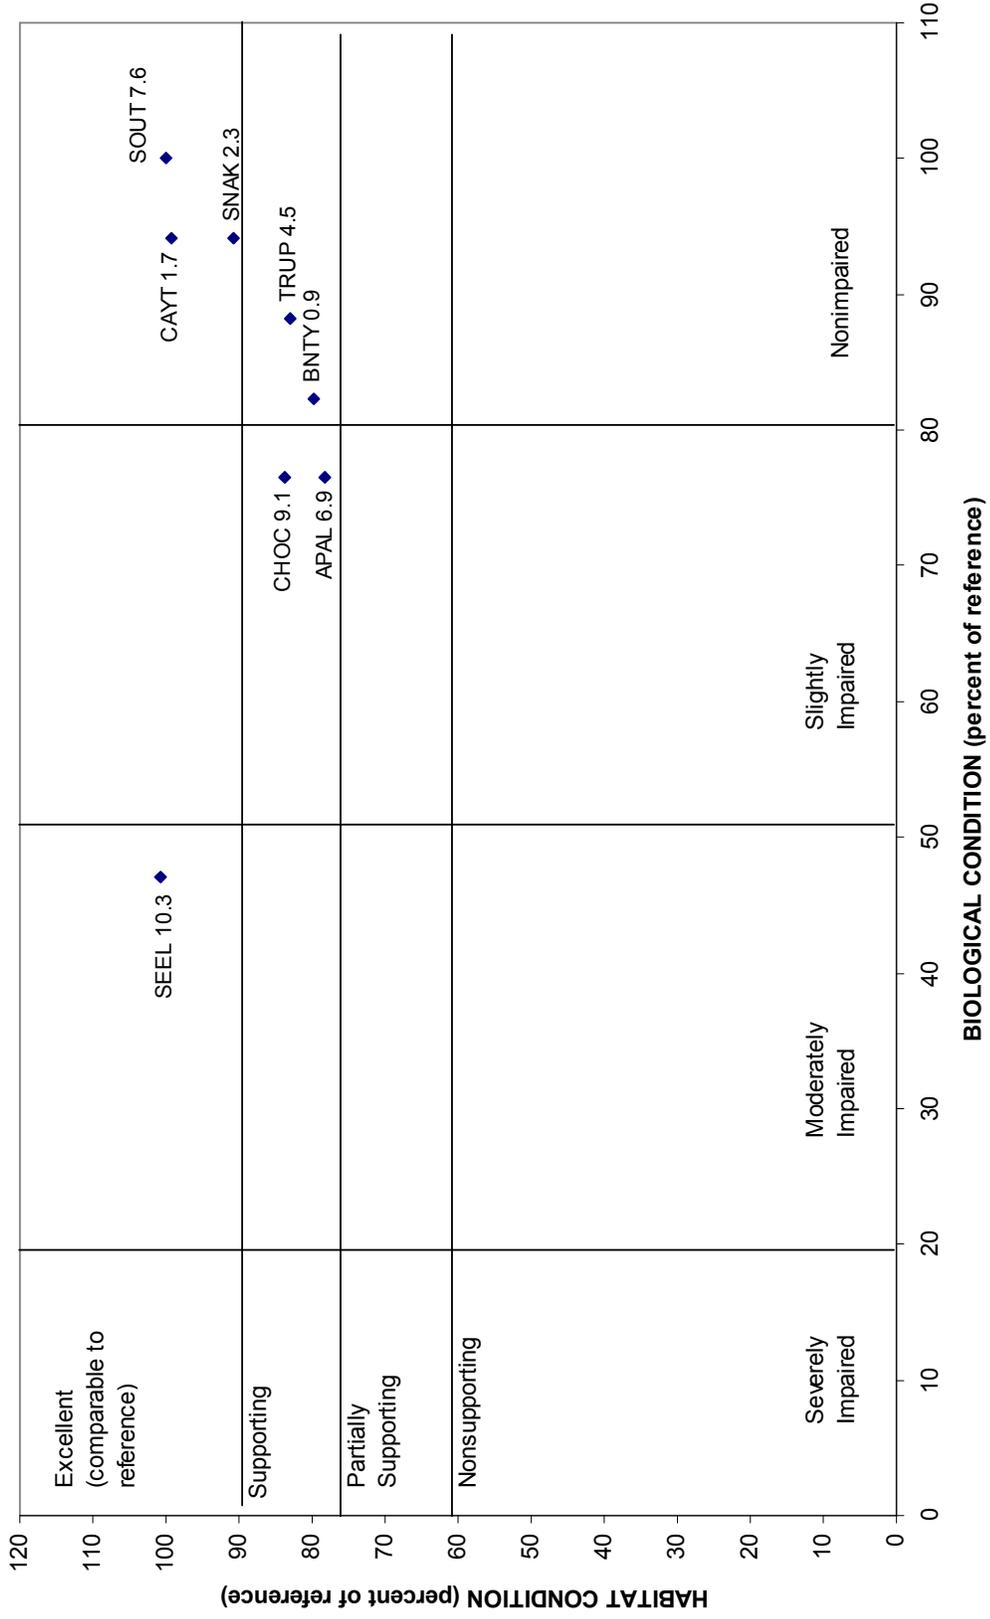
The chart below summarizes the biological and habitat data for the New York-Pennsylvania streams.

The reference site for the New York-Pennsylvania border streams was South Creek at Fassett, Pa. This site had the best combination of water quality, biological community, and physical habitat of all the New York-Pennsylvania sites. The rankings for the other New York-Pennsylvania border sites are compared to the conditions in South Creek. The macroinvertebrate community at South Creek showed high rankings for taxonomic richness, Shannon Diversity Index, Hilsenhoff Biotic Index, percent Ephemeroptera, percent Chironomidae, and percent dominant taxa. In the habitat assessment for SOUT 7.8, condition of banks and vegetative protective cover were rated as optimal.

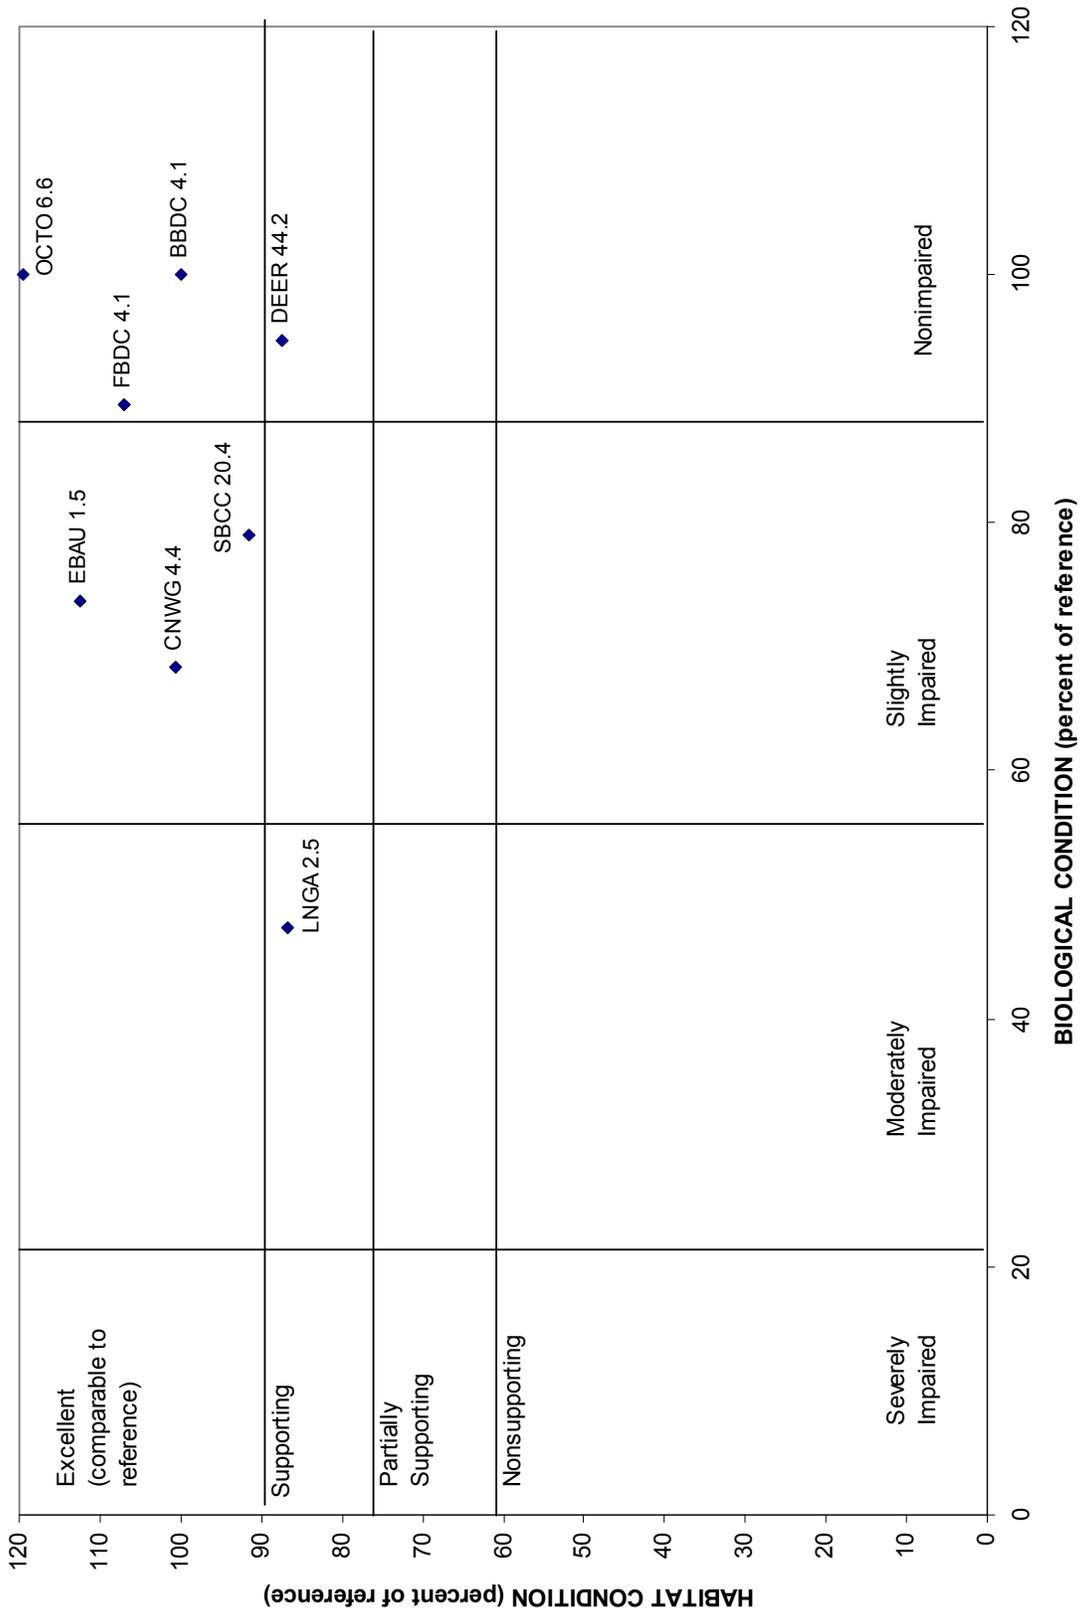
The chart below summarizes the biological and habitat data for the Pennsylvania-Maryland streams.

The reference site for the Pennsylvania-Maryland border streams was Big Branch Deer Creek at Fawn Grove, Pa. This site had the best combination of water quality, biological community, and physical habitat of all the Pennsylvania-Maryland sites. The rankings for the other Pennsylvania-Maryland border sites are compared to the conditions at Big Branch Deer Creek. The macroinvertebrate community at Big Branch Deer Creek showed high rankings for Hilsenhoff Biotic Index, EPT Index, and percent Chironomidae. In the habitat assessment for BBDC 4.5, instream cover, channel flow status, condition of banks, and vegetative protective cover were all rated as optimal.

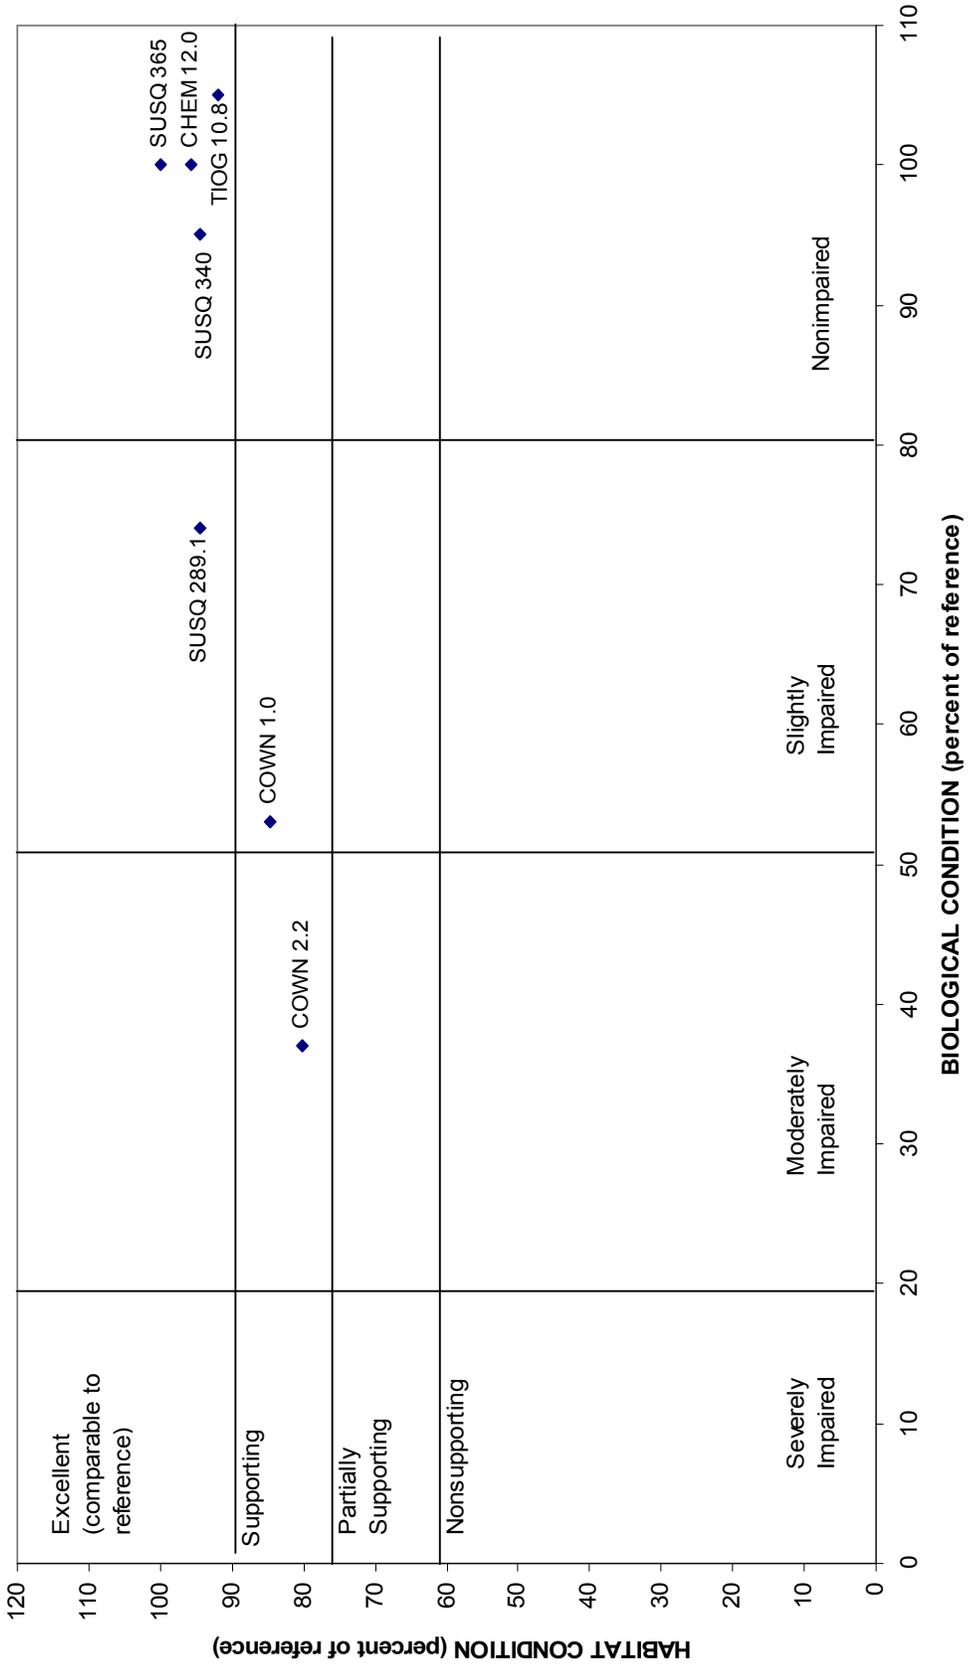
The chart below summarizes the biological and habitat data for the river sites.

River sites consisted of nine stations located on the Susquehanna, Chemung, Cowanesque, and Tioga Rivers. Two stations (SUSQ 10.0 and SUSQ 44.5) were not sampled for macroinvertebrates due to deep water and a lack of riffle habitat at the sites. Of the seven river sites that were sampled during fiscal year 2006, the biological community at four (57 percent) of these sites was nonimpaired. One site (14 percent) had slightly impaired biological conditions and two sites (29 percent) were ranked as moderately impaired. The habitat at five (71 percent) of the river sites was excellent and the other two sites (29 percent) rated as having supporting habitat. The most common habitat concern along the river sites is lack of riparian buffer.

The reference site for all of the interstate river sites was Susquehanna River 365. This site had the best combination of water quality, biological conditions, and physical habitat of all the sampled river sites. The rankings for the other river sites are compared to the conditions at Susquehanna River 365. The macroinvertebrate community at SUSQ 365 was at the top of all river sites in scores for taxonomic richness, Shannon Diversity Index, Hilsenhoff Biotic Index, EPT Index, and percent dominant taxa. In the habitat assessment for SUSQ 365, frequency of riffles, velocity/depth regimes, and vegetative protective cover were all rated as optimal.

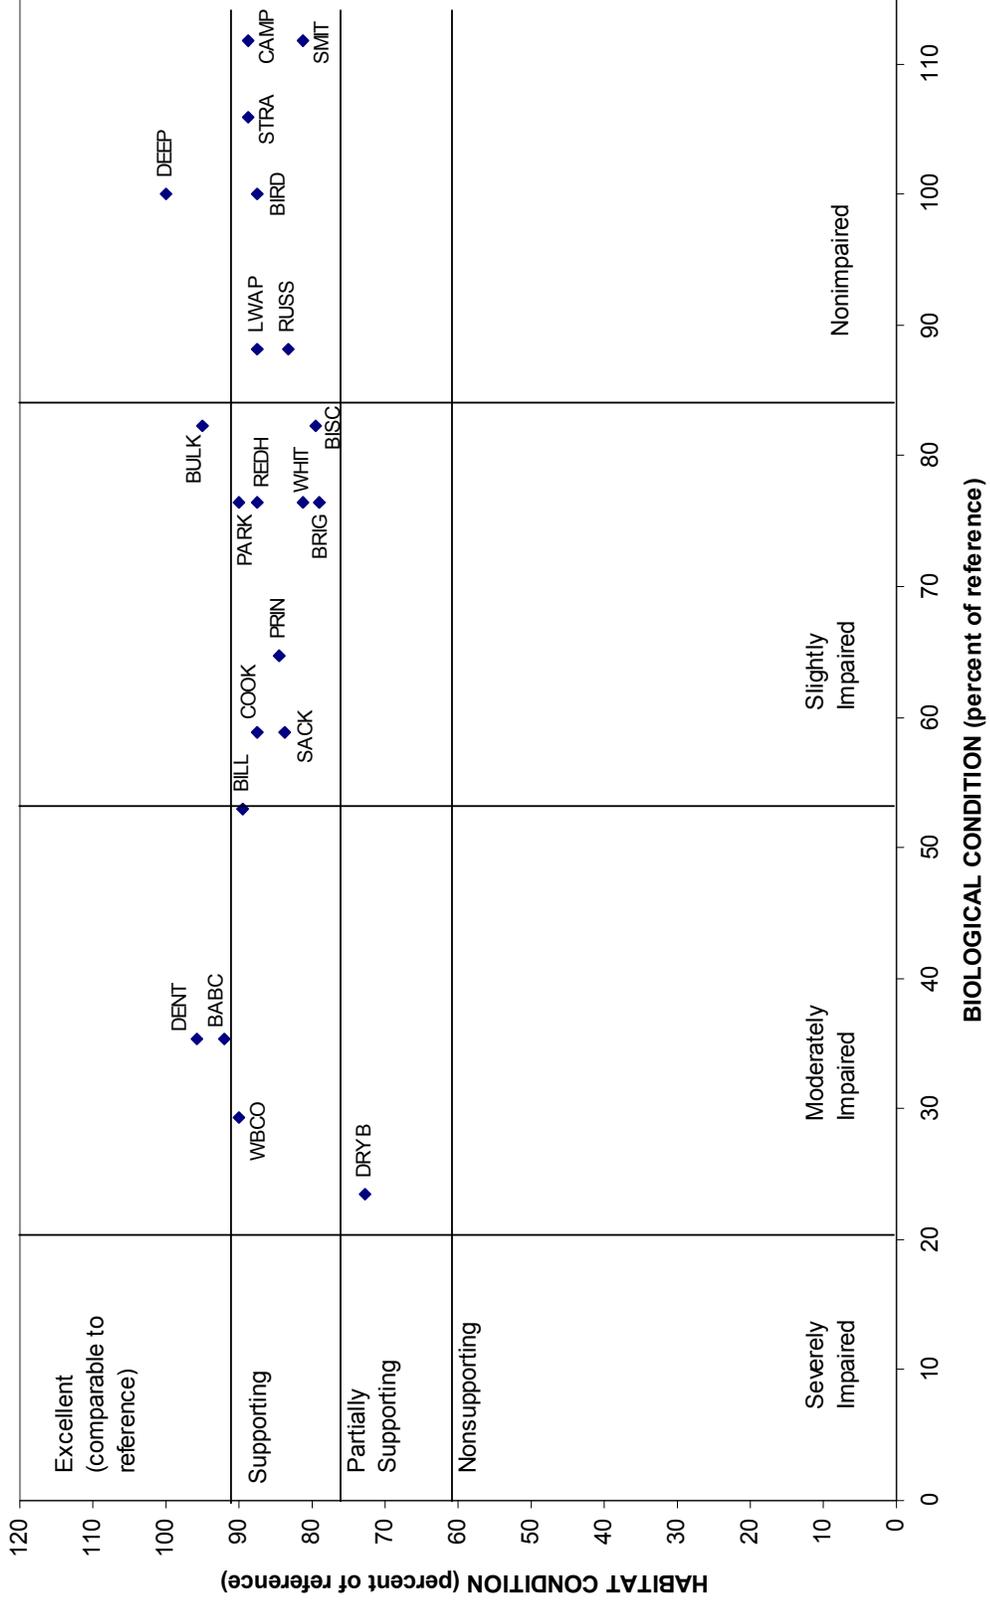
The chart below summarizes the biological and habitat data for the Group 3 streams.

Group 3 sampling stations consisted of 21 sites on small streams located along the New York-Pennsylvania border. Seven of the 21 sites sampled (33 percent) had nonimpaired biological conditions. Nine sites (43 percent) were slightly impaired, and five sites (24 percent) were moderately impaired. Six (29 percent) of the Group 3 sites had excellent habitat scores. Fourteen sites (67 percent) had supporting habitat conditions, while one site (4 percent) was designated partially supporting, and no sites were nonsupporting.

The reference site for the Group 3 streams was Deep Hollow Brook at Danville, N.Y. This site had the best combination of biological community and physical habitat of all the Group 3 sites. The rankings for the other Group 3 sites are compared to the conditions at Deep Hollow Brook. The macroinvertebrate community at DEEP showed highest rankings for taxonomic richness, Shannon Diversity Index, and EPT Index. In the habitat assessment for Deep Hollow Brook, epifaunal substrate, instream, cover, channel alteration, frequency of riffles, vegetative protective cover, and riparian vegetative zone were all rated as optimal.

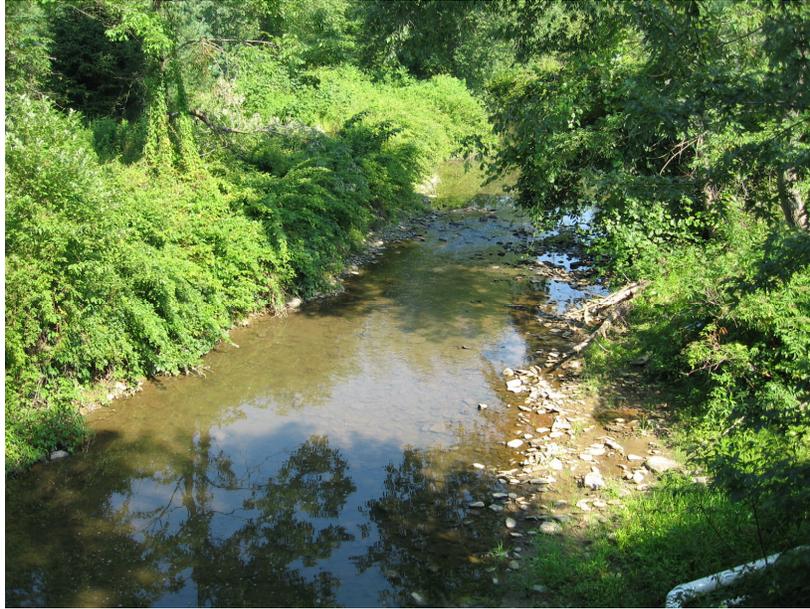
Apalachin Creek at Little Meadows, Pa. (APAL 6.9)

Water Quality: Aluminum, iron and dissolved oxygen exceeded water quality parameters.

Biological Condition: Slightly Impaired

Trends: Water quality and biological condition declined from last year, and the physical habitat remained at supporting.

Other notes: Staff noted an oil slick in the creek upstream of the sampling site in August 2006.

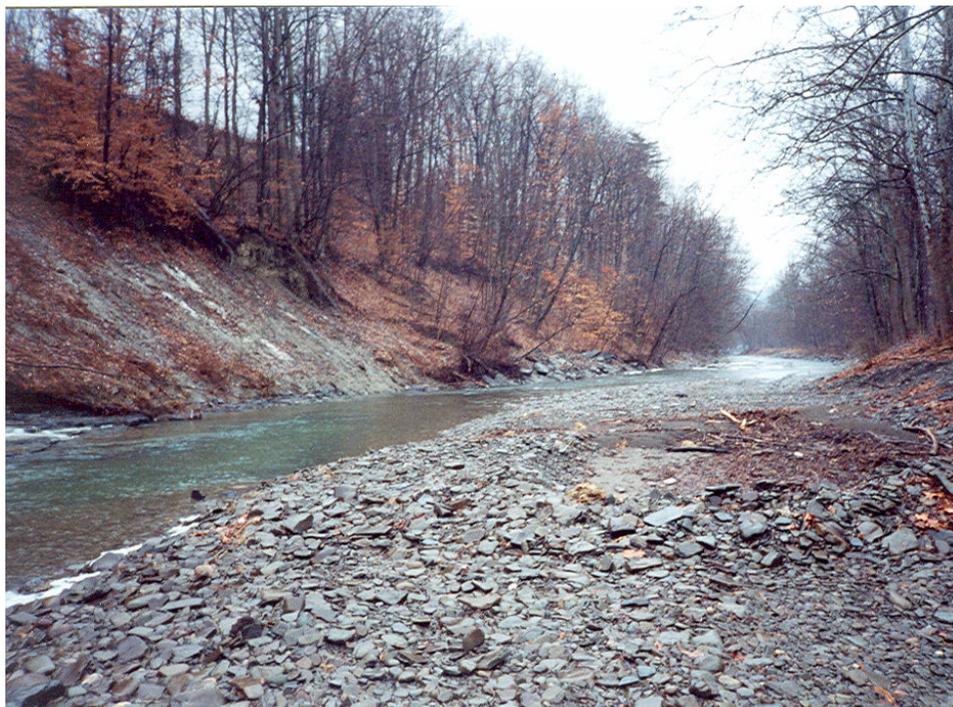
Bentley Creek at Wellsburg, N.Y. (BNTY 0.9)

Water Quality: Aluminum exceeded water quality standards.

Biological Condition: Slightly Impaired

Trends: Water quality and biologic condition both showed some decline from last year, while habitat assessment remained supporting.

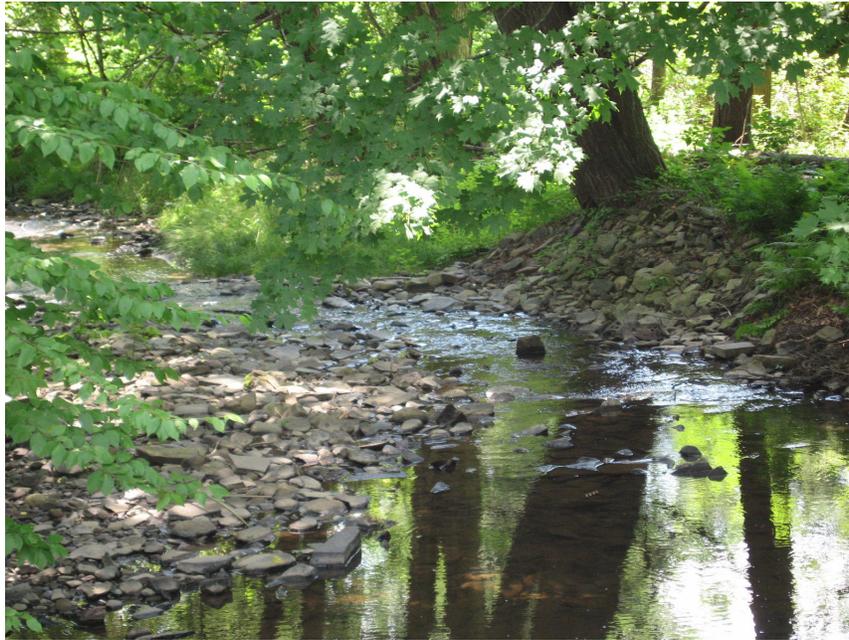
Cascade Creek at Lanesboro, Pa. (CASC 1.6)

Water Quality: Aluminum, iron, alkalinity, and pH all exceeded water quality standards.

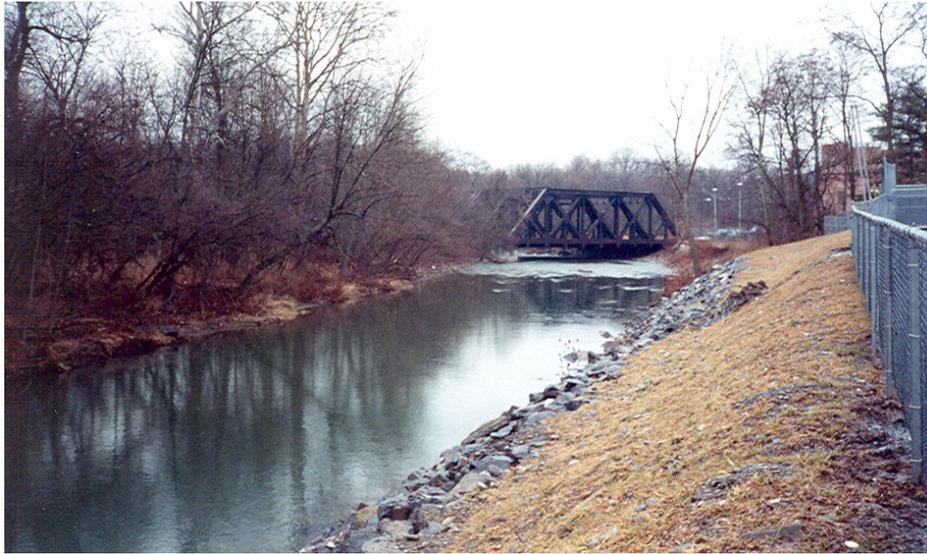
Cayuta Creek at Waverly, N.Y. (CAYT 1.7)

Water Quality: Aluminum, chlorine, and pH all exceeded water quality standards.

Biological Condition: Nonimpaired

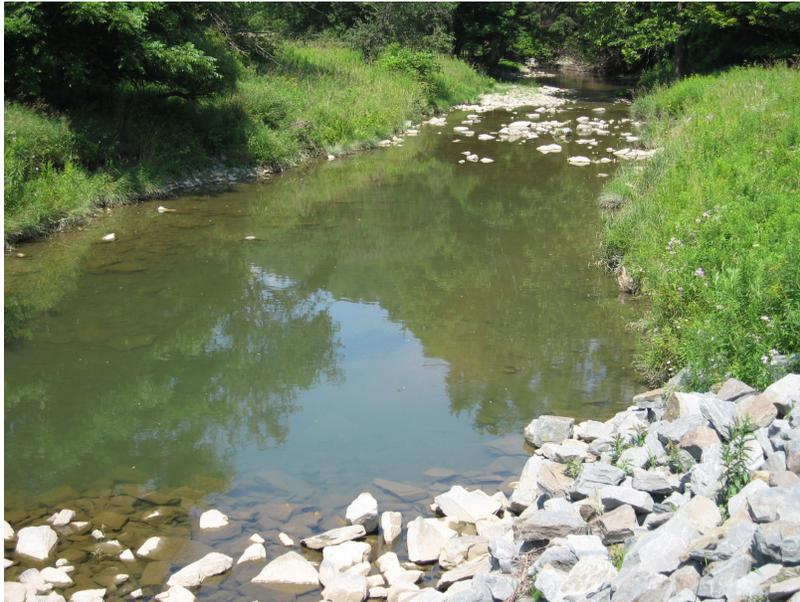
Choconut Creek at Vestal Center, N.Y. (CHOC 9.1)

Water Quality: Aluminum, iron, dissolved oxygen, and pH all exceeded water quality standards.

Biological Condition: Slightly Impaired

Trends: Water quality, biological condition, and habitat rating all declined from 2004-2005.

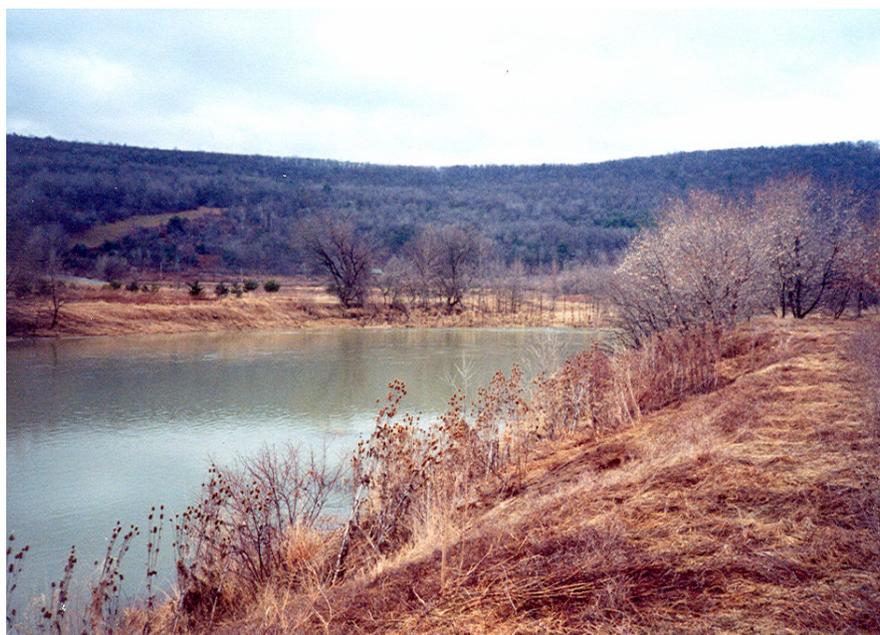
Cowanesque River at Lawrenceville, Pa. (COWN 1.0)

Water Quality: Aluminum and iron exceeded water quality standards.

Biological Condition: Moderately Impaired

Trend: Water quality declining slightly since 2004-2005; biological condition declining from last year; physical habitat remains the same.

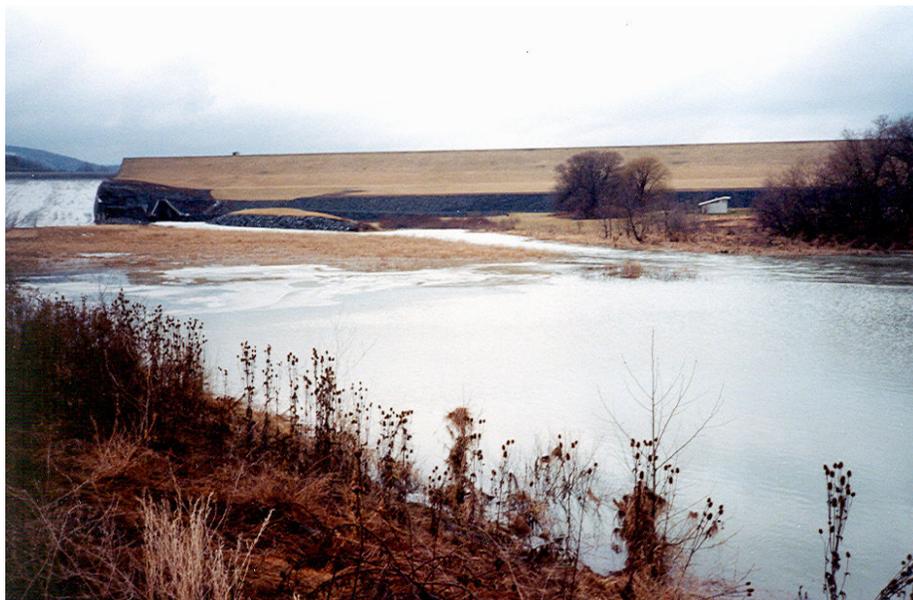
Cowanesque River at Lawrenceville, Pa. (COWN 2.2)

Water Quality: Aluminum and iron exceeded water quality standards.

Biological Condition: Moderately Impaired

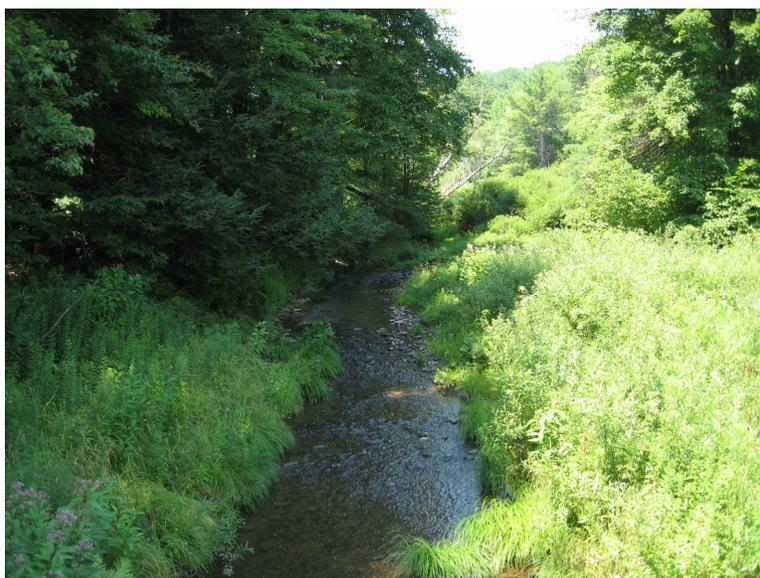
Little Snake Creek at Brackney, Pa. (LSNK 7.6)

Water Quality: Aluminum, alkalinity, and iron all exceeded water quality standards.

Trend: Water quality has been improving slightly over the last five years, and biological condition and habitat have remained consistent when there was enough water in the stream to sample in the summer.

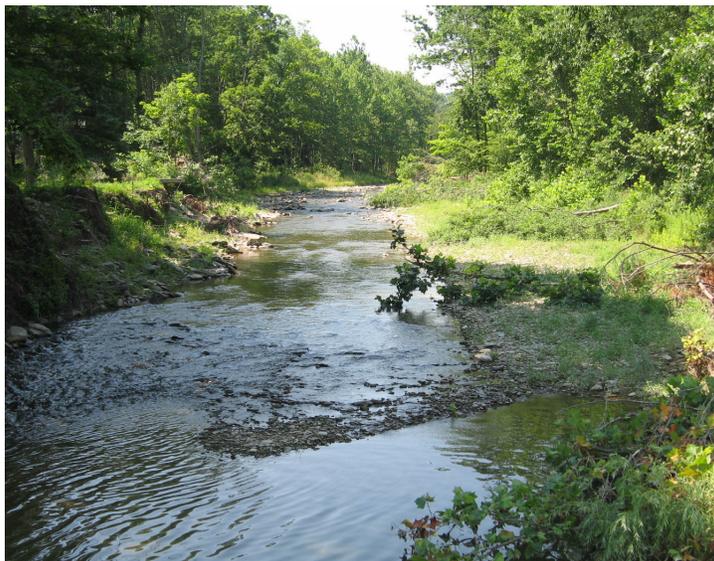
Snake Creek at Brookdale, Pa. (SNAK 2.3)

Water Quality: Aluminum exceeded water quality standards.

Biological Condition: Nonimpaired

Trends: Water quality remained about the same and biological condition and habitat rating both kept their nonimpaired and excellent ratings, respectively.

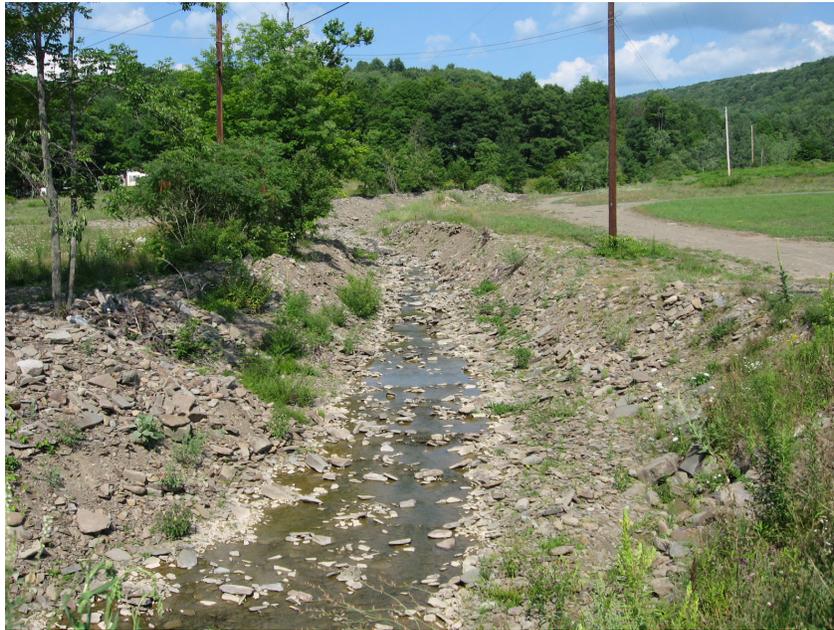
Trowbridge Creek at Great Bend, Pa. (TROW 1.8)

Trend: Water quality has remained fairly consistent over the past five years and biological condition has shown some improvement. However, this site has been dry two of the last five years.

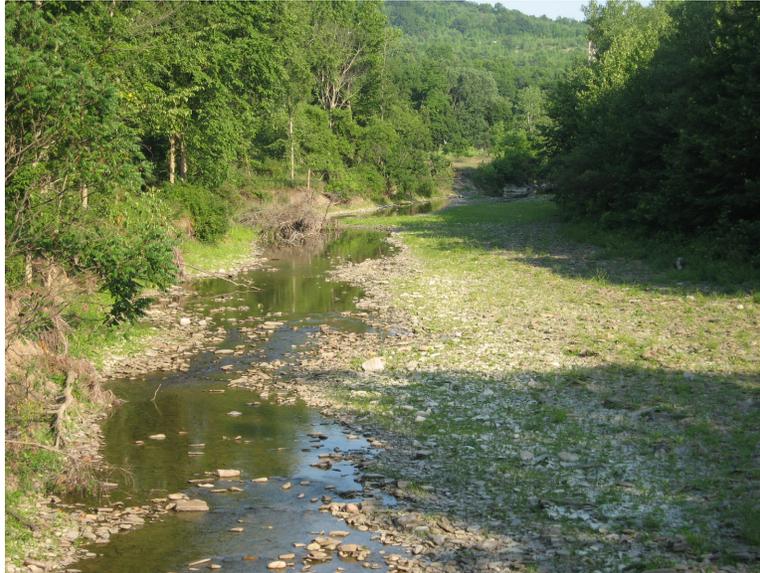
Wappasening Creek at Nichols, N.Y. (WAPP 2.6)

Trend: Water quality and biological condition have been steadily improving over the past five years. This is the first time in five years that the stream has been dry during a sampling event.

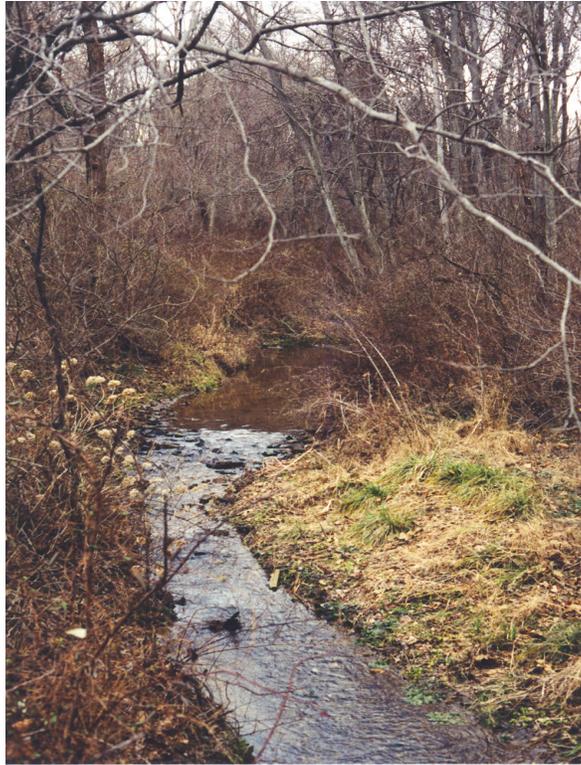
Big Branch Deer Creek at Fawn Grove, Pa. (BBDC 4.1)

Water Quality: No parameters exceeded water quality standards.

Biological Condition: Reference (Nonimpaired)

Trends: Water quality, biological condition, and physical habitat remained the same over the last year.

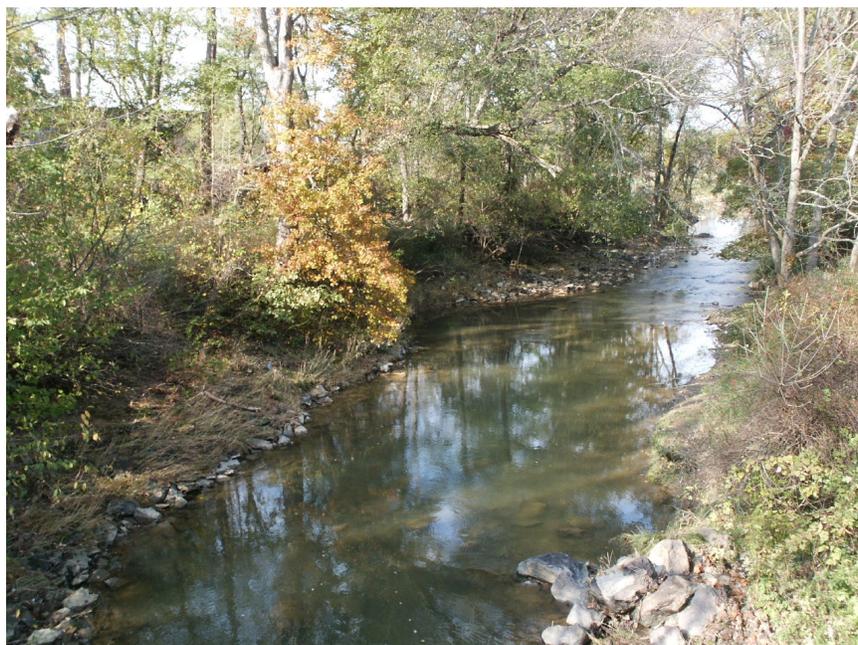
Conowingo Creek at Pleasant Grove, Pa. (CNWG 4.4)

Water Quality: Nitrate plus nitrite exceeded water quality standards.

Biological Condition: Slightly impaired

Other Notes: Staff noted poor riparian vegetative habitat at this sampling location.

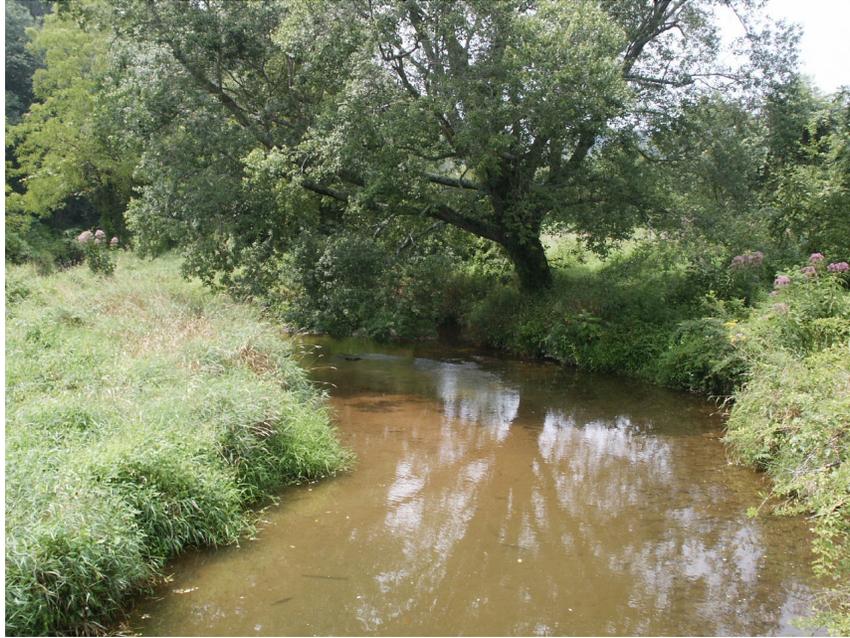
Deer Creek at Gorsuch Milles, Md. (DEER 44.2)

Water Quality: No parameters exceeded water quality standards.

Biological Condition: Nonimpaired

Trends: Water quality showed a slight decline since last year with higher WQI scores, biological condition remained nonimpaired but habitat ranking fell to supporting.

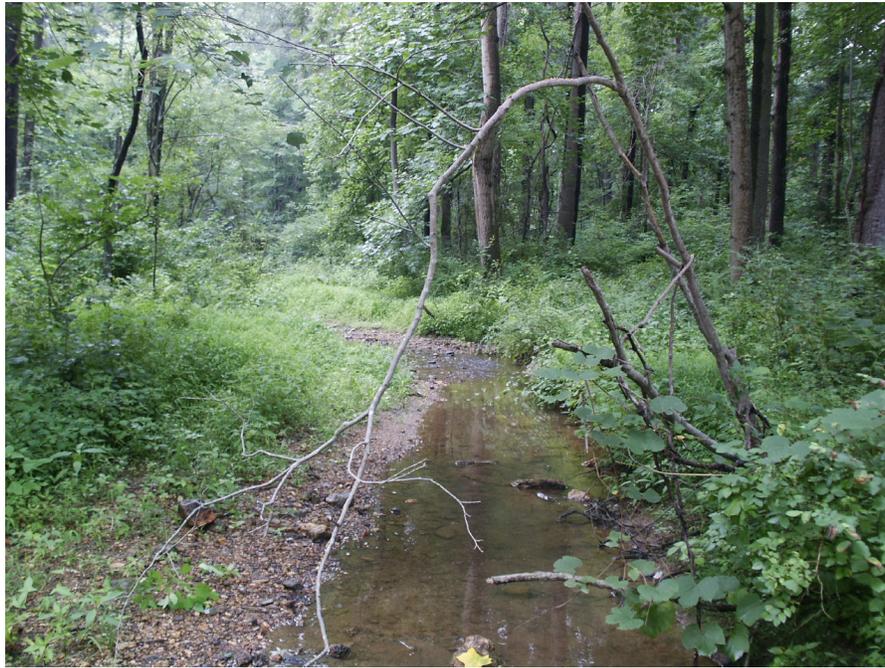
Ebaughs Creek at Stewartstown, Pa. (EBAU 1.5)

Water Quality: Chlorine exceeded water quality standards.

Biological Condition: Slightly impaired

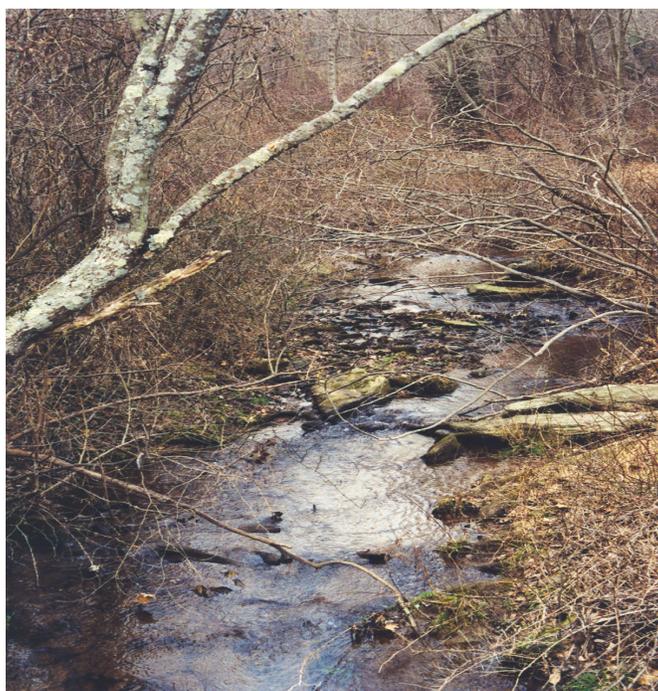
Falling Branch Deer Creek at Fawn Grove, Pa. (FBDC 4.1)

Water Quality: Alkalinity exceeded water quality standards.

Biological Condition: Nonimpaired

Other Notes: Staff noted excellent instream cover and vegetative protective bank cover at this sampling site.

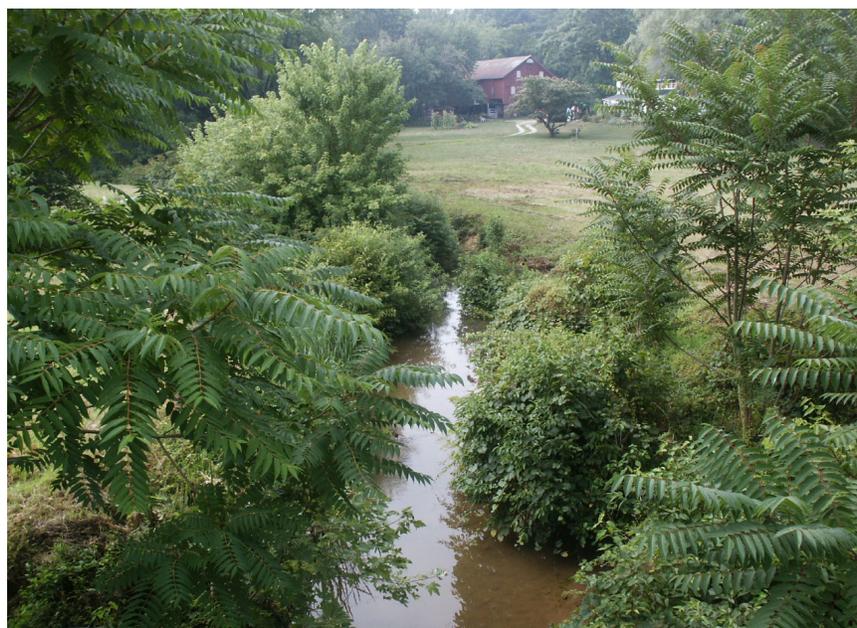
Long Arm Creek at Bandanna, Pa. (LNGA 2.5)

Water Quality: At LNGA 2.5, pH exceeded the water quality standard.

Biological Condition: Moderately impaired

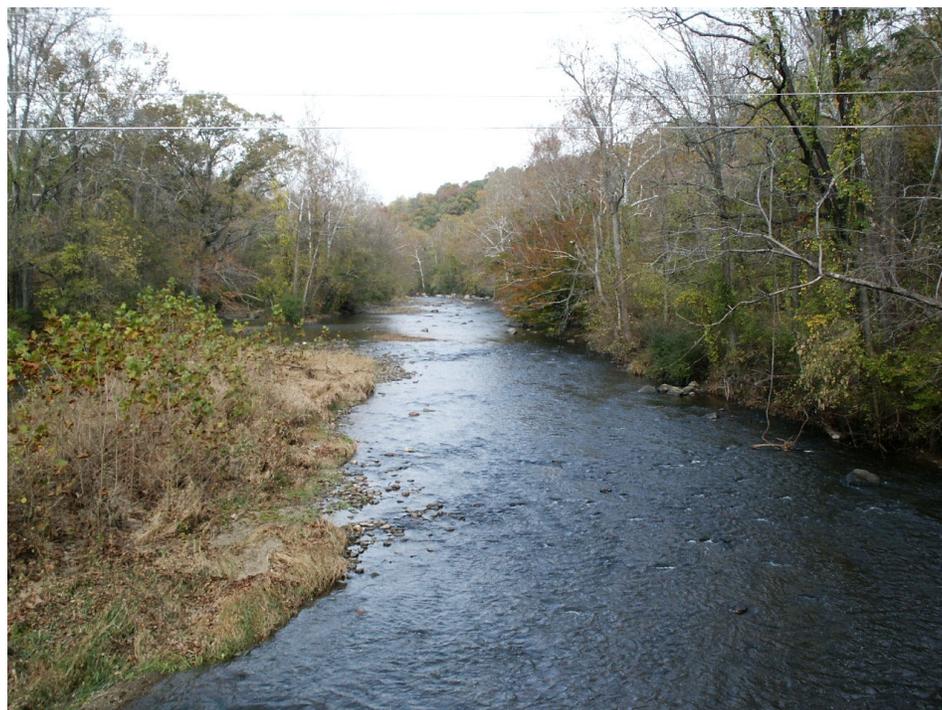
Octoraro Creek at Rising Sun, Md. (OCTO 6.6)

Water Quality: No parameters exceeded water quality standards.

Biological Condition: Nonimpaired

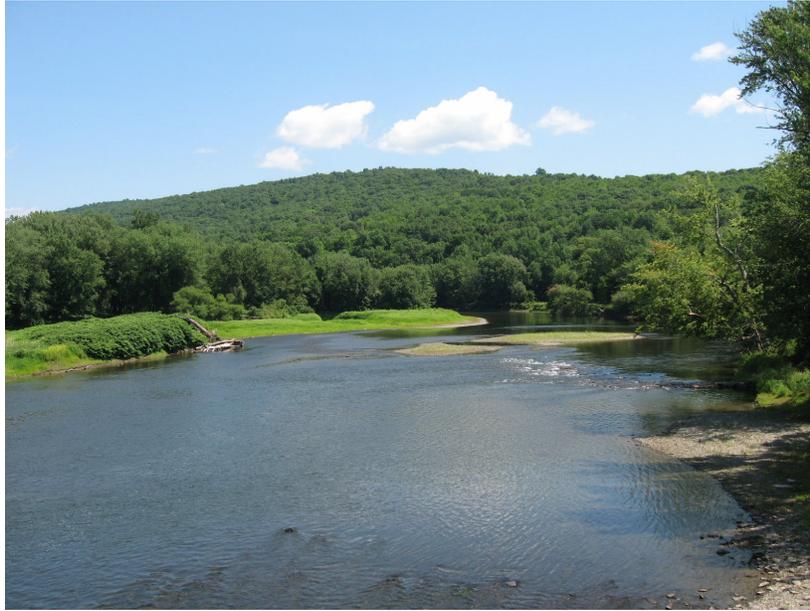
Susquehanna River at Windsor, N.Y. (SUSQ 365.0)

Water Quality: Aluminum and iron exceeded water quality standards.

Biological Condition: Reference (Nonimpaired)

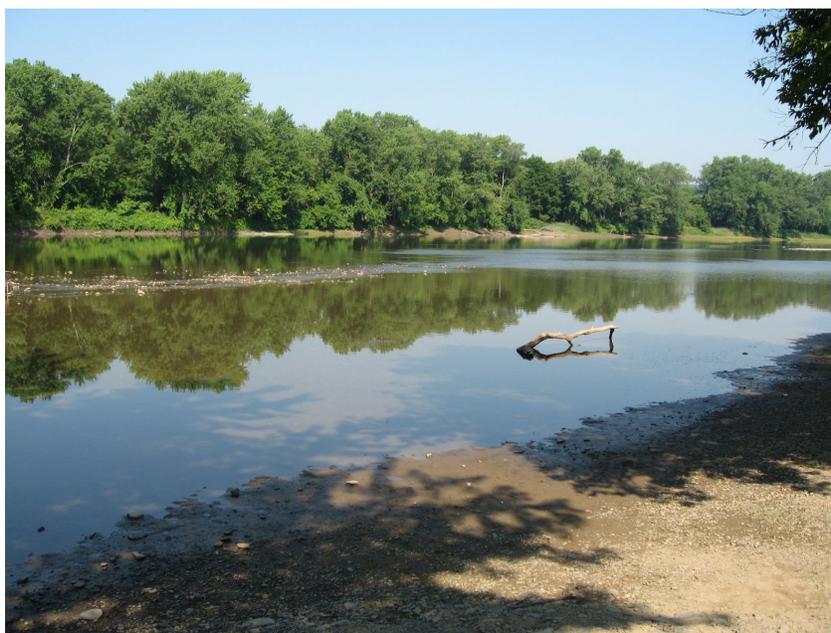
Susquehanna River at Kirkwood, N.Y. (SUSQ 340.0)

Water Quality: Aluminum and iron exceeded water quality standards.

Biological Condition: Nonimpaired

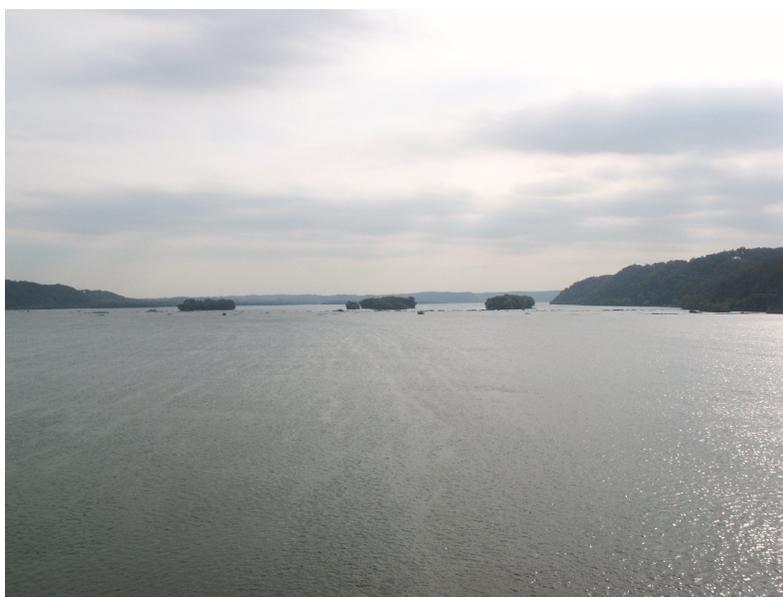
Susquehanna River at Marietta, Pa. (SUSQ 44.5)

Water Quality: No parameters exceeded water quality standards.

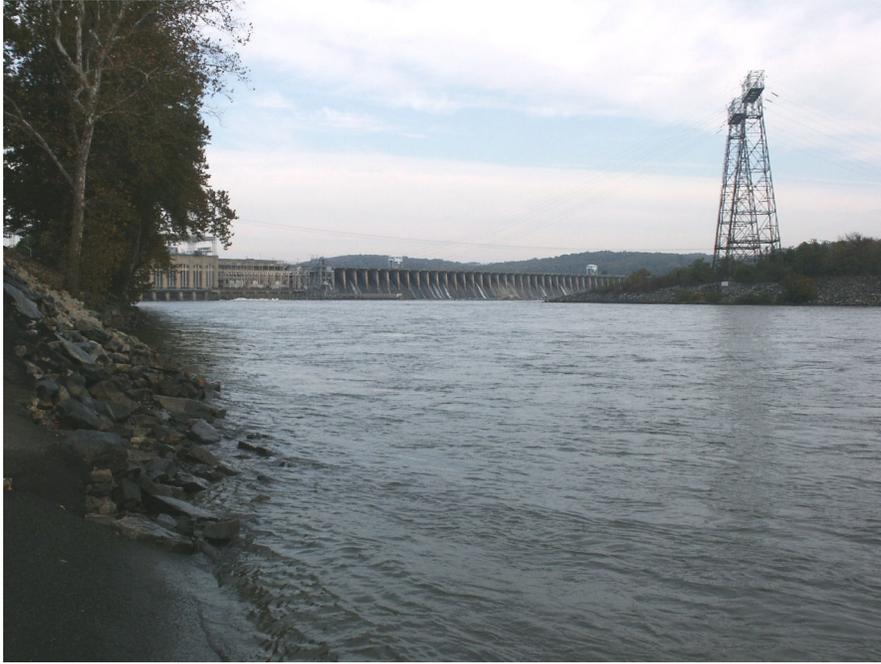
Susquehanna River at Conowingo, Md. (SUSQ 10.0)

Water Quality: Dissolved oxygen exceeded water quality standards.

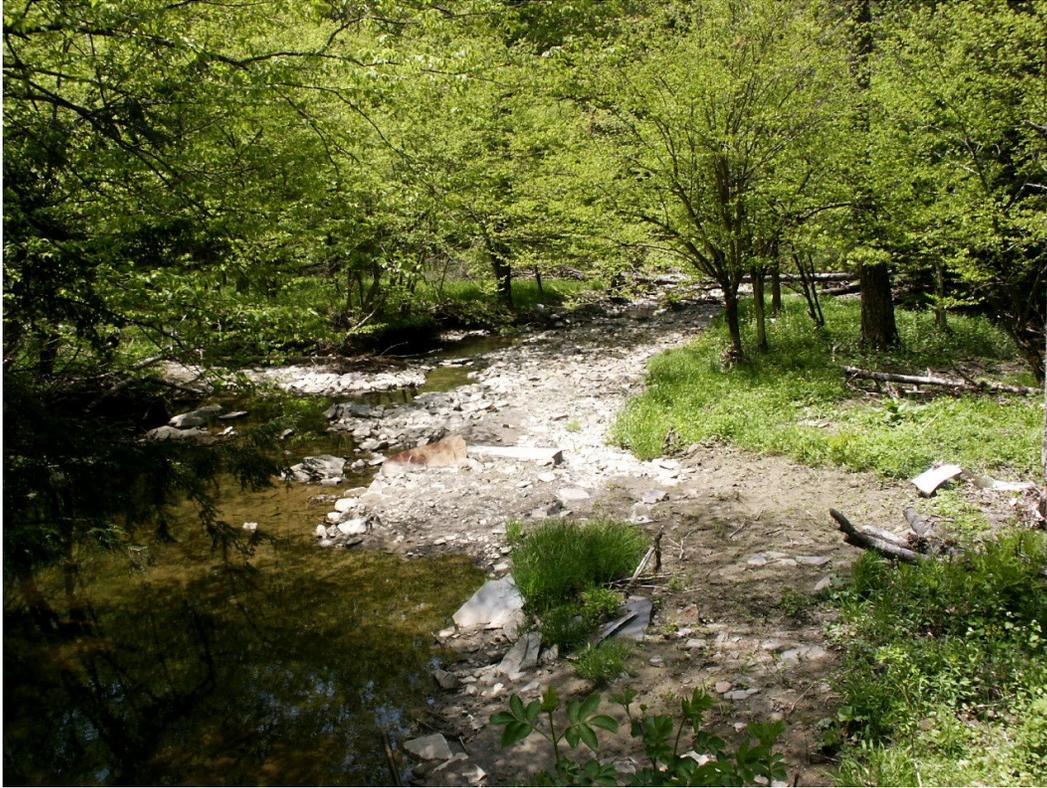
Babcock Run (BABC)

During May 2006, the macroinvertebrate community of Babcock Run near Cadis, Pa., was designated as moderately impaired; which is a marked decline from last years nonimpaired rating. BABC had low metric scores for EPT Index, percent Chironomidae, and percent dominant taxa. The pollution tolerant Chironomidae midges were almost 60 percent of the entire sample. Physical habitat conditions were once again rated excellent, with good scores for epifaunal substrate, velocity/depth regimes, frequency of riffles, and vegetative protective cover. All field chemistry parameters were within acceptable limits. BABC is located in a mostly forested watershed, and the stream bed is dominated by cobble substrate.

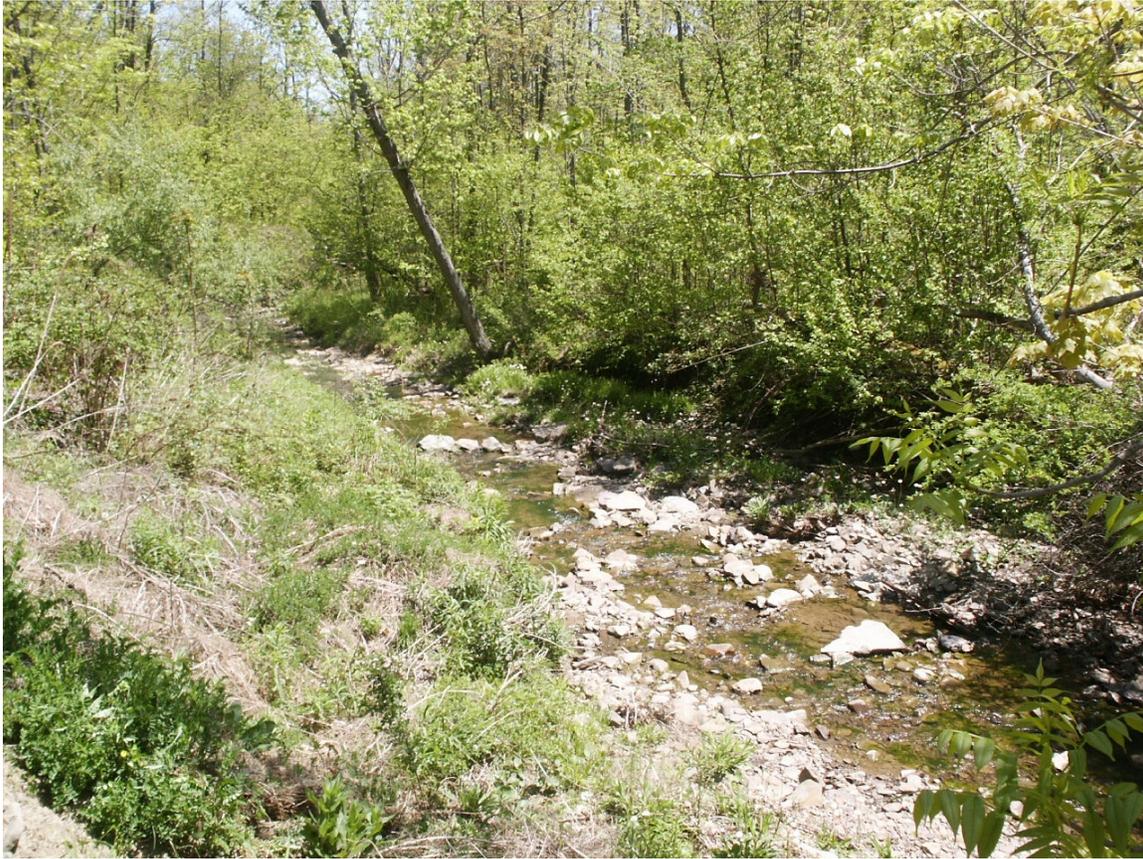
Beagle Hollow/Redhouse Run (BEAG)

Slightly impaired biological conditions existed at Beagle Hollow Run (this stream is also sometimes called Redhouse Run) near Osceola, Pa., during May 2006. The sample contained a large number of organic pollution-intolerant organisms, such as the stonefly genus *Leuctra* (Plecoptera: Leuctridae) and the mayfly genus *Eperous* (Ephemeroptera: Heptageniidae). This resulted in high scores for Hilsenhoff Biotic Index and percent Ephemeroptera. However, taxonomic richness and Shannon Diversity did not rank very high. Habitat conditions were considered supporting, with good scores for frequency of riffles and vegetative protective cover but poor scores for condition of banks and riparian vegetative zone width. All field chemistry parameters were within natural ranges.
