**ASSESSMENT OF INTERSTATE
STREAMS IN THE
SUSQUEHANNA RIVER BASIN**

Monitoring Report No. 20
July 1, 2005, Through June 30, 2006

*Watershed Assessment and Protection Division
Susquehanna River Basin Commission*

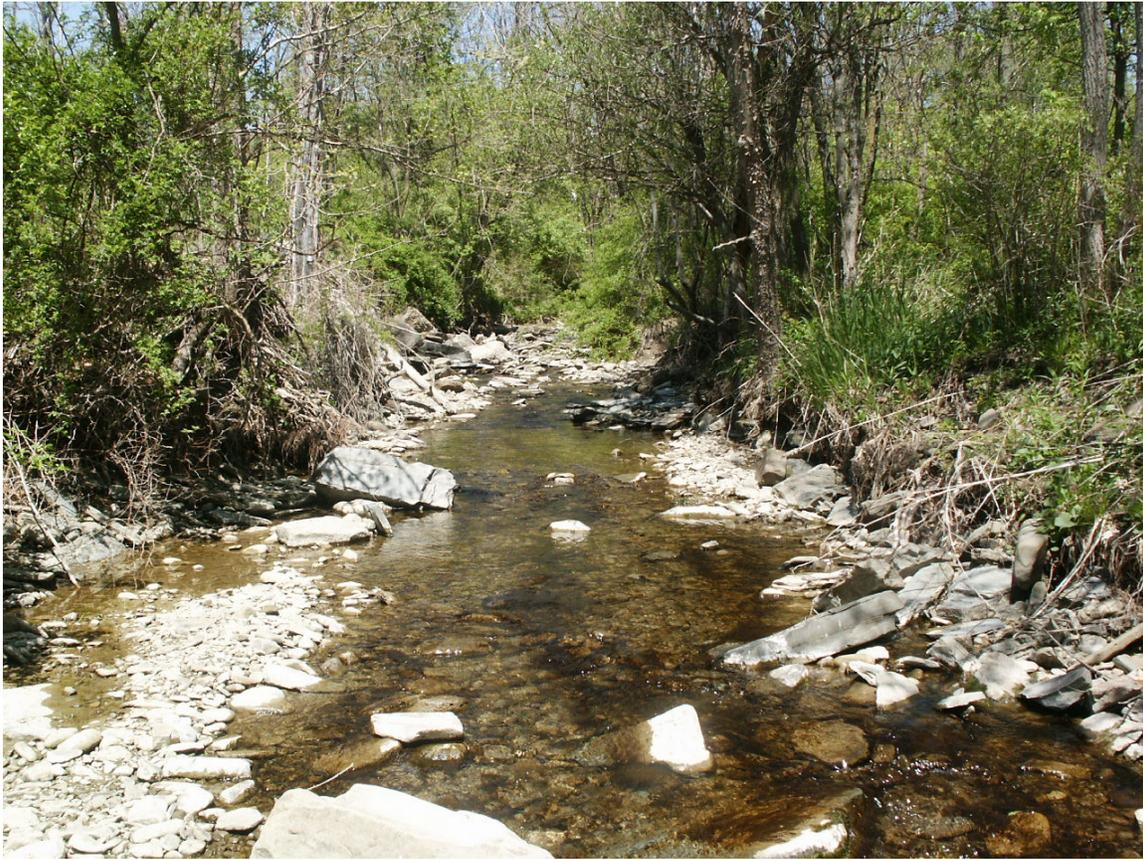
Bill Hess Creek (BILL)

Bill Hess Creek near Nelson, Pa., was designated moderately impaired, which is a decline from last years ranking of slightly impaired. The biological community showed poor scores for Shannon Diversity Index, Hilsenhoff biotic Index, and percent Chironomidae. Midges dominated the sample at greater than 60 percent of the sample. The habitat was rated supporting again this year, with low scores given for condition of banks, velocity/depth regimes, riparian vegetative zone, and channel flow status. All field chemistry parameters were within acceptable limits.

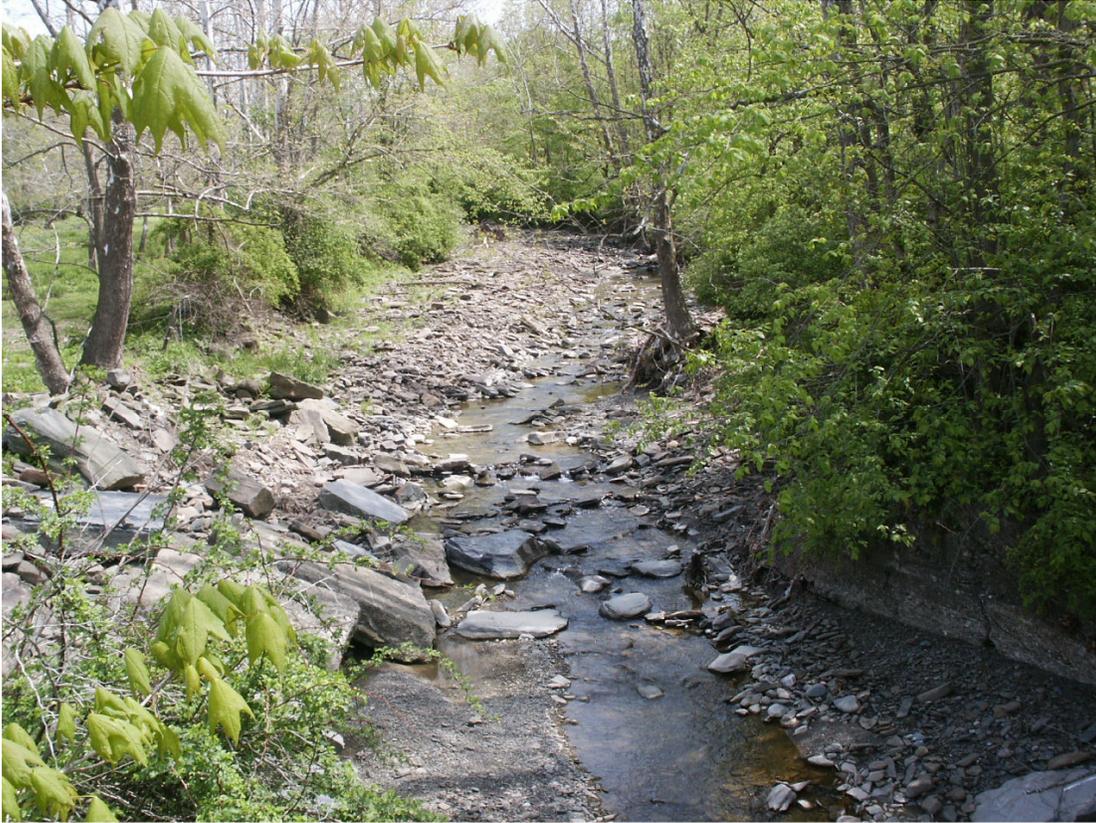
Briggs Hollow Run (BRIG)

Briggs Hollow Run near Nichols, N.Y., was designated slightly impaired during the 2006 sampling season for the second consecutive year. The sample showed with good metric scores for Hilsenhoff Biotic Index and percent Ephemeroptera. The very low metric score for Hilsenhoff Index means there were a large number of pollution intolerant organisms in the sample, such as the mayfly genera *Epeorus*. However, BRIG also had a fairly low taxonomic richness and Shannon Diversity Index. The physical habitat was designated as supporting and was given low scores for epifaunal substrate, embeddedness, channel flow status, and riparian vegetative zone width. All field chemistry parameters were within acceptable limits.

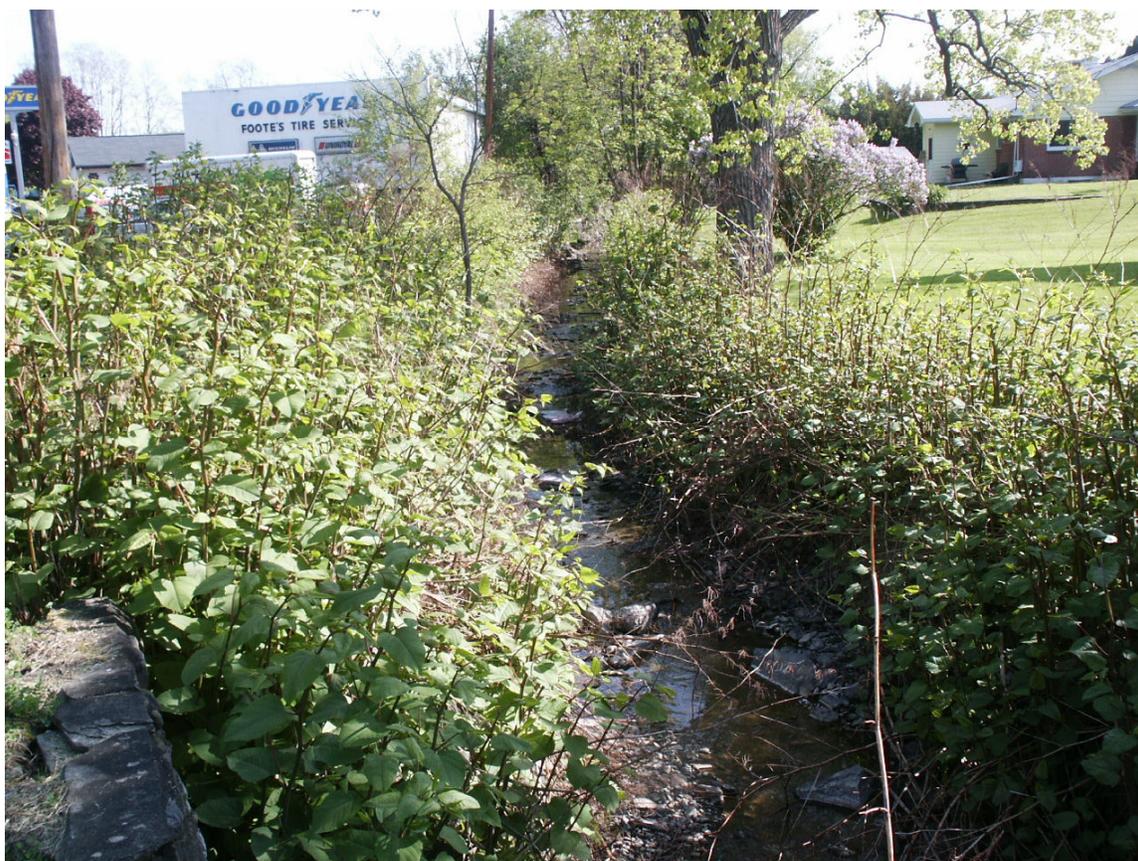
Dry Brook (DRYB)

Dry Brook at Waverly, N.Y., was sampled again in 2006 after being dry in 2005. The biological condition was rated as moderately impaired. Dry Brook had the poorest scores of all the Group 3 streams for Shannon Diversity Index, Hilsenhoff Biotic Index, percent Chironomidae, and percent dominant taxa. Habitat was rated as partially supporting with low scores for riparian vegetative zone, velocity/depth regimes, condition of banks, and sediment deposition. This site is located in a primarily residential area. Staff noted the presence of human refuse around the site. All field chemistry parameters were within the acceptable range.

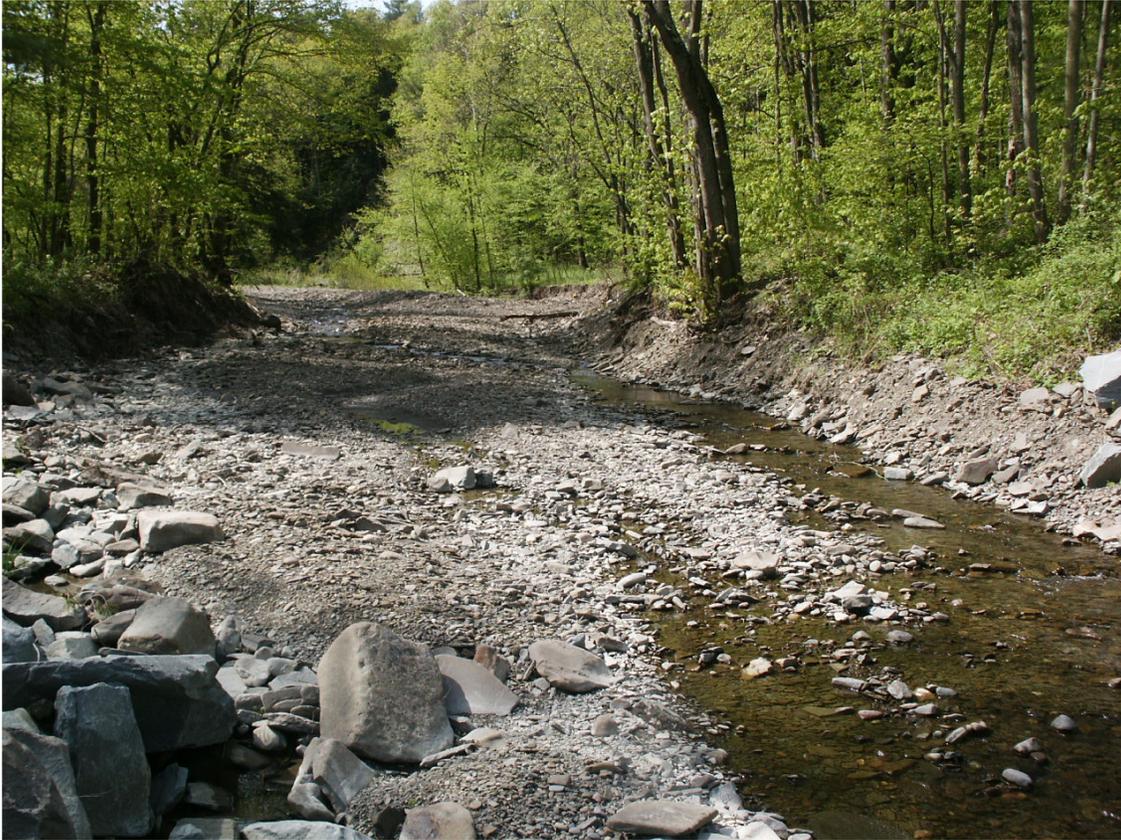
Parks Creek (PARK)

Parks Creek was sampled near Litchfield, N.Y., and was designated as having a slightly impaired biological community for the second straight year. This site scored high on the Hilsenhoff Biotic Index and percentage of Chironomidae but fairly low for EPT Index and taxonomic richness. Parks Creek had an excellent habitat ranking in 2006, with high scores for a number of parameters, including epifaunal substrate, sediment deposition, frequency of riffles, and riparian vegetative zone. At the time of sampling, staff noted that the bank conditions were poor on both left and right banks. The predominant land use is forested, with a considerable amount of woody debris and fallen trees in the stream channel. All field chemistry parameters were within acceptable ranges.

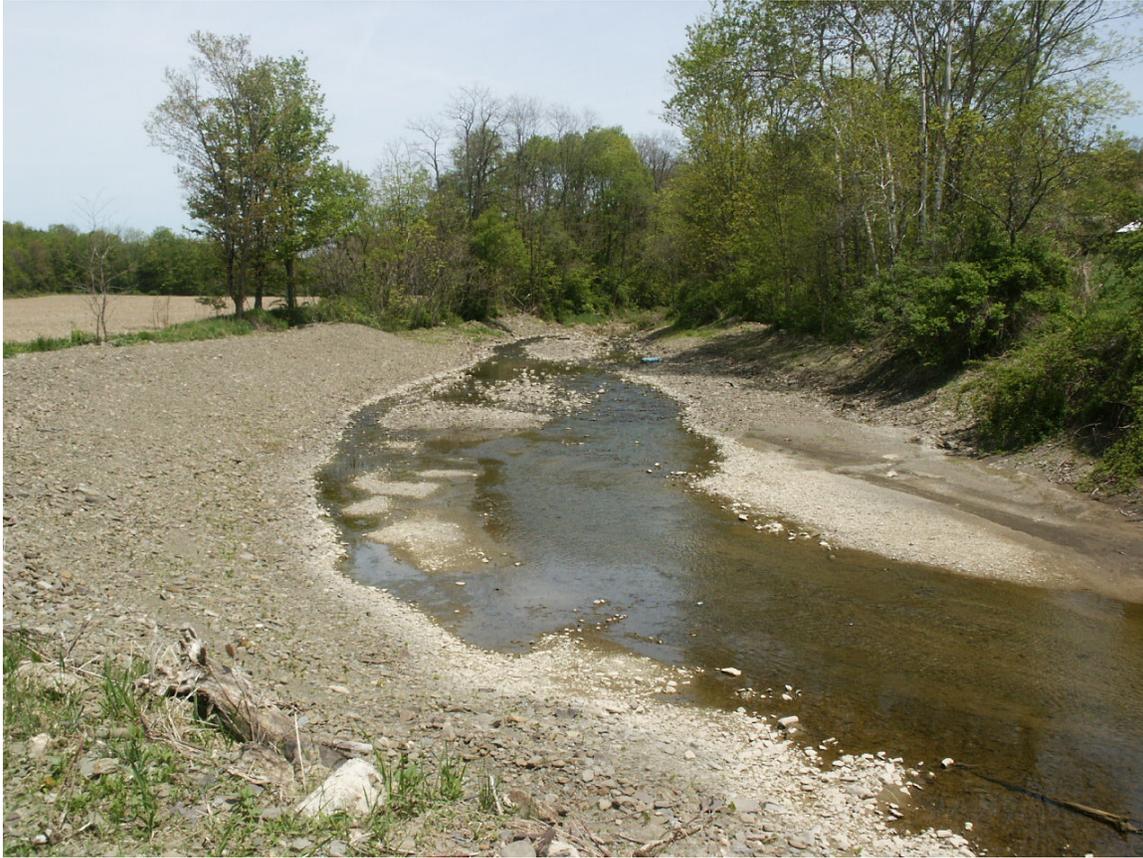
Prince Hollow Run (PRIN)

Prince Hollow Run near Cadis, Pa., was designated slightly impaired in May 2006, showing a slight decline from its nonimpaired rating last year but still better than the severely impaired conditions of past years. This site had very low scores for percent Chironomidae, which were the dominant taxa. However, Prince Hollow Run did show good scores for taxonomic richness EPT Index. The habitat was rated as supporting, with low scores for condition of banks, embeddedness, and riparian vegetative zone width but high scores for frequency of riffles and epifaunal substrate. At the time of sampling, staff noted the presence of human trash along the stream banks. All field chemistry parameters were within the acceptable ranges.

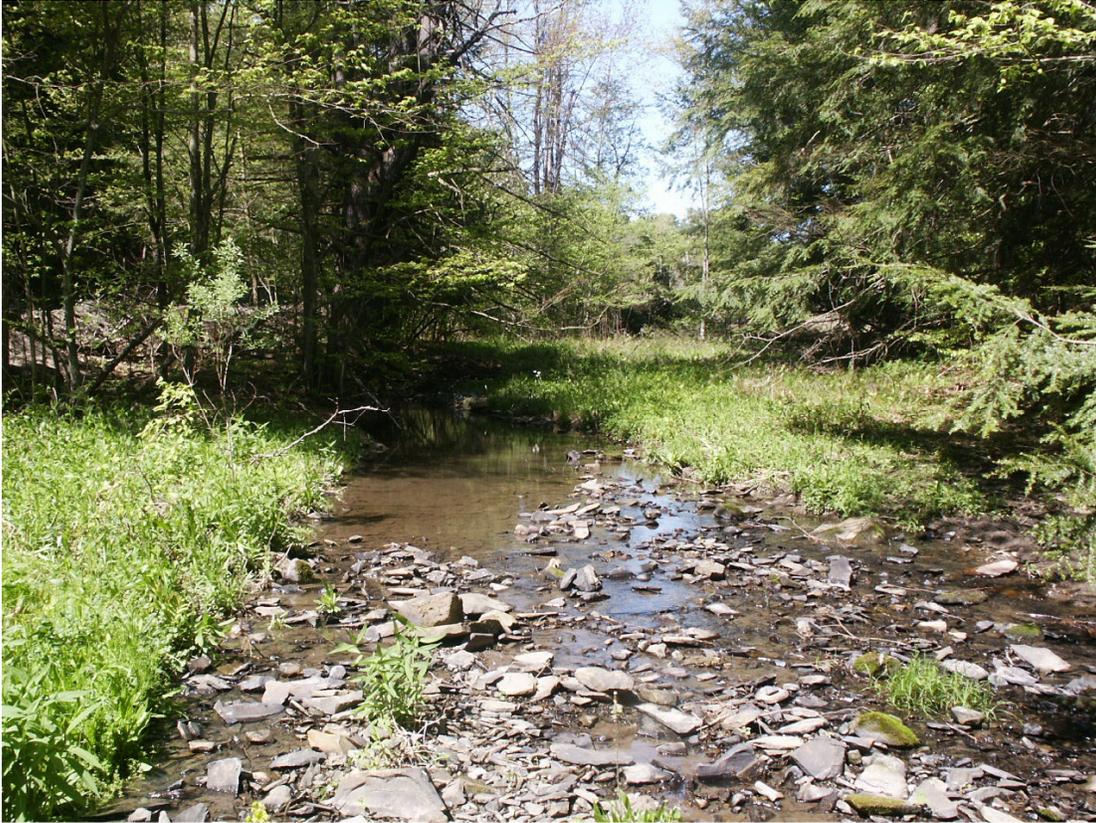
Smith Creek (SMIT)

Smith Creek near East Lawrence, Pa., was designated as having a nonimpaired biological community with supporting physical habitat in May 2006. SMIT had the best score for percent dominant taxa of all the Group 3 streams and also had above average scores for Shannon Diversity Index, taxonomic richness, and EPT Index. Low habitat scores were given for a number of parameters, including sediment deposition, velocity/depth regimes, embeddedness, and riparian vegetative zone width. This small stream drains a wetland area and mixed coniferous forest. There were no field chemistry parameters that exceeded state limits.

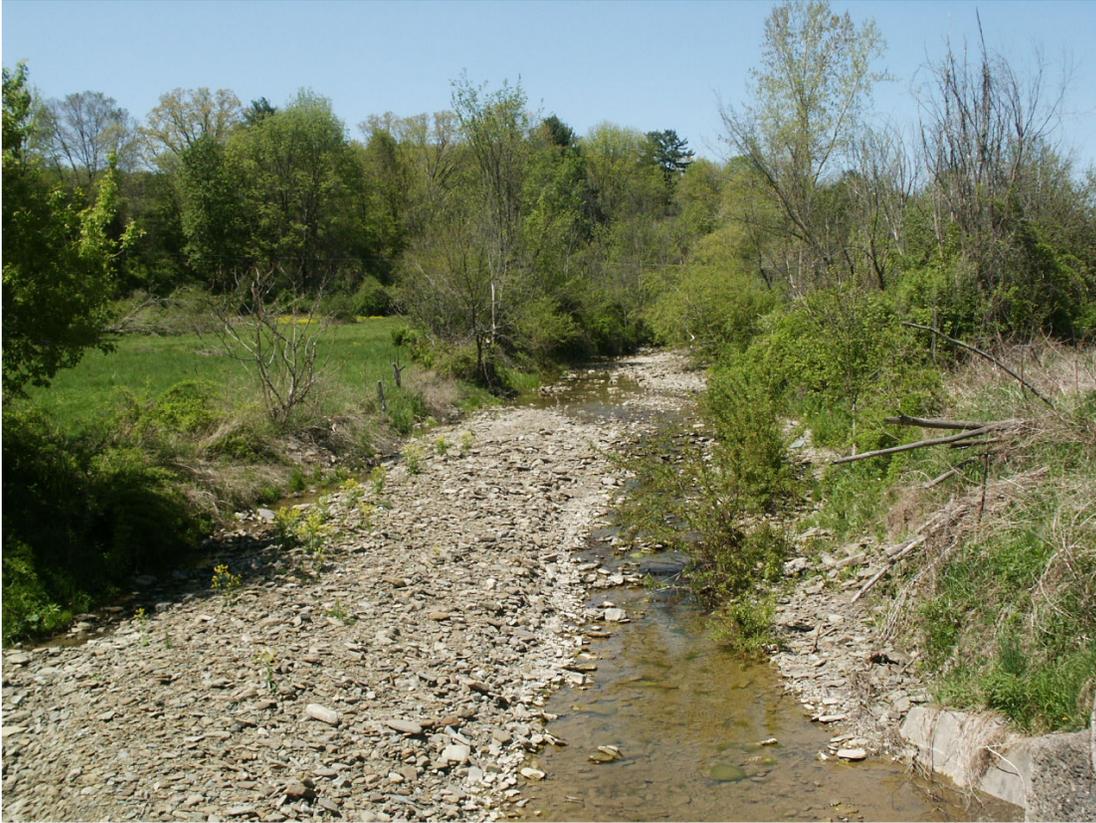
Strait Creek (STRA)

A nonimpaired biological community existed at Strait Creek near Nelson, Pa., during fiscal year 2006, for the second consecutive year. The site received excellent rankings for Hilsenhoff Biotic Index due to the number of pollution intolerant genera such as the mayfly *Epeorus* (Ephemeroptera; Heptageniidae) and the stonefly *Alloperla* (Plecoptera: Choloroperlidae). The physical habitat was designated supporting, and all field chemistry parameters were within normal limits. Low habitat scores were given for channel flow status, condition of banks, and riparian vegetative zone width. However, frequency of riffles and vegetative protective cover were rated as optimal.
