**RE: Muddy Run Pumped Storage Project, FERC Project No. 2355, License Article 401 –  
2020 American Eel Collection Facility in Octoraro Creek Report**

## Muddy Run Pumped Storage Project American Eel Collection Facility in Octoraro Creek, 2020

FERC Project No. 2355

Prepared By:  
Normandeau Associates, Inc.  
1921 River Road  
Drumore, Pennsylvania 17518

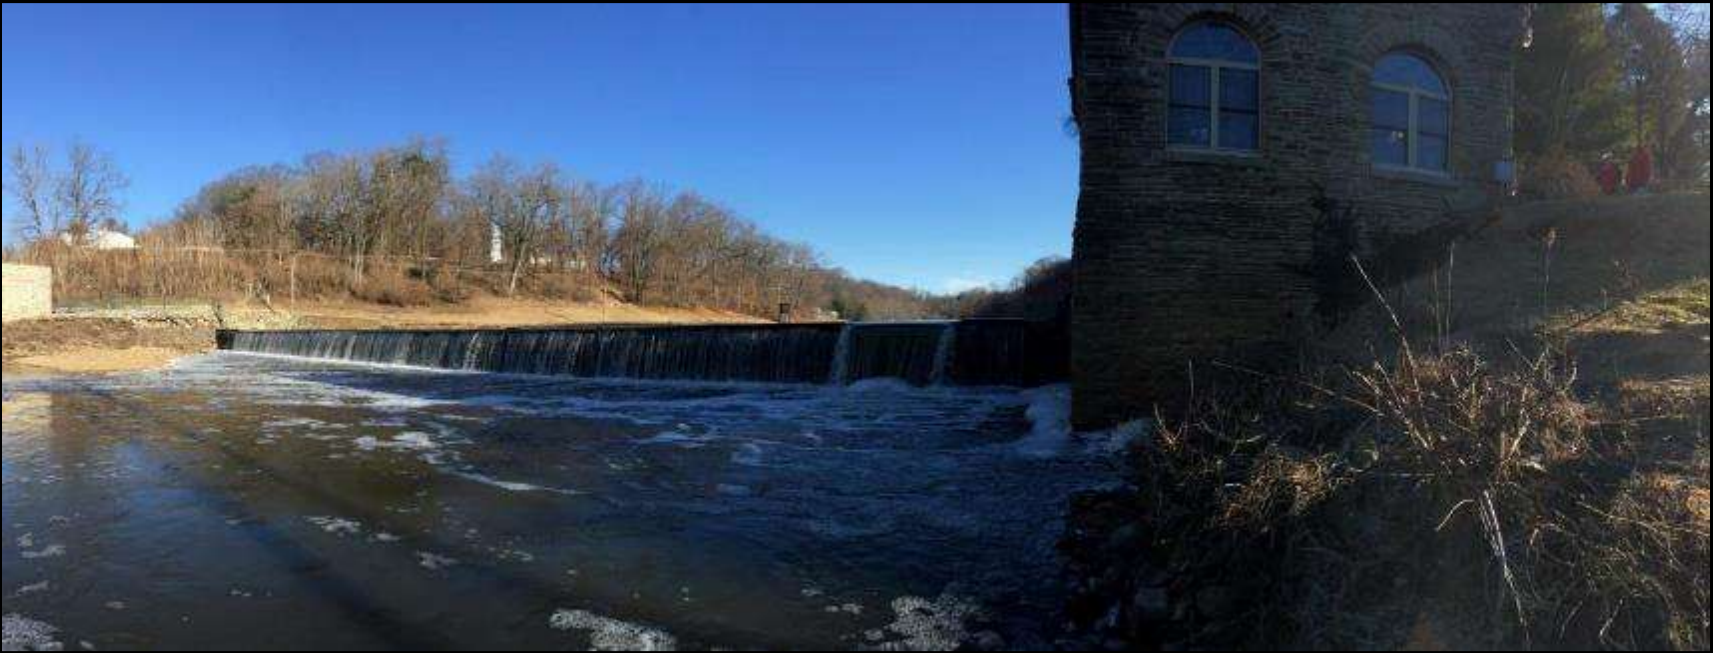
Figure 2.0-2: Location of the Juvenile Eel Collection Facility on South Shore (Left Bank) Of Octoraro Creek Downstream of Art Building

Areas of lower Octoraro Creek up to and including the area near CWA's Pine Grove Low-Head Dam were surveyed over a 13-week period from June 16 through September 10, 2014, using fyke nets, red-light headlamps, and fine mesh dip nets ([Figure 2.0-1](#) and [Normandeau Associates and Gomez and Sullivan 2014](#)). Based on the information gathered during the 2014 survey, eels were consistently found in the north corner of the spillway adjacent to the Dam, whereas eels did not seem to be as abundant at the downstream sites during the same period. The report recommended that a site near the dam be considered for future juvenile eel trapping ([Normandeau Associates and Gomez and Sullivan 2014](#)). Exelon and EPAG discussed the possibility of utilizing this north corner of the spillway site for the temporary eel collection facility in 2015. However, due to concerns by the CWA relating to existing structures at the site, an alternative site along the south shore of the Pine Grove Low-Head Dam was selected and approved by the CWA and EPAG. The alternative site is located immediately downstream of the Art Building ([Figure 2.0-2](#)).

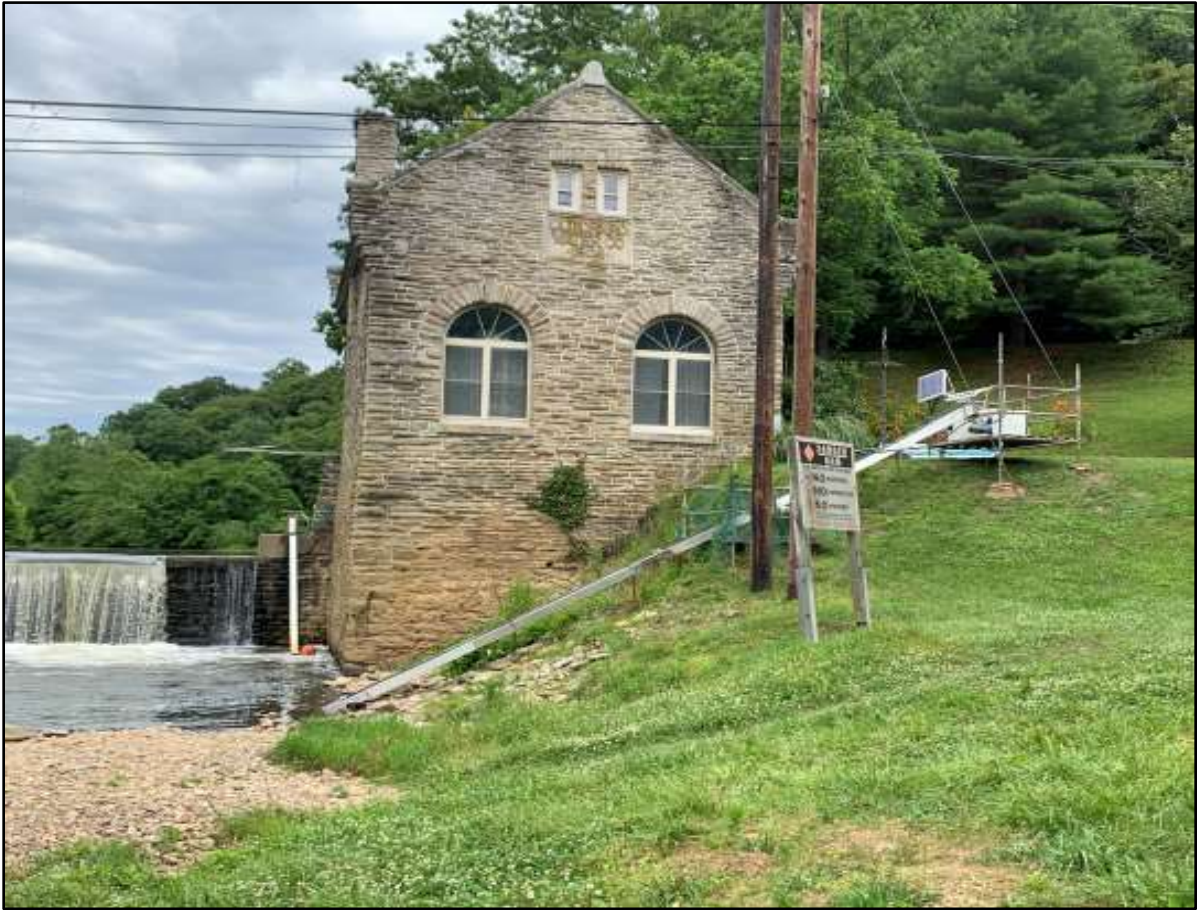
**Figure 3.1-1: Scaffolding and Collection Tank on top of the hill, Octoraro Creek Eel Facility, 2020**

The longer juvenile eel ramp was constructed and installed with the identical entrance location to the previous ramps ([Figure 3.1-1](#)). The ramp consisted of approximately 12.3 meter (m) x 305 millimeter (mm) wide cable trays positioned at a 30° angle, plus a continuous length of tray that was bent and shaped at a 90° angle over a 25 mm radius at the top of the ramp to convey juvenile eels into the collection tank. The entrance of the ramp was underwater during all flow conditions, which allowed for a smooth transition from the existing riverbed adjacent to a quiescent pool located in the creek. The ramp was supported by the previous scaffolding and held in place by four T-shaped solid metal braces, evenly spread across the length of the ramp, and driven into the ground beneath the ramp ([Figure 3.1-3](#)). On either side of these braces, a hole was drilled into the flat bar and a bungee cord was used to fasten the ramp to these braces. The ramp was covered from the top down to near the tail water median flow height to protect juvenile eels when ascending. A hinged cover was added to the new ramp over the spray bar to decrease light inside the ramp at the top of the ramp.

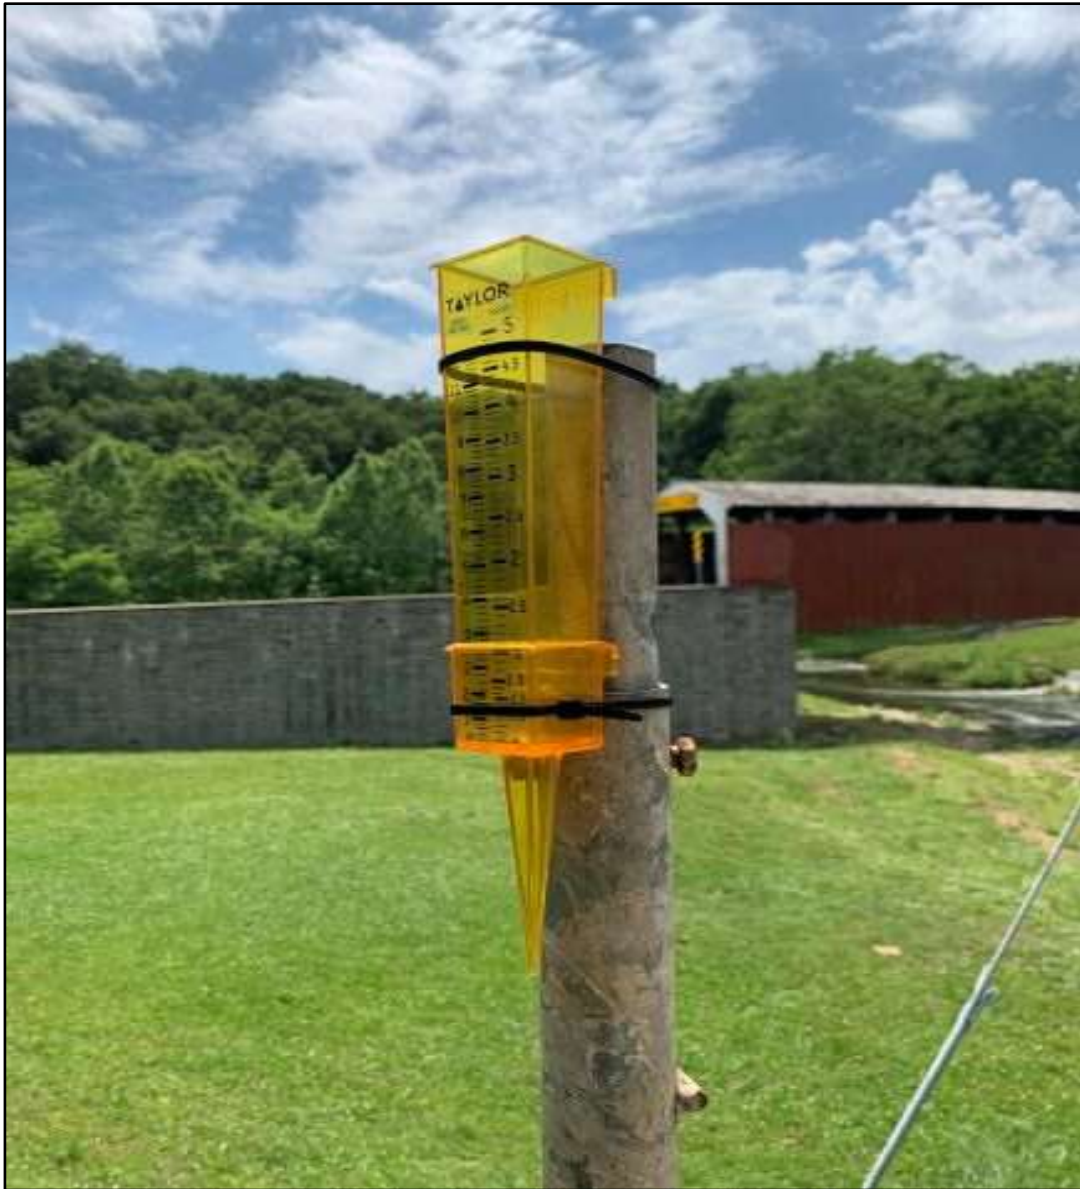
**Figure 3.1-2: Rainfall gauge, Octoraro Creek Eel Facility, 2020**

Juvenile eel collection and rainfall did not appear to be related during the 2020 season. Rainfall was recorded typically in tenth of inch (in) by a rain gauge affixed to the scaffolding platform. The largest amount of rain fall was recorded on July 7, 2020 with 2.1 inches ([Table 4.5-5](#) and [Figure 4.5-5](#)). However, on August 4, 2020, Tropical storm Isaias traveled across southern Pennsylvania dropping large amounts of rain over the Octoraro Creek watershed. The morning of August 4, 2020, the eel facility was checked and the observed rainfall amount was 1.75 inches ([Table 4.5-5](#) and [Figure 4.5-5](#)). Rainfall was not measured from August 5 through August 8, 2020 when the ramp was out of service due to damage from the high flows from Tropical Storm Isaias. Recorded rainfall amounts over 1.0 inch were observed on three days during the 2020 season: July 11, August 25, and September 30. On 73.7% of the season (70 of the 95 days), the rain gauge recorded values of 0.0 inches.

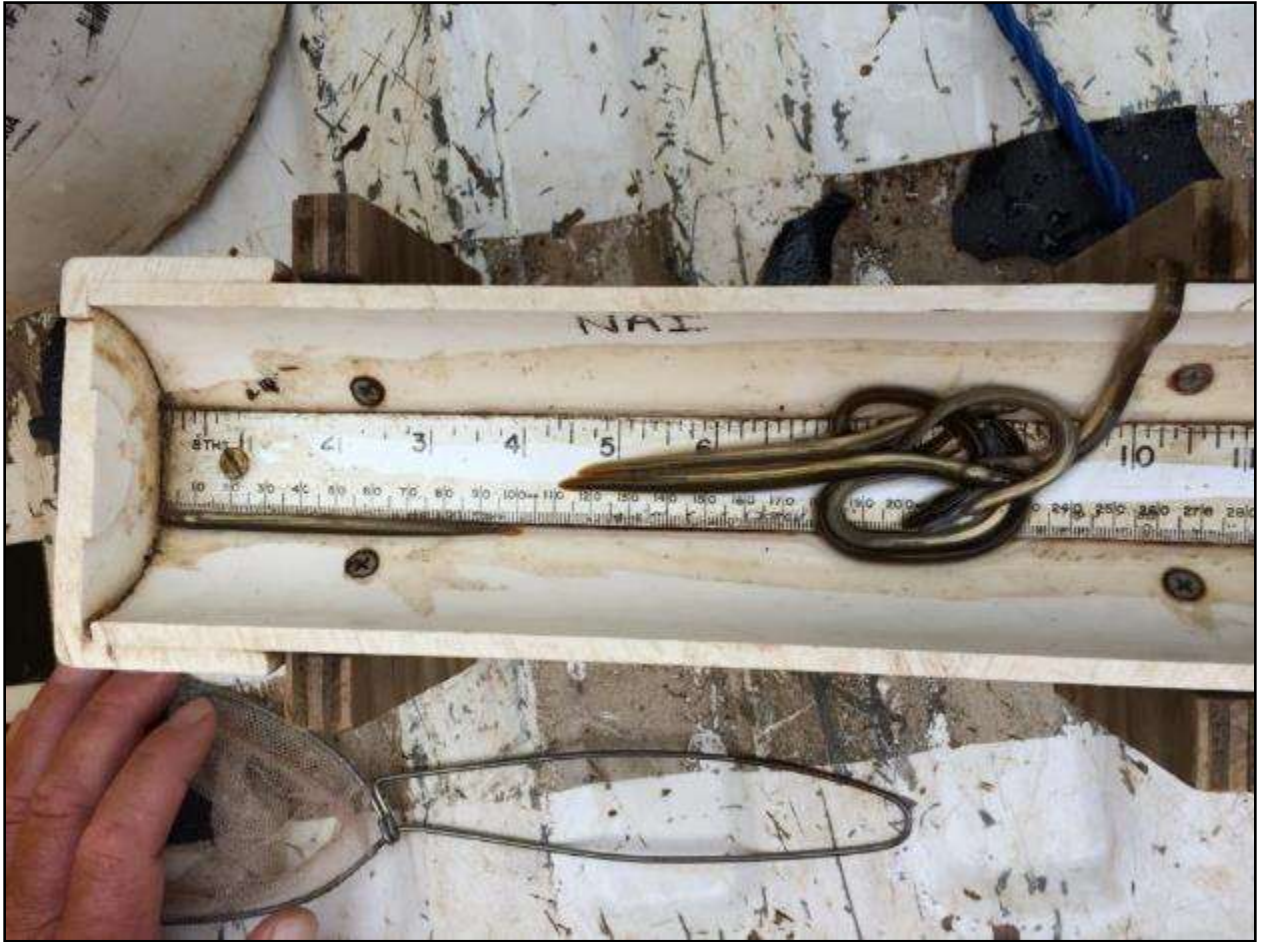
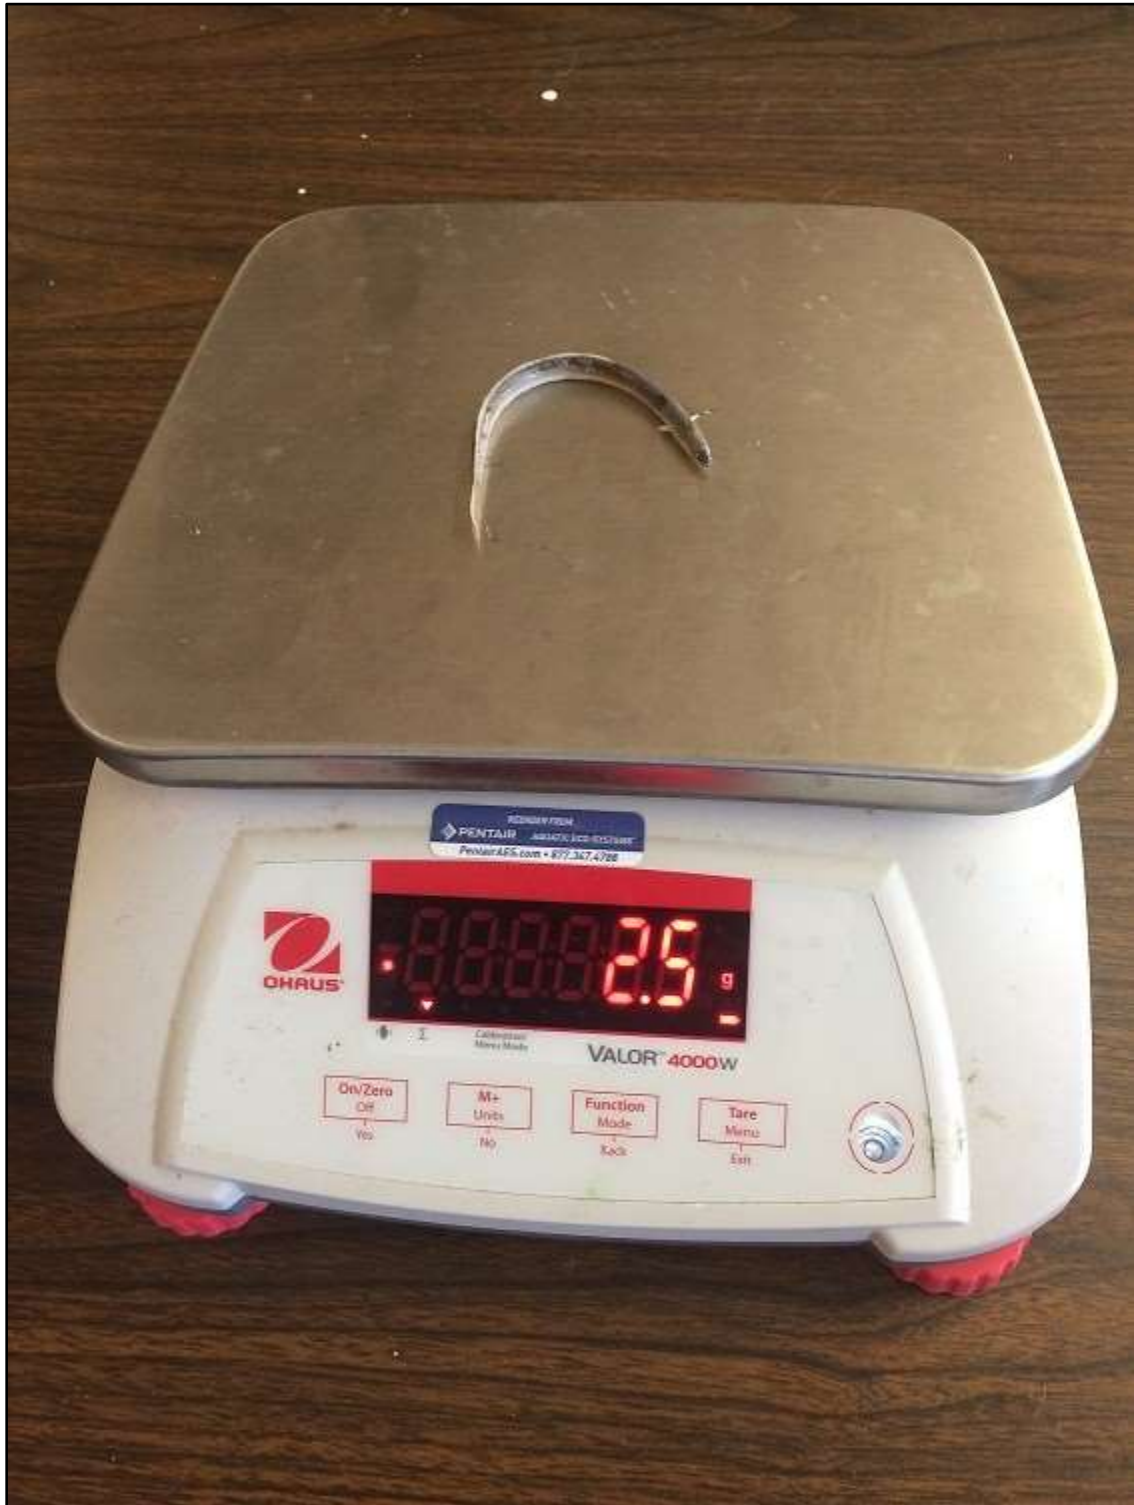
**Figure 3.2-1: Measuring Juvenile Eels to Nearest Millimeter While Sedated, Octoraro Creek Eel Facility, 2020**

Length and weight measurements, along with condition factor were recorded biweekly from a maximum of 25 individuals (when available). Eels were measured and weighed after being anesthetized ([Figures 3.2-1](#) and [3.2-2](#)).

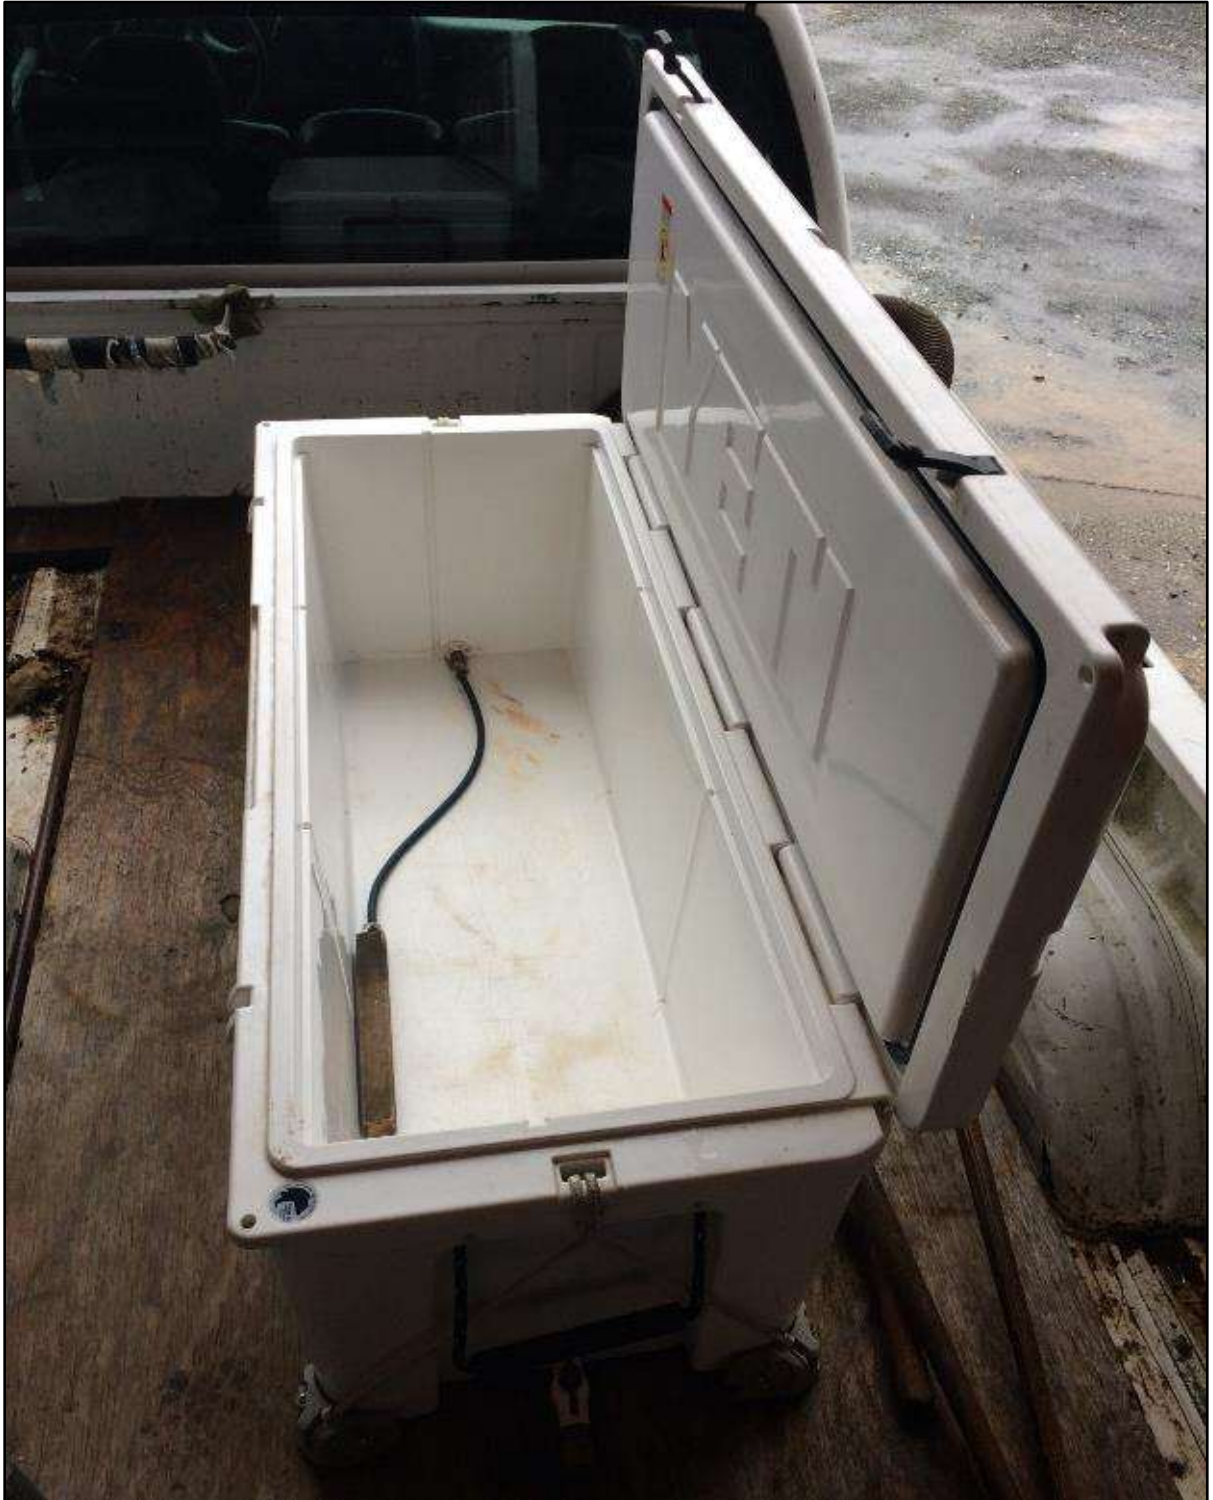
**Figure 3.3-1: Small Eel Transport Tank, Octoraro Creek Eel Facility, 2020**

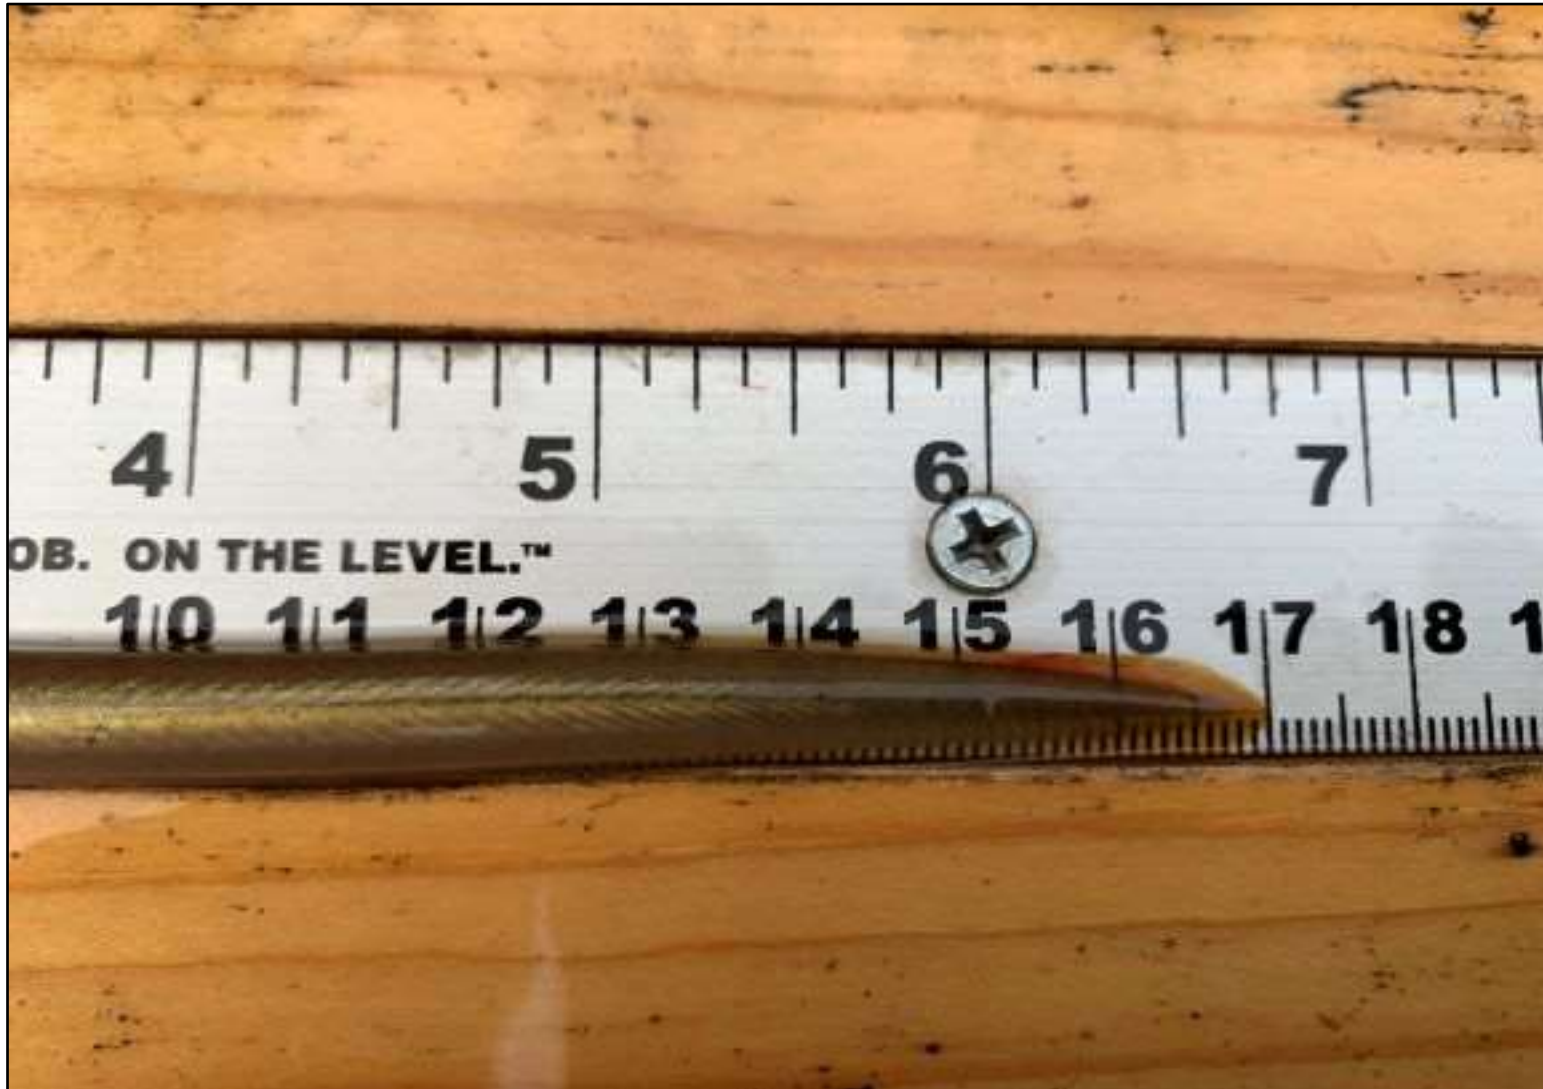
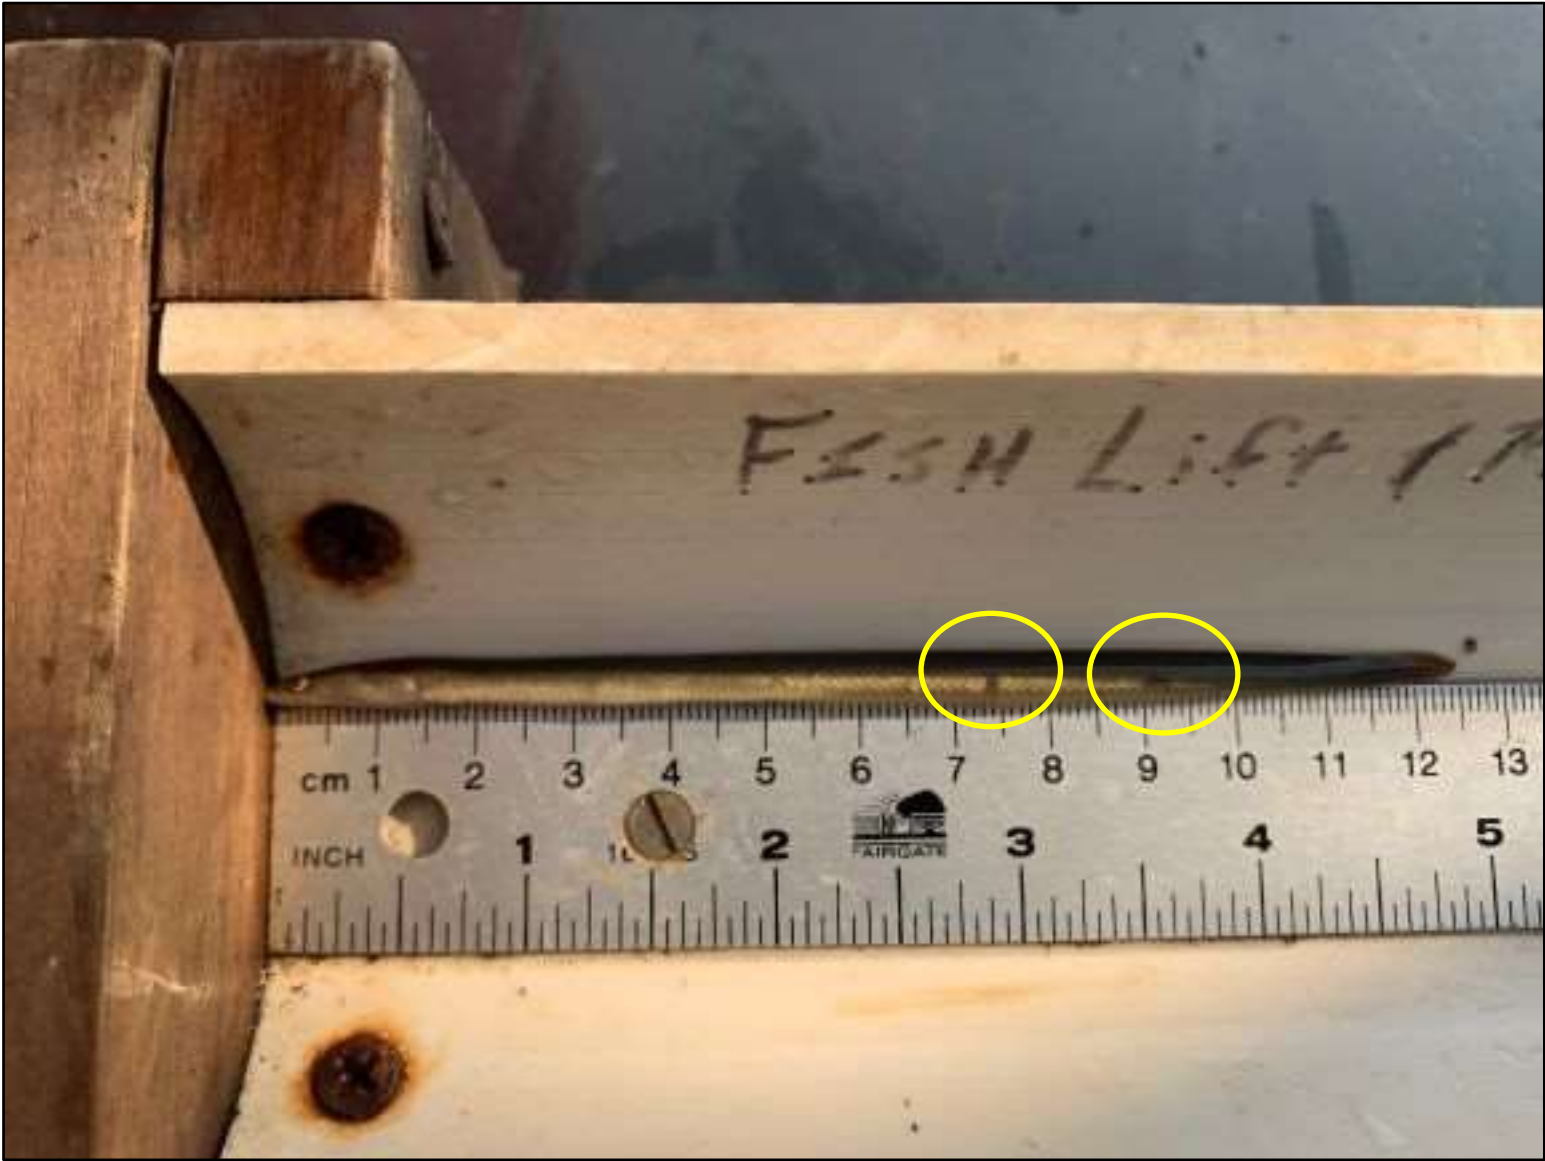
Figure 4.2-1: Image of Minor Hemorrhage Caudal Tail, Octoraro Creek Eel Facility, 2020

Eels from each biweekly subsample were examined for external injuries. Individual condition factors, date, and detailed biological data for these are shown on [Table 4.2-4](#). External injuries were noted on 1.0%, (2 of 194 individuals) of the examined eels. Injuries were observed on August 17 and 27, 2020, were coded as a minor hemorrhage to the caudal tail and scrapes on body, respectively ([Figures 4.2-1](#) and [4.2-2](#)).

<b>Date</b>	<b>Length (mm)</b>	<b>Weight (grams)</b>	<b>Condition Factor</b>
8/17/2020	168	5.5	Slight Hemorrhage Caudal Tail
8/27/2020	125	1.0	Scrapes on body

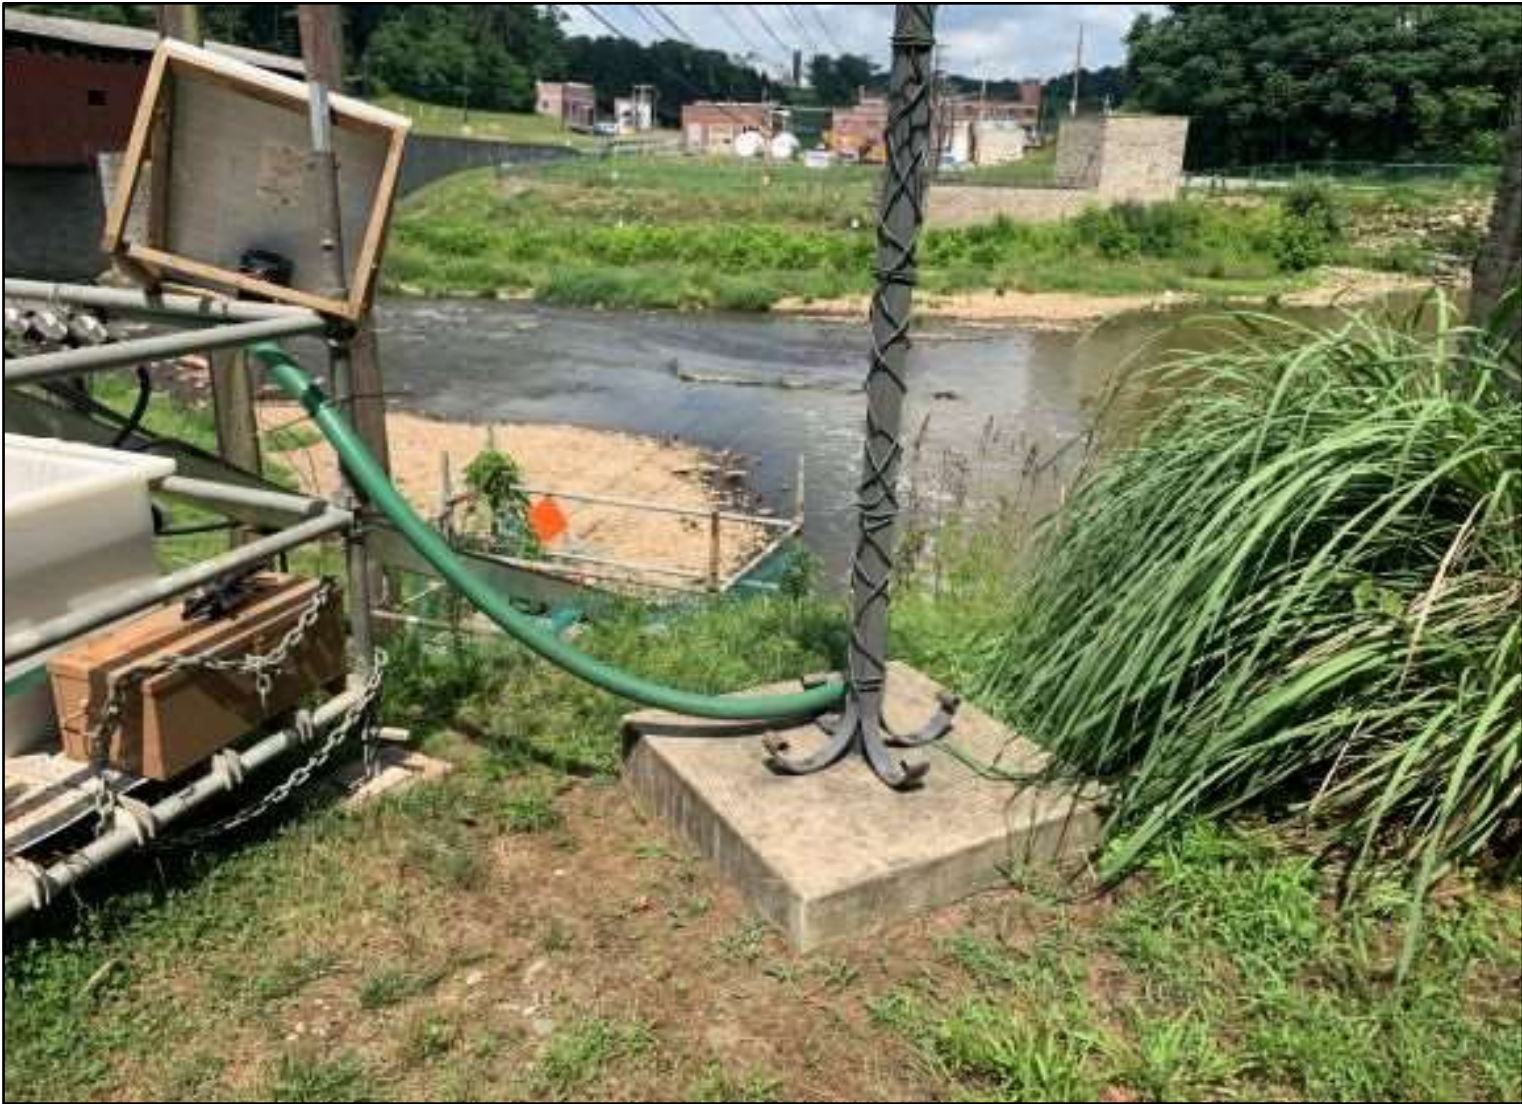
Figure 5.0-1: Cobble/gravel Outcrop Downstream of the Eel Ramp Entrance, Octoraro Creek Eel Facility, 2020

The average creek flow value per the USGS gage station during the 2020 season was similar to the previous years of operation (2015-present) during the operational period. The average creek flow value during the operational period of May 1 through September 15, 2015-2019 was 218.2 cfs compared to the average creek flow value of 224 cfs in 2020 ([Table 5.0-1](#) and [Normandeau Associates and Gomez and Sullivan 2015, 2016, and 2018a](#) and [Normandeau Associates 2018a and 2019a](#)). In 2020, daily average creek flow exceeded 1,000 cfs on two days, and the daily average creek flow was below 100 cfs for 18 days compared to 24, 65, 46, 4, and 13 days in 2015, 2016, 2017, 2018, and 2019, respectively. CWA operated its hydro facility on 23 of the 95 days (24.2%) this year, but we observed no relationship between eel catch and hydro operation ([Table 4.0-1](#)). The cobble/gravel outcrop that was formed just downstream of the entrance to the eel ramps in 2018, did not change much after then major creek flow in early August ([Figure 5.0-1](#)). The outcrop did not change the location of the ramp's entrance, which remained underwater throughout the entire 2020 season, just as in previous years.

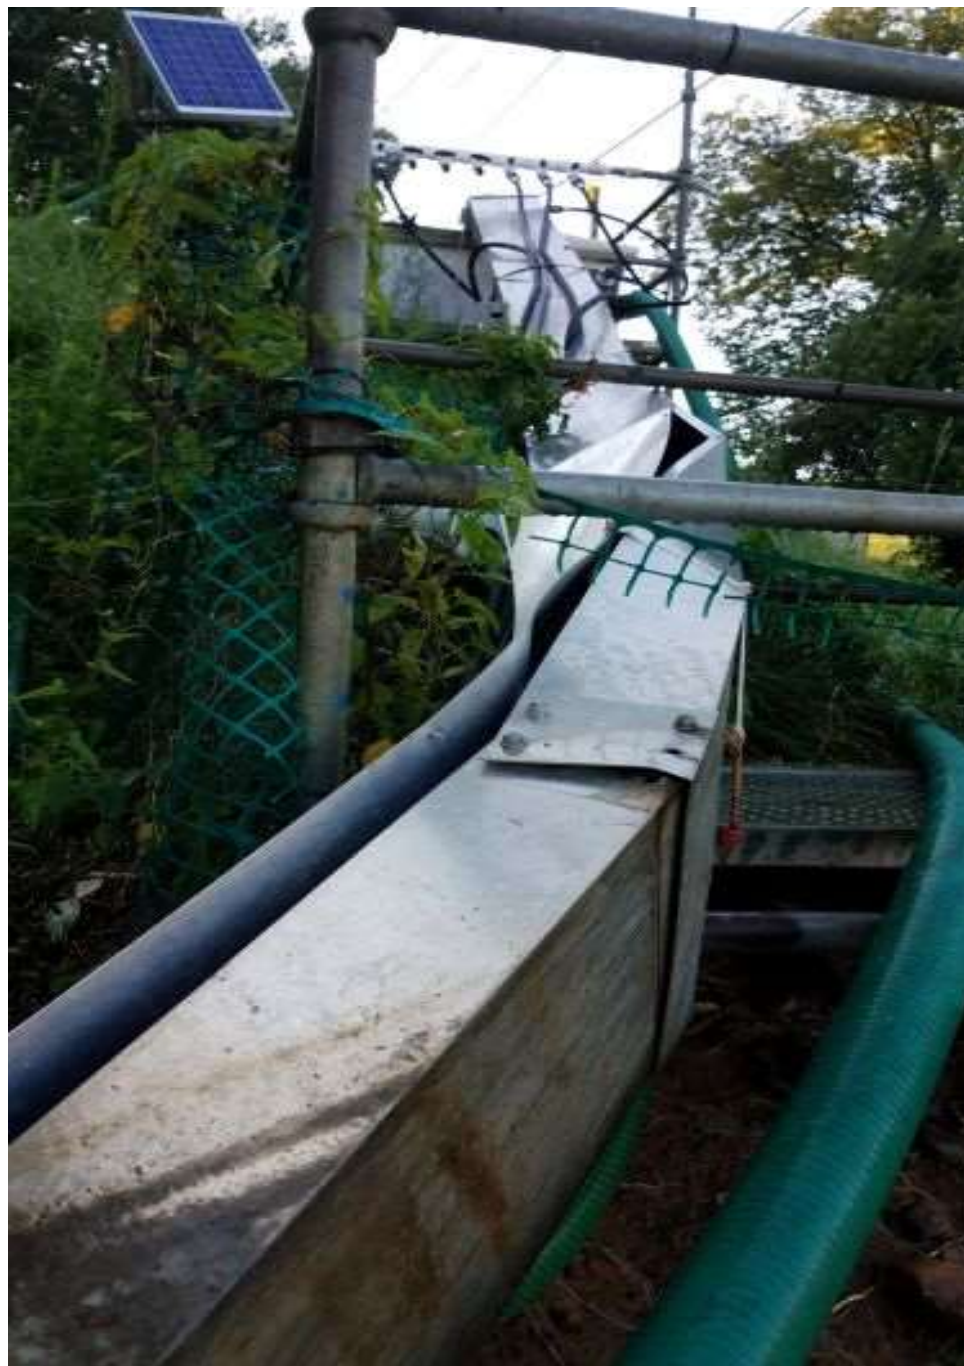
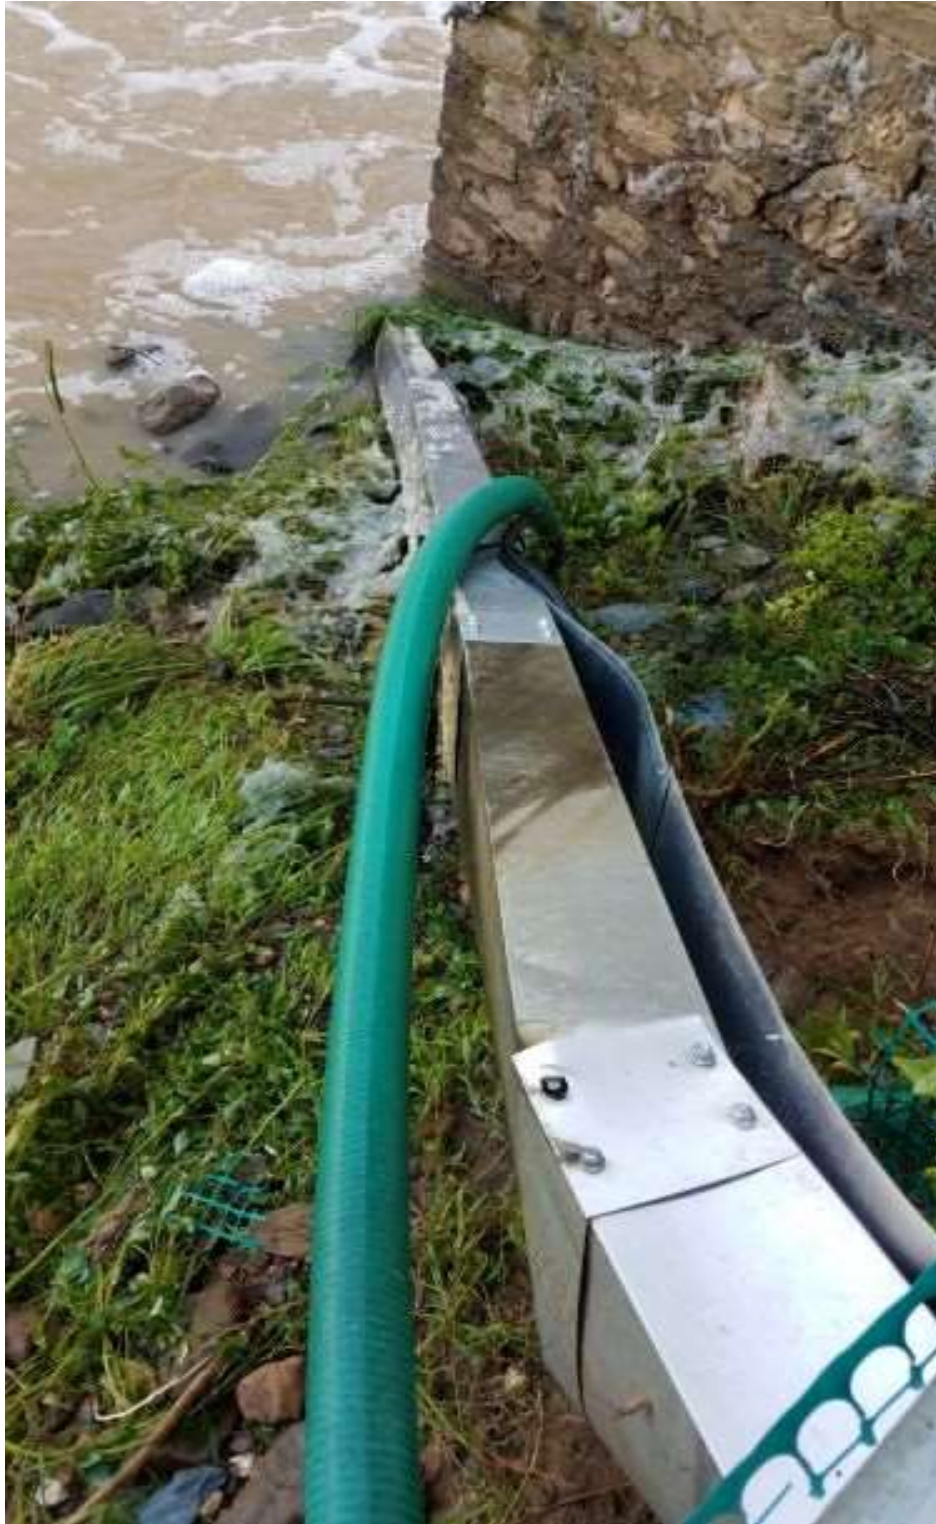
Figure 5.0-3 Damaged from High Creek Flows, Octoraro Creek Eel Facility, 2020

After starting the 2020 season on June 26, 2020, the Octoraro Creek Eel Facility was interrupted for a few days due to damage to the ramp because of high creek flows. The ramp was damaged on August 4, 2020 by the effects of Tropical Storm Isaias, and was removed on August 5<sup>th</sup> for repairs ([Figures 5.0-3](#) and [5.0-4](#)). The repairs were made on August 6, and it was reinstalled on August 8 and the attraction flow was restarted. Eels (63 individuals) were removed on August 4, 2020 in the afternoon prior to the water being turned off and transported and stocked at Columbia (Site 3B). A power event occurred on September 10, 2020. Normandeau arrived at the facility in the morning to find the circuit had tripped and the pump did not automatically restart. This was rectified, and no other electrical issues were observed for the rest of the season. No mortality was observed due to the above events in 2020.
