# Muddy Run Pumped Storage Project American Eel Collection Facility in Octoraro Creek, 2021

FERC Project No. 2355

Prepared By:  
Normandeau Associates, Inc.  
482 Old Holtwood Road  
Holtwood, Pennsylvania 17532

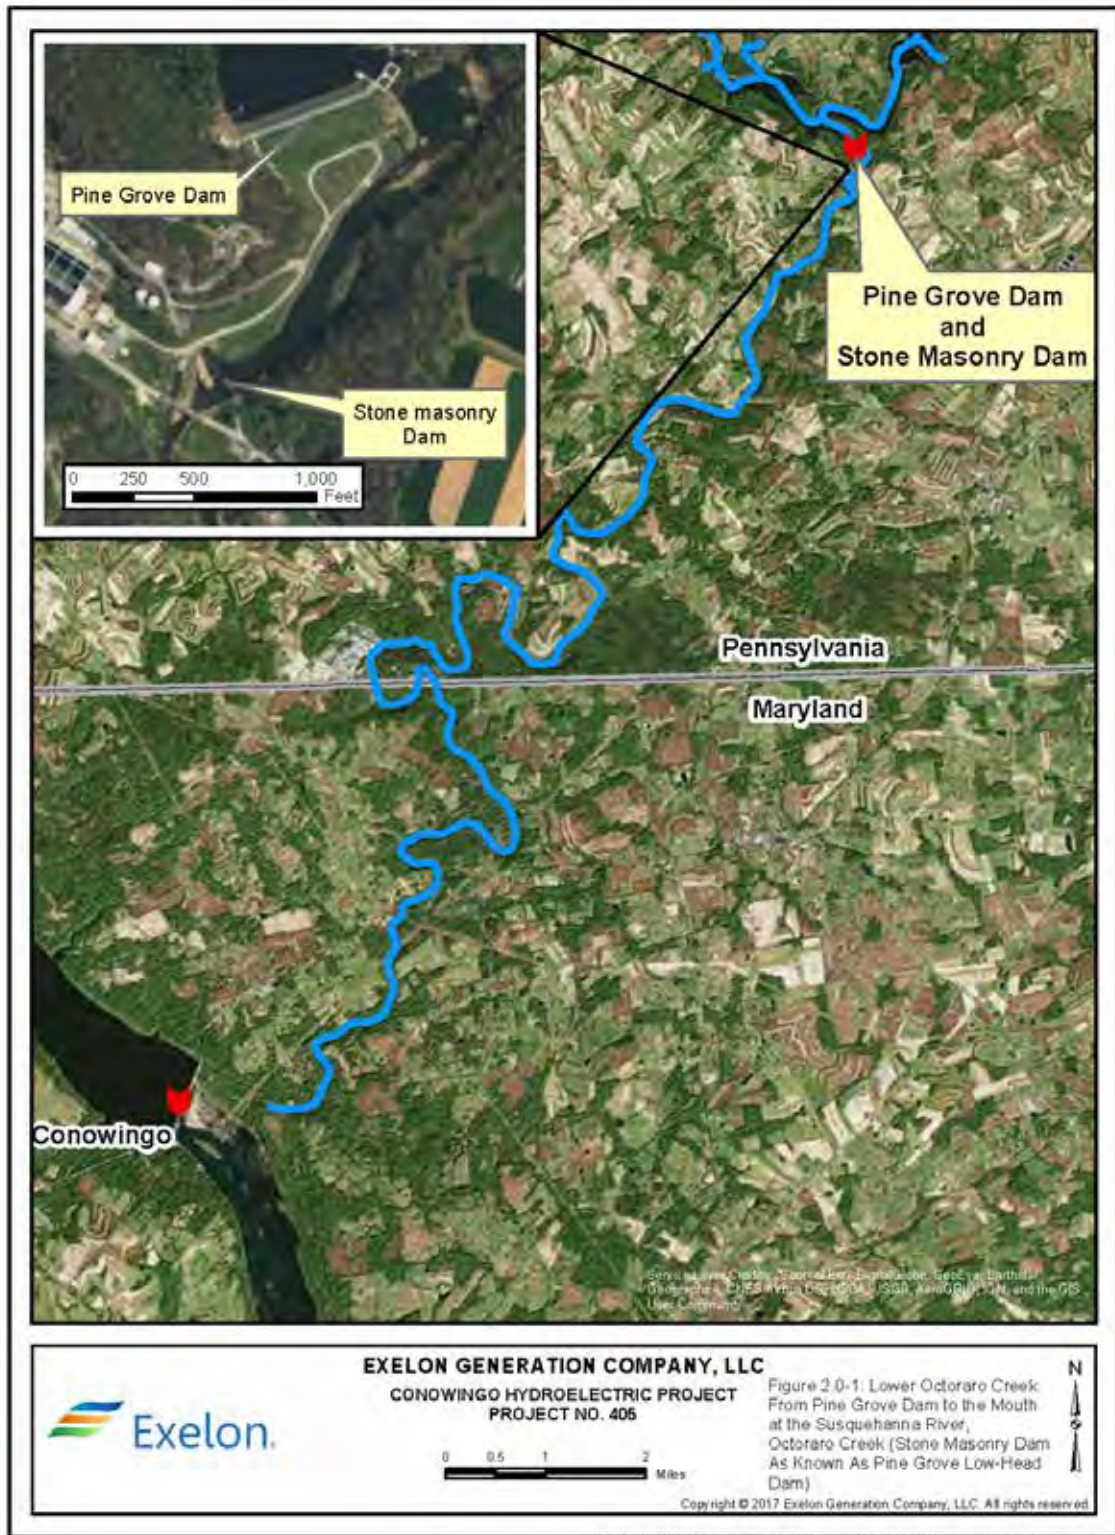
Figure 2.0-1: Lower Octoraro Creek from Pine Grove Dam to the Mouth at the Susquehanna River, Octoraro Creek (Stone Masonry Dam also Known as Pine Grove Low-Head Dam)

Areas of lower Octoraro Creek up to and including the area near CWA's Pine Grove Low-Head Dam were surveyed over a 13-week period from June 16 through September 10, 2014, using Fyke nets, red-light headlamps, and fine mesh dip nets ([Figure 2.0-1](#) and [Normandeau Associates and Gomez and Sullivan 2014](#)). Based on the information gathered during the 2014 survey, eels were consistently found in the north corner of the spillway adjacent to the dam, whereas eels did not seem to be as abundant at the downstream sites during the same period. The report recommended that a site near the dam be considered for future juvenile eel trapping ([Normandeau Associates and Gomez and Sullivan 2014](#)). Exelon and EPAG discussed the possibility of utilizing this north corner of the spillway site for the temporary eel collection facility in 2015. However, due to concerns by the CWA relating to existing structures at the site, an alternative site along the south shore of the Pine Grove Low-Head Dam was selected and approved by the CWA and EPAG. The alternative site is located immediately downstream of the Art Building ([Figure 2.0-2](#)).

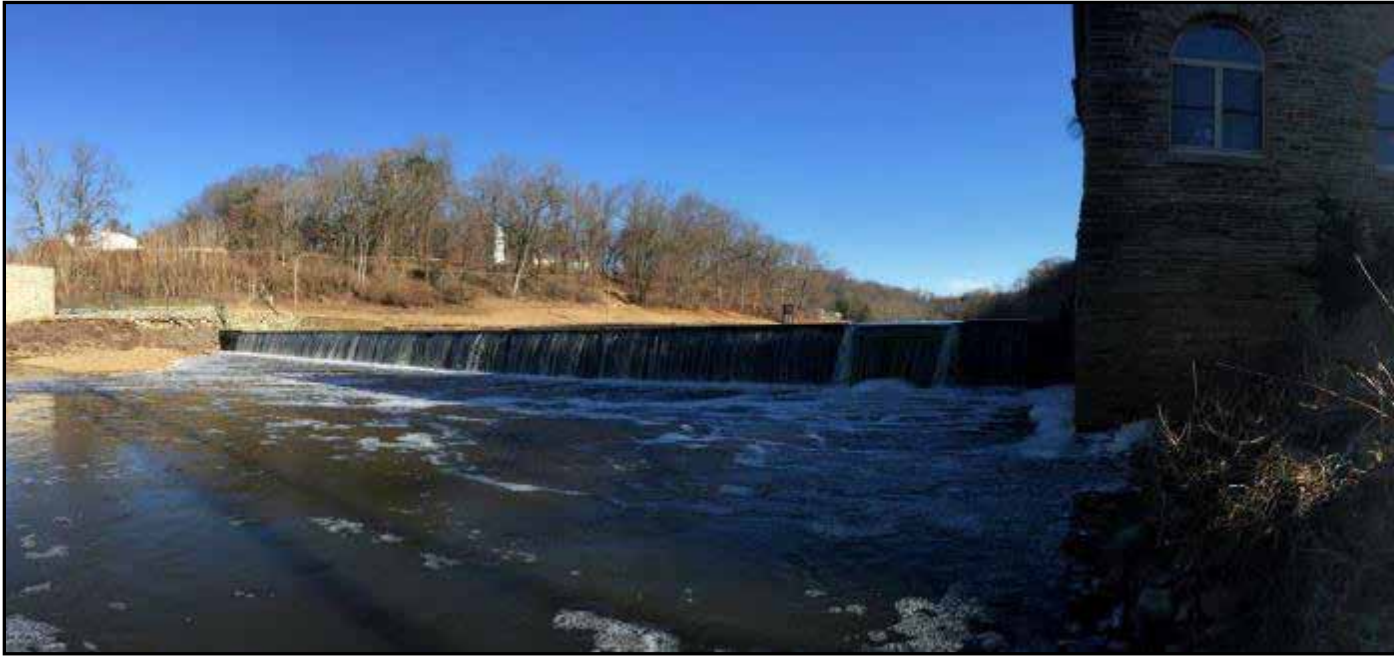
Figure 2.0-2: Location of the Juvenile Eel Collection Facility on South Shore (Left Bank) Of Octoraro Creek Downstream of Art Building

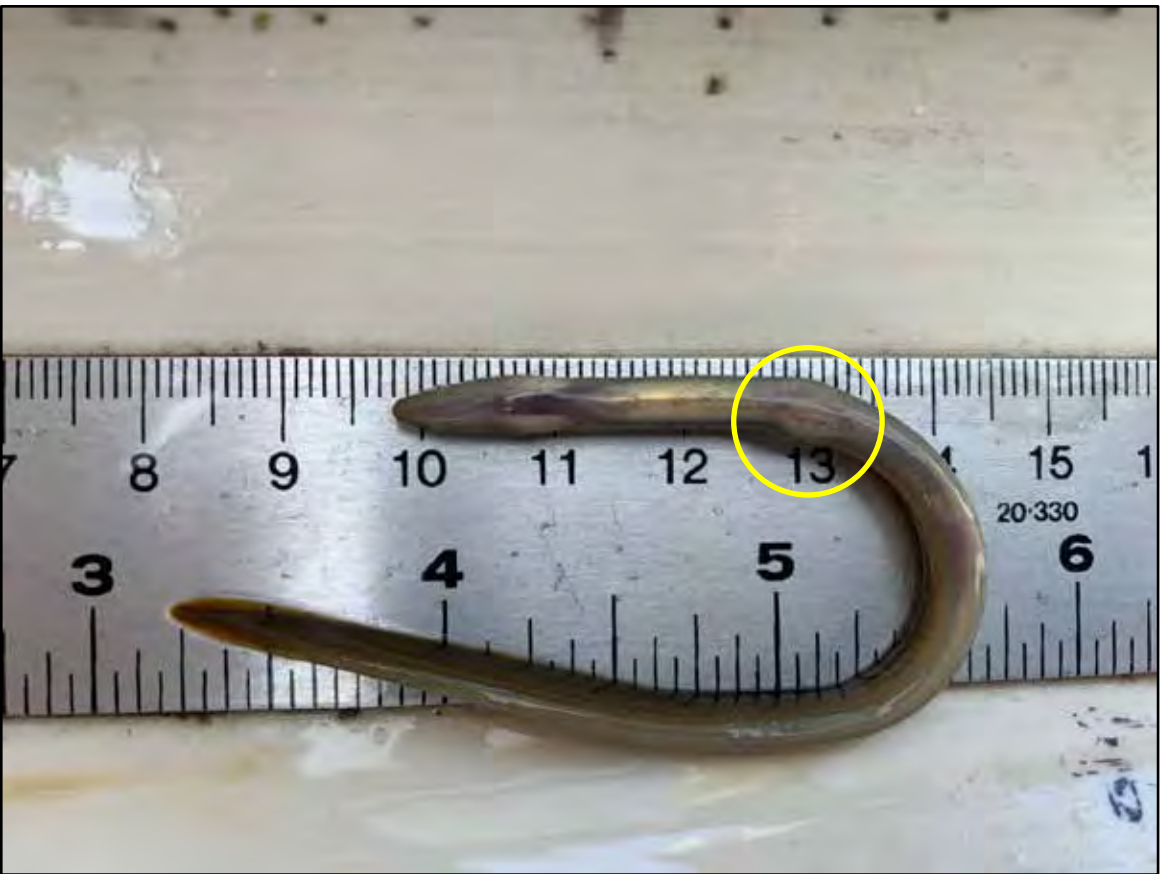
Figure 4.2-2: Image of Enlarged Belly, Octoraro Creek Eel Facility, 2021

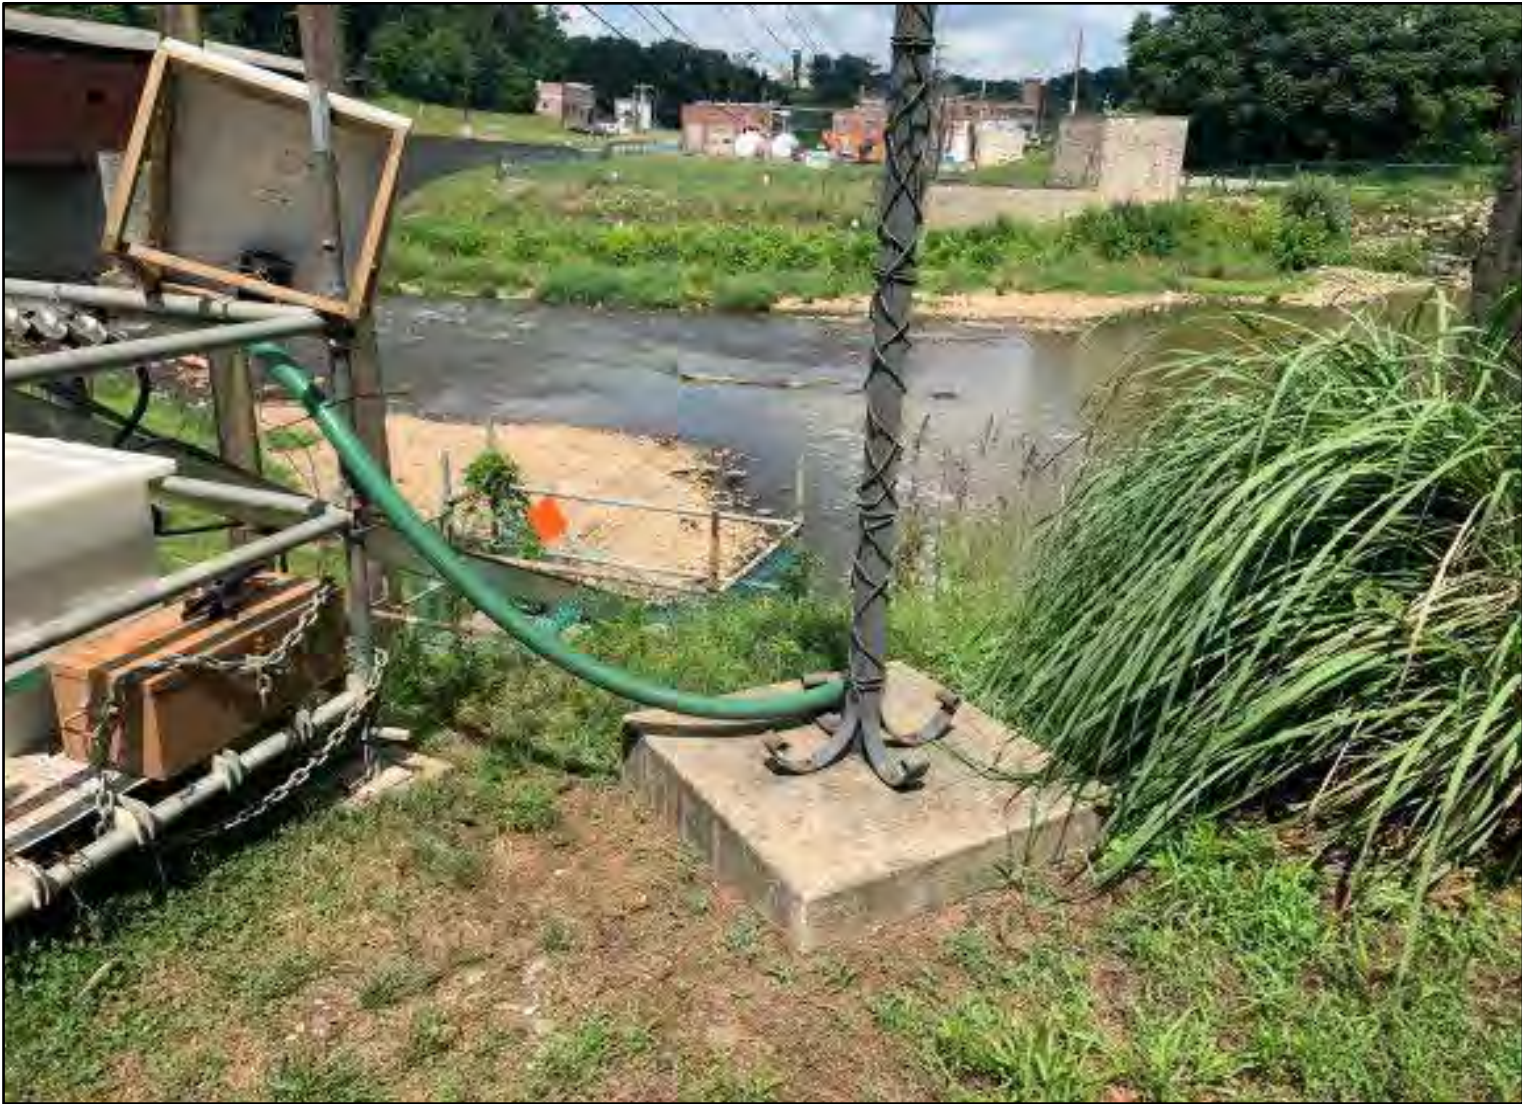
Figure 5.0-1: Cobble/gravel Outcrop Downstream of the Eel Ramp Entrance, Octoraro Creek Eel Facility, 2021

The average creek flow value per the USGS gage station during the 2021 season was similar to the previous years of operation (2015-2020). The average creek flow value during the operational period of May 1 through September 15, 2015-2020 was 219.2 cfs compared to the (May 1 through September 1) average creek flow value of 203 cfs in 2021 ([Table 5.0-1](#) and [Normandeau Associates and Gomez and Sullivan 2015, 2016, and 2018a](#) and [Normandeau Associates 2018, 2019, and 2020](#)). In 2021, daily average creek flow exceeded 1,000 cfs on only one day. The daily average creek flow was below 100 cfs for two days compared to 24, 65, 46, 4, 13, and 18 days in 2015, 2016, 2017, 2018, 2019, 2020, respectively. CWA operated its hydro facility on three of the 124 days (2.4%) this year, but we observed no relationship between eel catch and hydro operation ([Table 4.0-1](#)). The cobble/gravel outcrop that was formed just downstream of the entrance to the eel ramps in 2018, and was still present through September 1, 2021 when the Octoraro Creek Eel Facility was removed ([Figure 5.0-1](#)). The outcrop did not change the location of the ramp's entrance, which remained underwater throughout the entire 2021 season, just as in previous years.

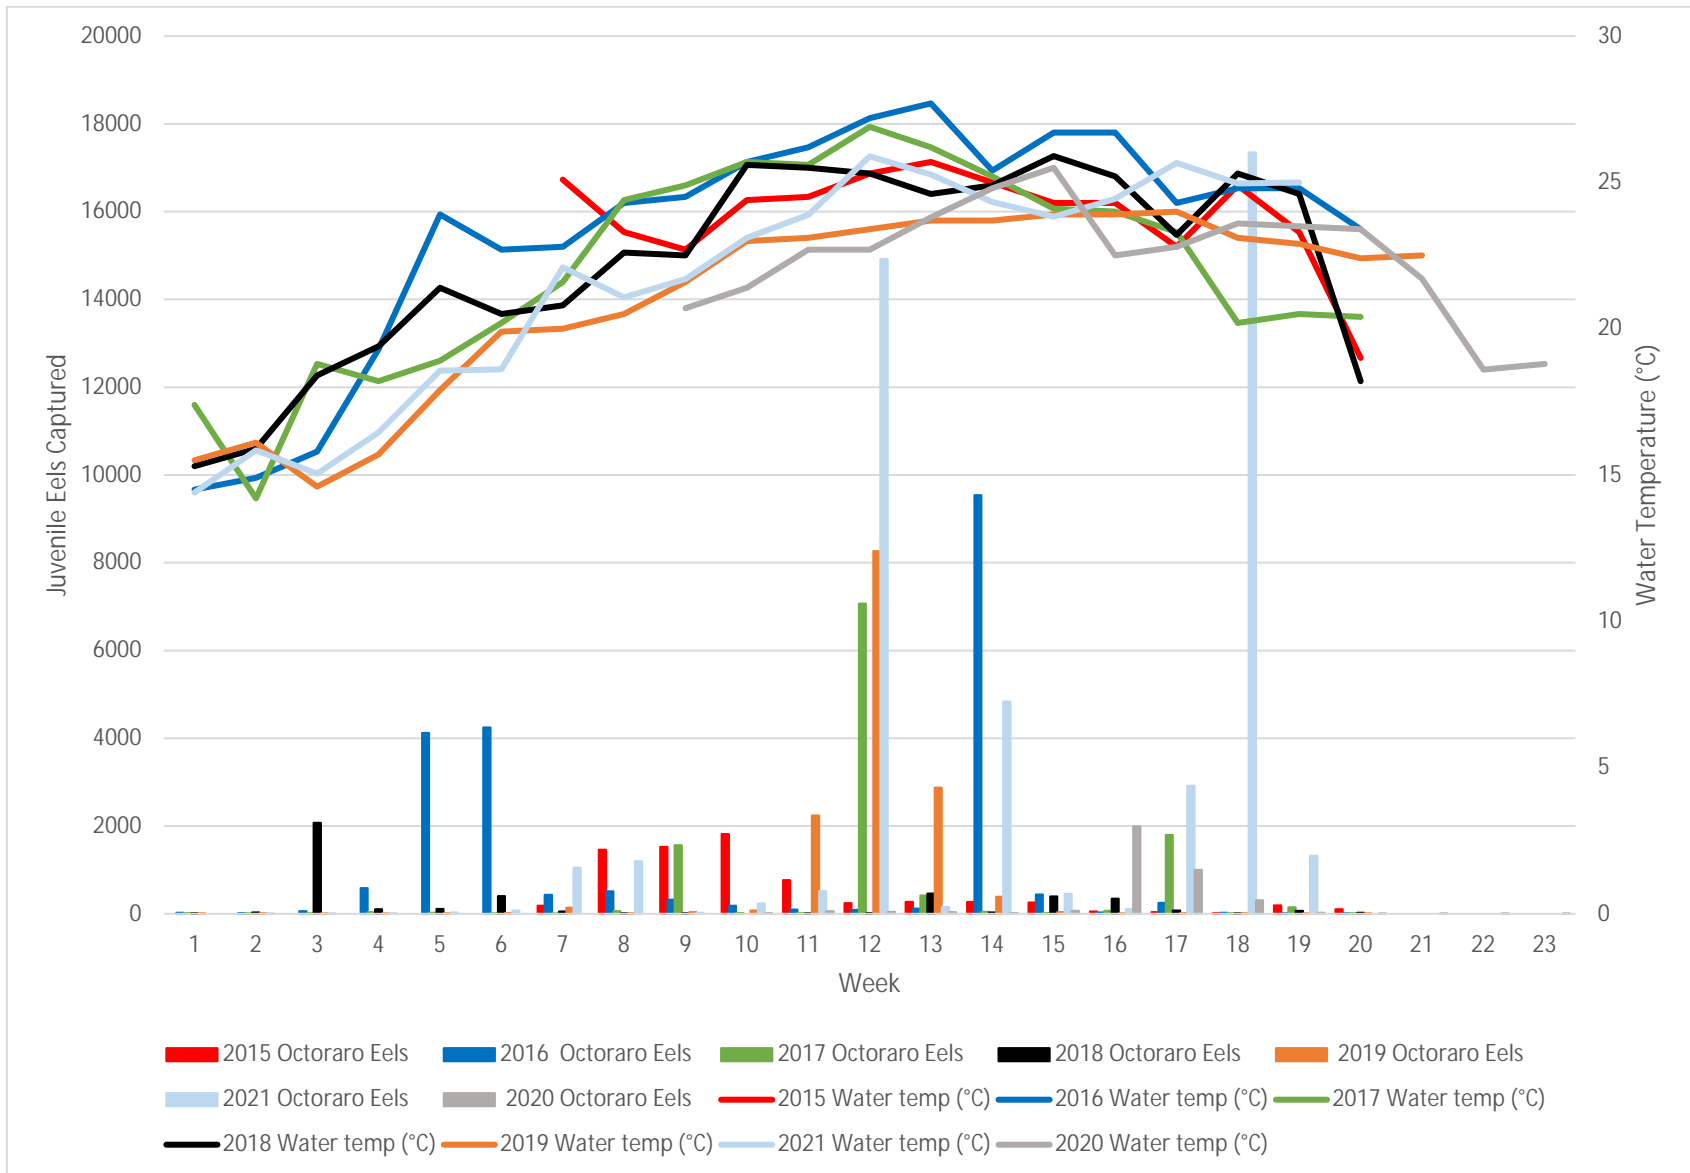
Eel Catch (Collection) to Water Temperature (2015-2021)
