## Muddy Run Pumped Storage Project American Eel Collection Facility in Octoraro Creek, 2022

**FERC Project No. 2355**

**Submitted On:**  
January 13, 2023

**Prepared By:**  
Normandeu Associates, Inc.  
482 Old Holtwood Road  
Holtwood, Pennsylvania 17532

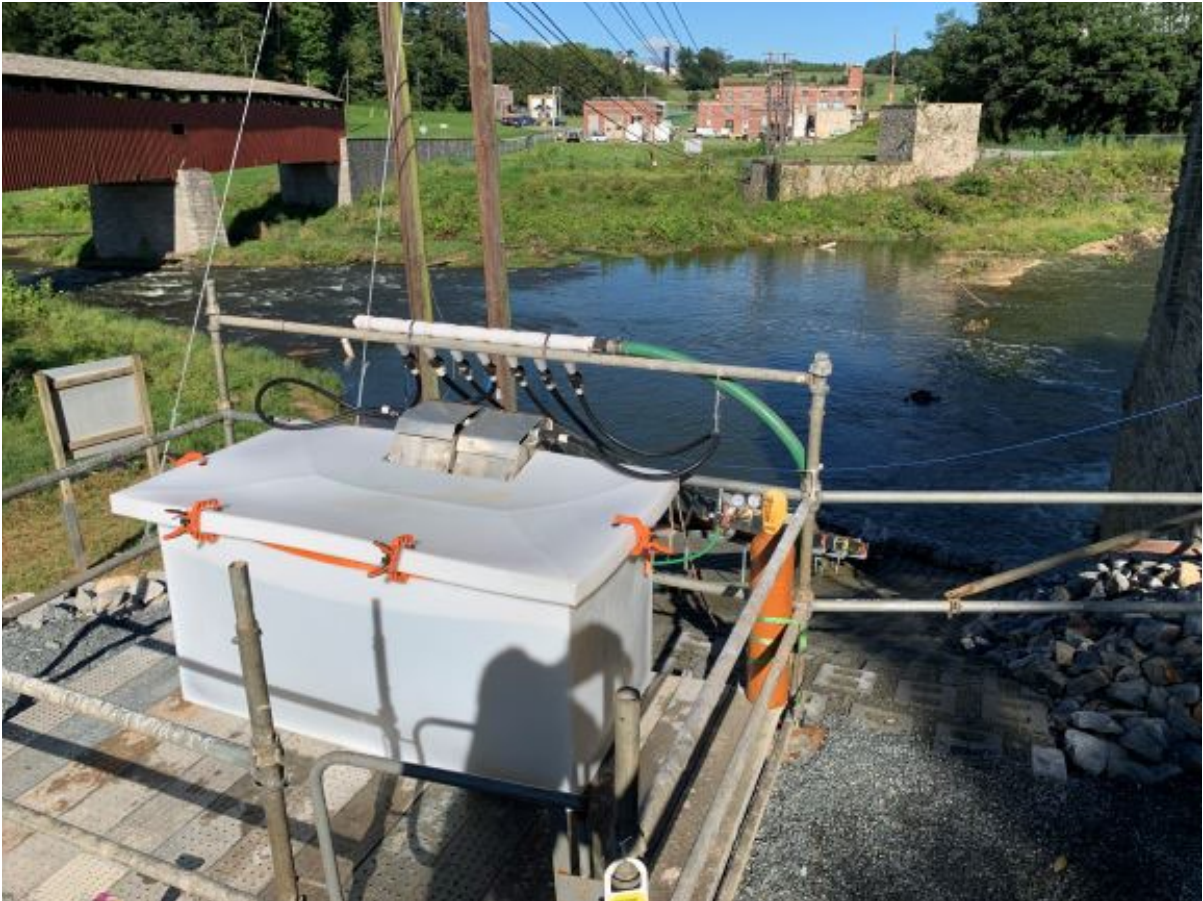
**Figure 3.1-1: Scaffolding and Collection Tank on top of the hill, Octoraro Creek Eel Facility, 2022**

In 2022, the size of the scaffolding platform was increased to an eight foot by ten-foot platform to support the larger collection tank and oxygen supply system ([Figure 3.1-1](#)). The 310.4-liter collection tank that had been used in previous years was replaced by a 1,061-liter collection tank, which increased the holding capacity of the tank from 3,104 eels to 10,610 eels. This larger tank was installed to minimize holding mortality of eels during periods of high capture. The manifold and submersible pump remained the same as the previous years ([Normandeau Associates and Gomez and Sullivan 2020 and 2021](#)). The rainfall gauge was reinstalled on the corner of the scaffolding to capture and record daily rainfall events.

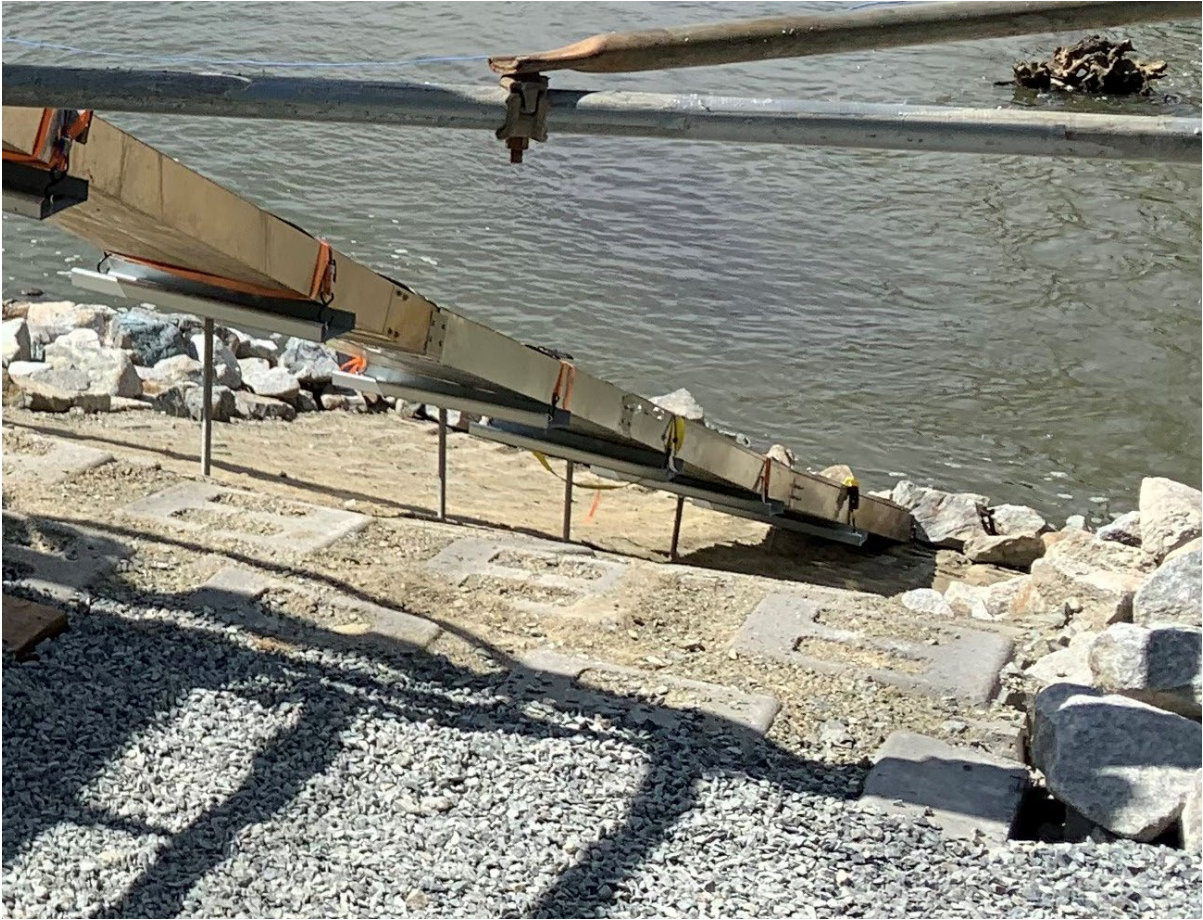
**Figure 3.1-2: T-bar supports driven through ACBs, Octoraro Creek Eel Facility, 2022**

The OCEF began operations on September 5, 2022, and were temporarily suspended on September 10, 2022, due to the bulging of the larger collection tank. This was remedied by supporting the collection tank with scaffolding on September 14, 2022, and the OCEF was returned to operation. The 2022 operations ceased on November 20, 2022, when the Octoraro Creek water temperature at CWA decreased below 10.0 °C for three consecutive days. The OCEF in 2022 contained two longer ramps, one with Enkamat substrate and one with Milieu substrate, which were the substrates used from 2015-2019 and 2021.

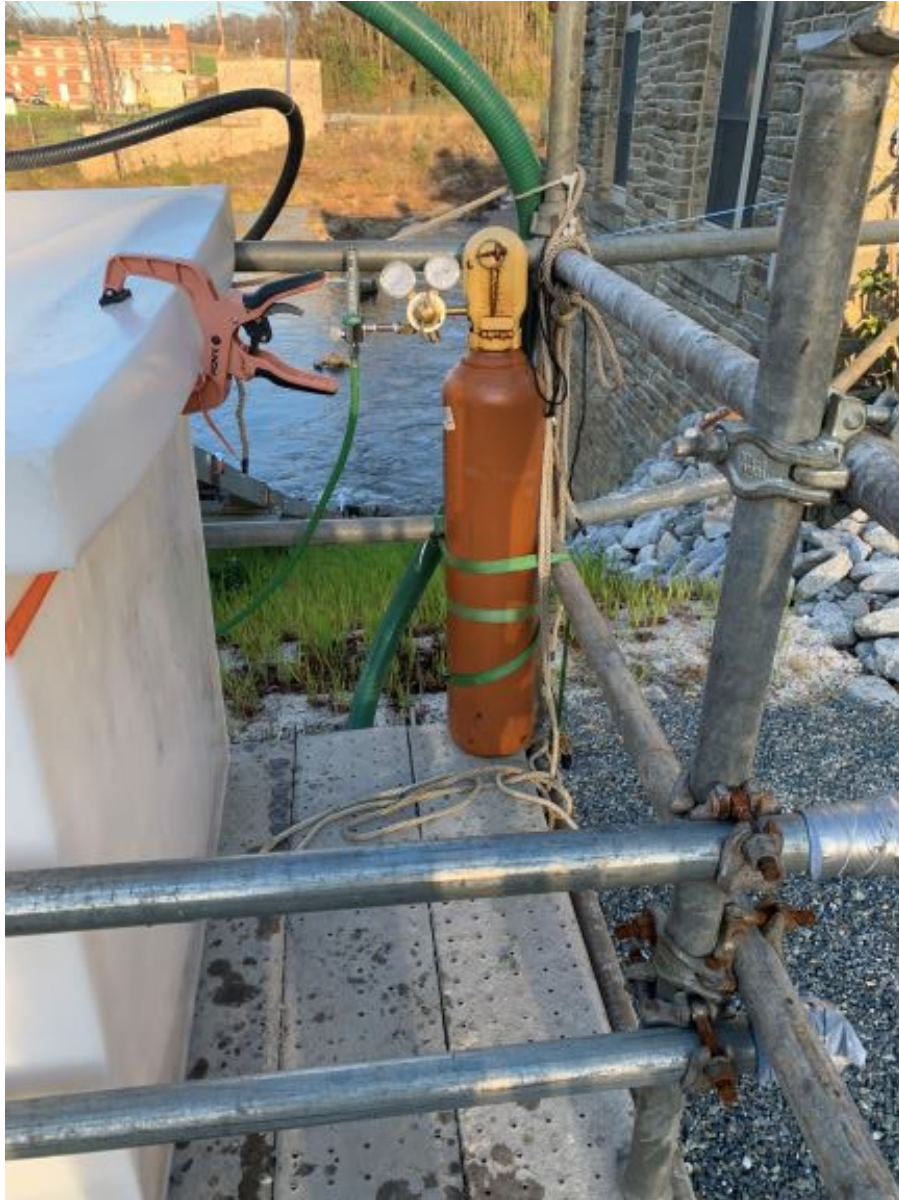
**Figure 3.1-3: Oxygen Supply System, Octoraro Creek Eel Facility, 2022**

The oxygen supply system, which was added in 2022, provided additional oxygen to the collection tank to minimize holding mortality. An oxygen regulator was attached to an oxygen bottle with a manifold that terminated at a micropore diffuser in the collection tank ([Figure 3.1-3](#)).

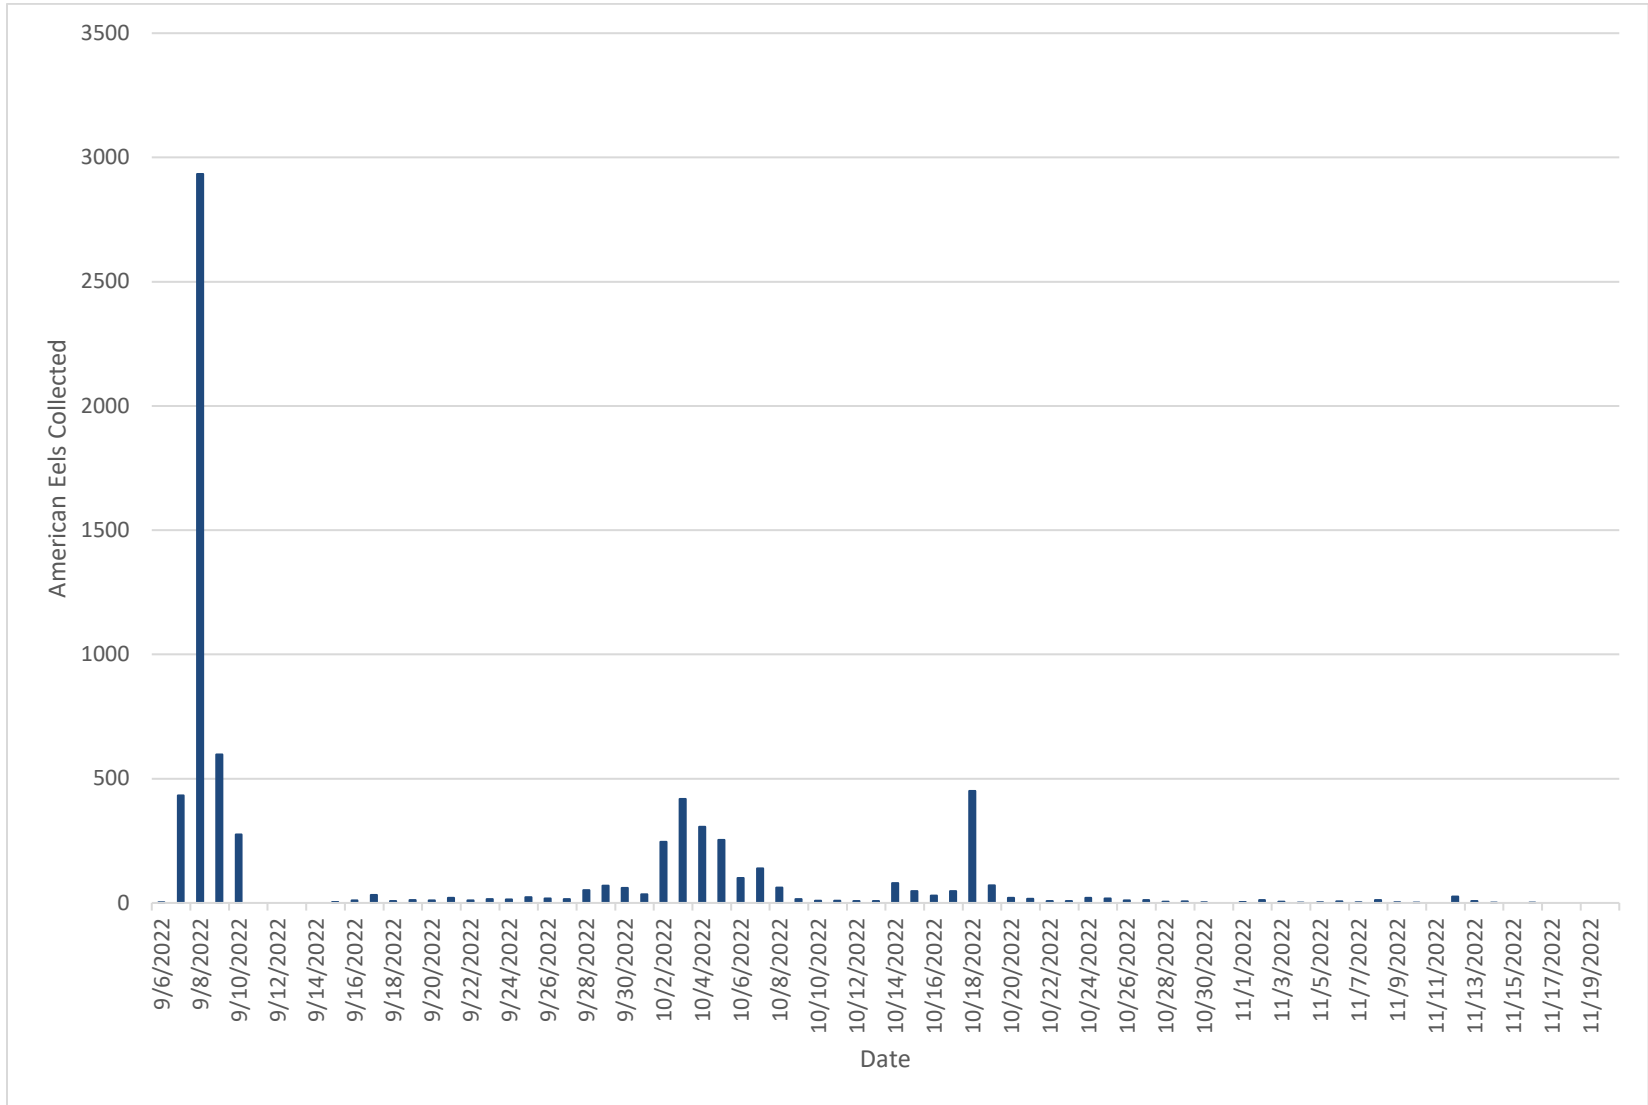
Figure 4.1-1: Daily Eel Catch, Octoraro Creek Eel Facility, 2022

A total of 7,159 juvenile American Eels were captured at the OCEF during the 2022 season ([Table 4.0-1](#)). The highest single-day collection of 2,933 juvenile eels occurred on September 8, which accounted for 41.0% of the total 2022 collection season ([Table 4.0-1](#) and [Figure 4.1-1](#)). Volumetric estimations of collected eels, which are indicative of high collection rates, were required on two days (2.7%), while individual counts were recorded the remaining 71 days of daily monitoring ([Table 4.0-1](#)). Eel collections greater than 1,000 individuals occurred on one of the 73 collection days (1.4%). Daily juvenile eel collections of less than 10 individuals were recorded on 30 of the 73 collection days (41.1%).

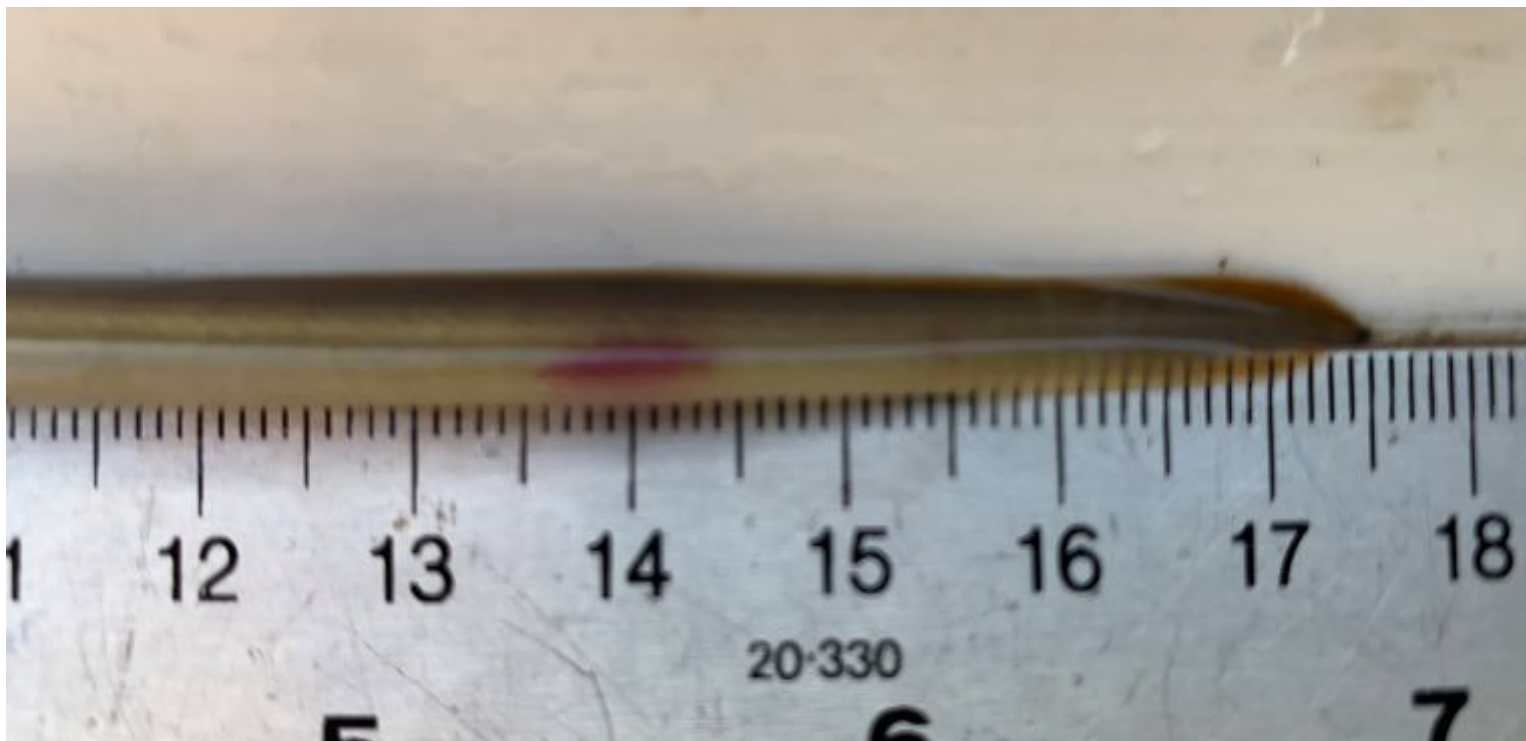
Figure 4.2-1: Image of Hemorrhage near vent, Octoraro Creek Eel Facility, 2022

Eels from each biweekly subsample were examined for external injuries. Individual condition factors, date, and detailed biological data for these are shown on [Table 4.2-4](#). External injuries were noted on 0.8% (2 of 247 individuals) of the examined eels. These injuries were observed on October 3 and 10, 2022 and were consisted of a bruise and a hemorrhage, respectively ([Figures 4.2-1](#)).

<b>Date</b>	<b>Length (mm)</b>	<b>Weight (grams)</b>	<b>Condition Factor</b>
10/03/2022	143	3.4	Bruise mid-body
10/10/2022	142	2.7	Hemorrhage near vent

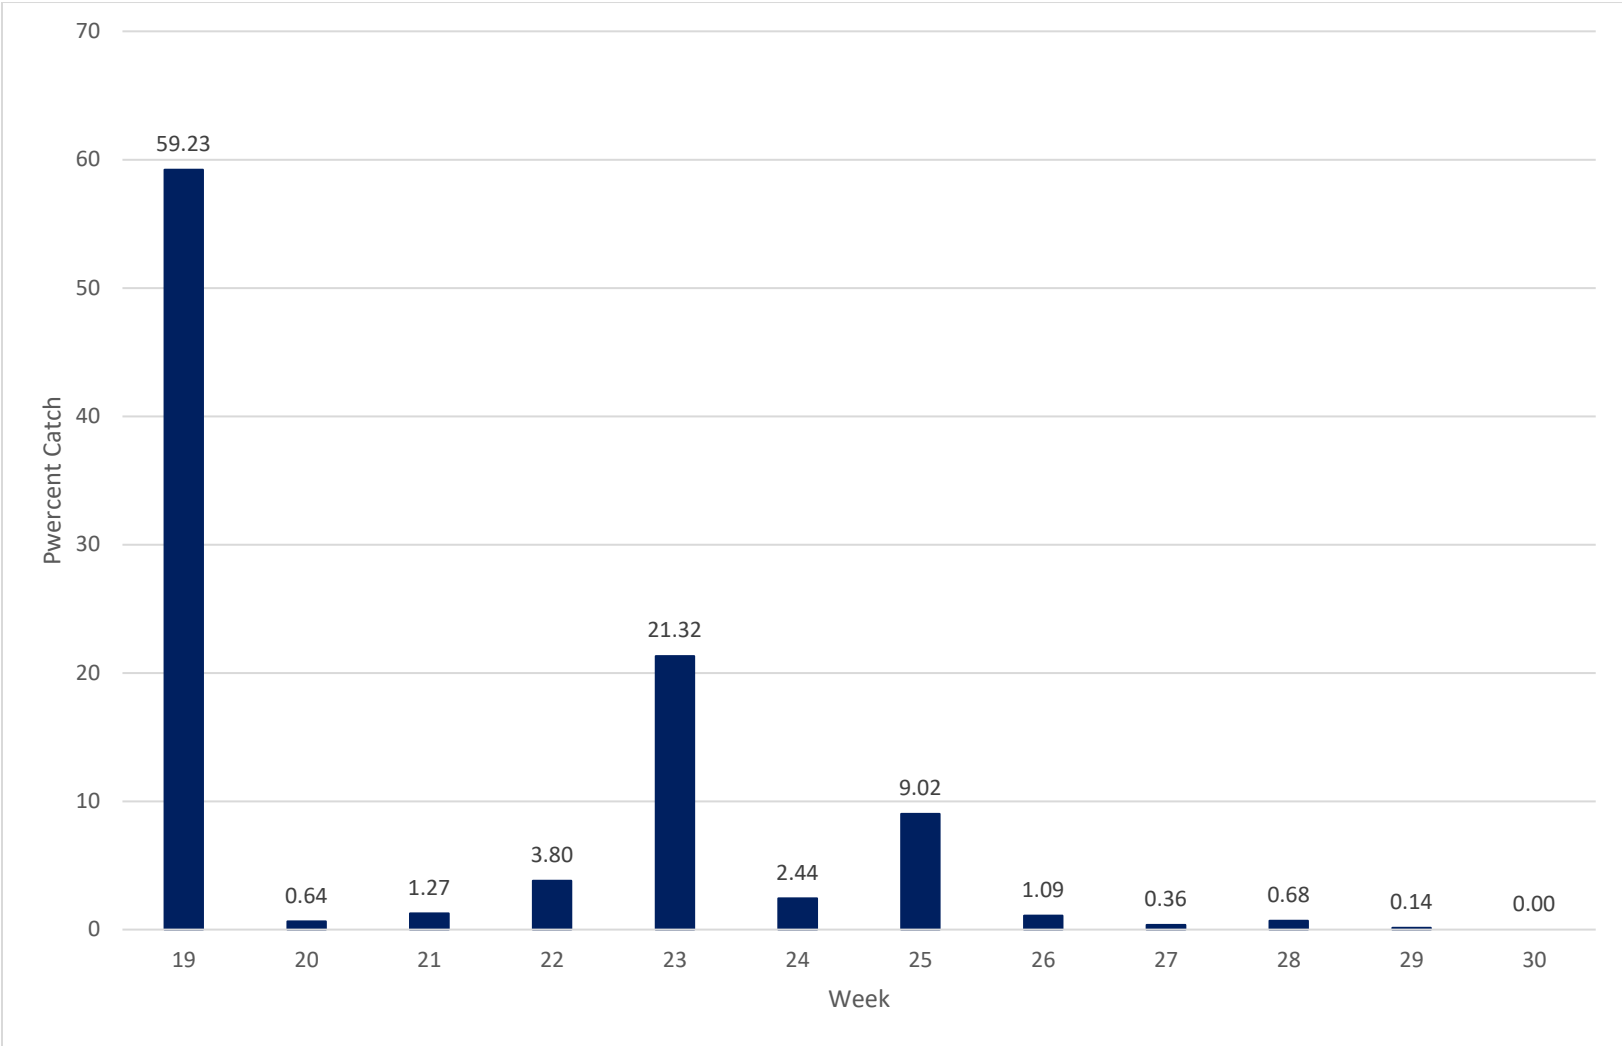
Figure 4.3-1: Percentage Eel Catch per Week, Octoraro Creek Eel Facility, 2022

The majority of the juvenile eels were collected during Week 19 (September 4-9) when the OCEF collected 59.2% (4,240 individuals) of the season total ([Table 4.3-1](#) and [Figure 4.3-1](#)). Eel collections during Week 23 comprised the second greatest weekly total of 21.3% (1,526 eels) of the season

total. Weeks 20 and 27-30 each collected less than 1.0% (less than 71 eels) of the season total ([Table 4.3-1](#) and [Figure 4.3-1](#)). Weekly catch data are also provided in [Appendix A](#).

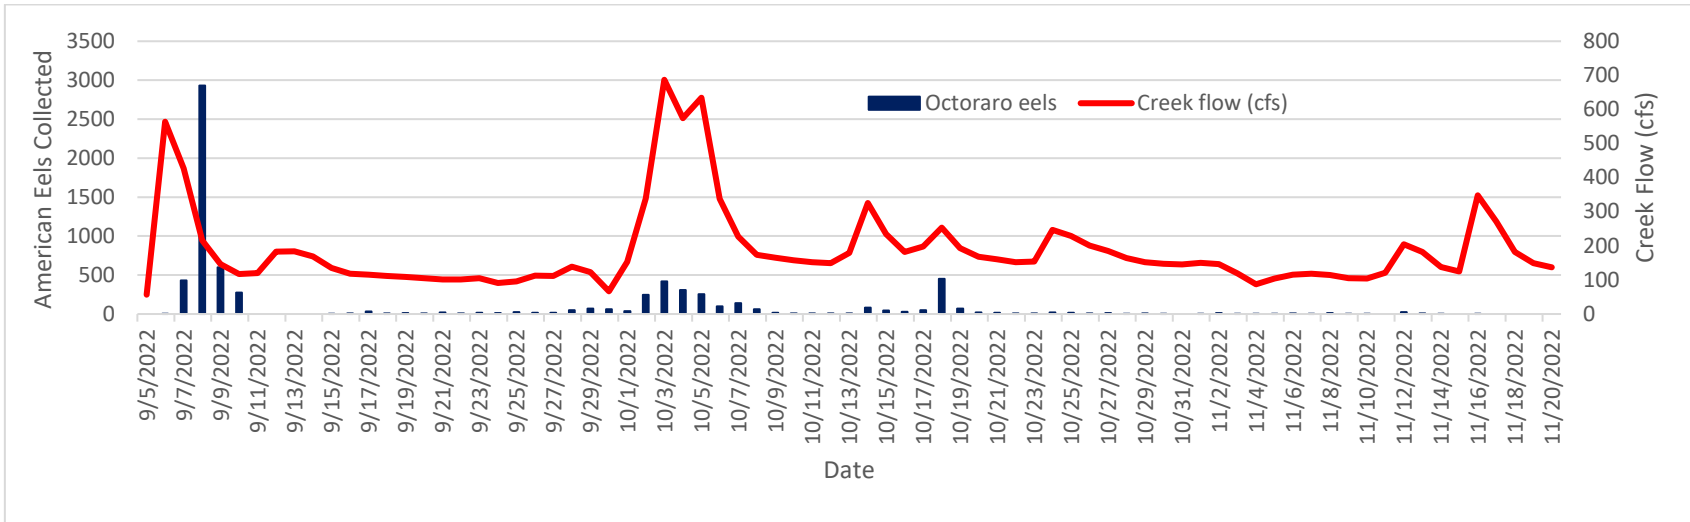
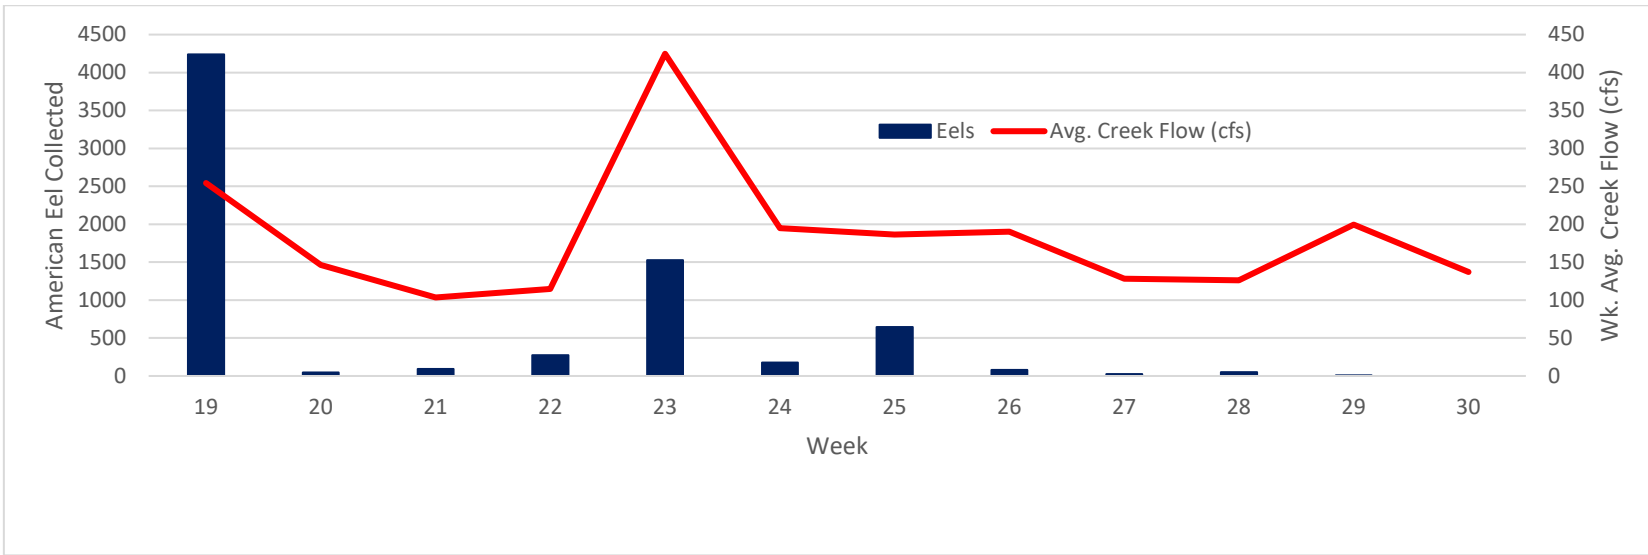
**Figure 4.5-1: Daily Eel Catch and Daily Average Creek Flow (cfs, top graph) and Weekly Eel Catch and Weekly Average Creek Flow (cfs, bottom graph), Octoraro Creek Eel Facility, 2022**

Creek flow and juvenile eel catch appeared to be correlated during the 2022 season. Daily average creek flow was taken from the United States Geological Survey (USGS) Gage 01578475 on Octoraro Creek at Richardsmere, MD, located approximately 21 kilometers (km) downstream of CWA's Pine Grove Low-Head Dam ([Table 4.5-1](#)). The highest daily average creek flow value when the OCEF was in operation occurred on October 3, 2022 (687 cubic feet per second, [cfs]), which corresponded with a small peak collection period ([Table 4.5-1](#)). Two days prior to the largest eel collection day during the 2022 season (September 8-9), a substantial rain event produced a freshet with a maximum discharge of 943 cfs, which was the highest instantaneous creek discharge recorded during the 2022 operational period

During Week 23, the highest weekly average creek flow did not coincide with the highest weekly catch ([Table 4.0-1](#) and [4.5-1](#) and [Figure 4.5-1](#)). Week 23 had an increase in flow which produced the second largest week of collection at the OCEF ([Figure 4.5-1](#) and [Appendix B](#)). The highest weekly catch occurred during Week 19 and could have been a factor of the first week of the 2022 season. Typical of most eel ladders, freshets in Octoraro Creek generally corresponded to greater numbers of eels collected during the 2022 operational period, but higher catch numbers during periods without an increase of flow may be a function of other environmental or behavioral variables.

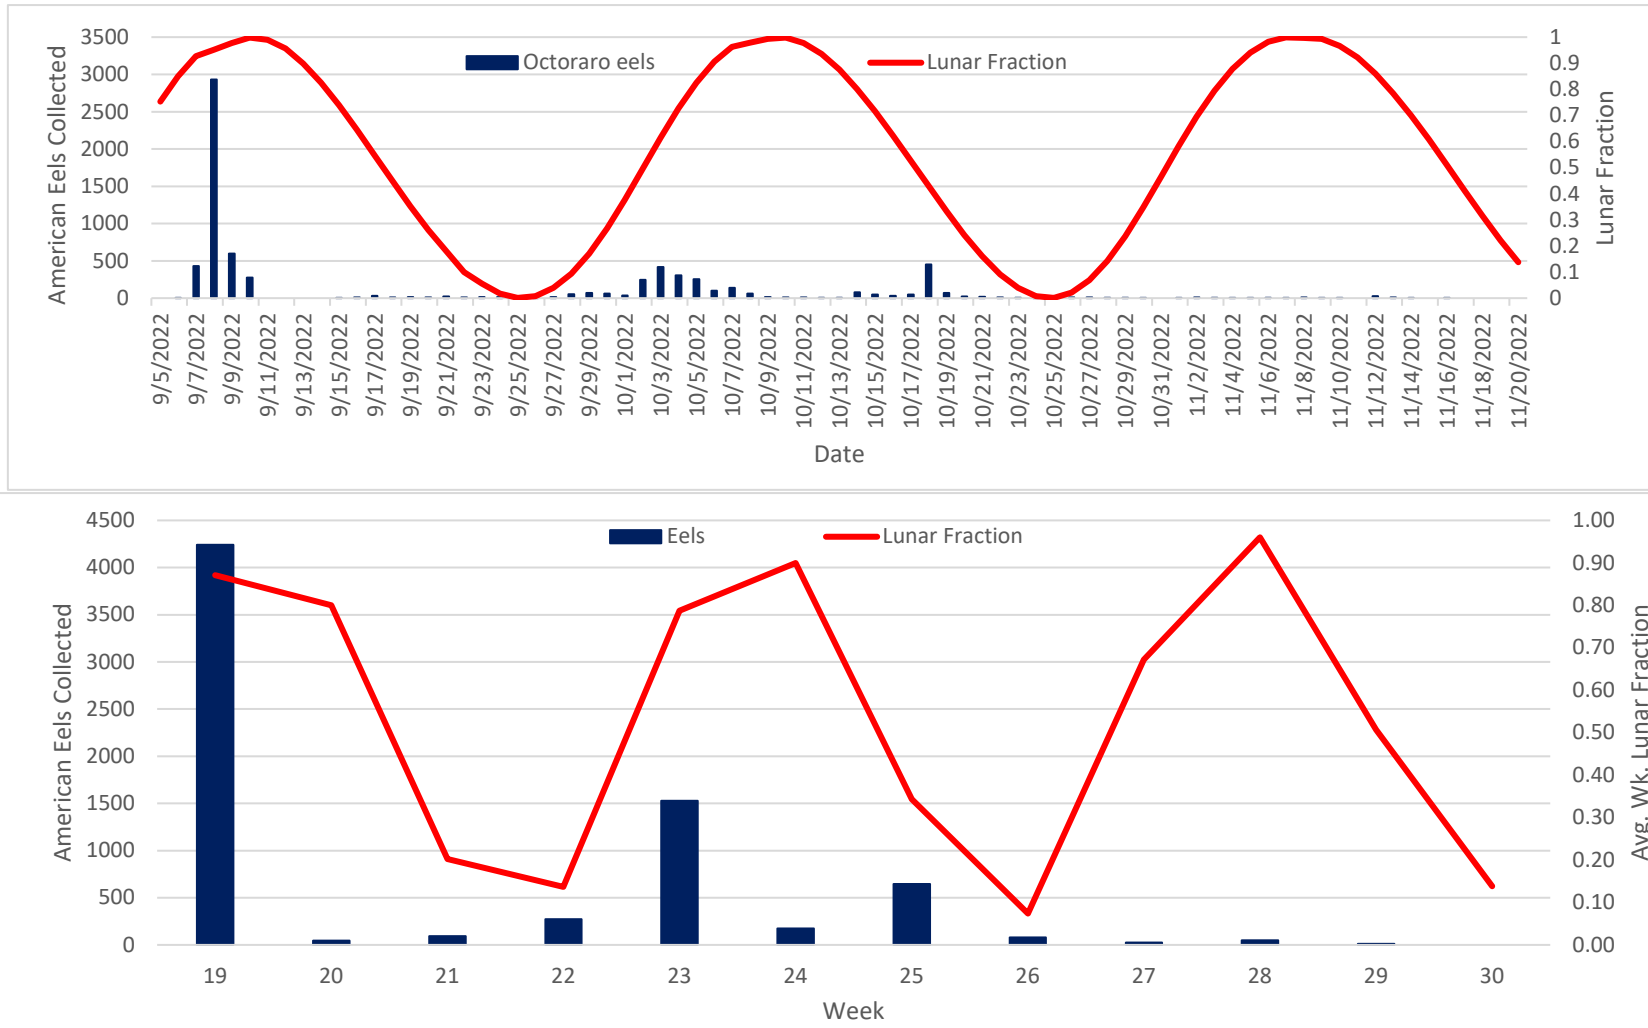
Figure 4.5-2: Eel Catch and Lunar Fraction (Daily above, Weekly Average below), Octoraro Creek Eel Facility, 2022 (1.0 Equals Full Moon)

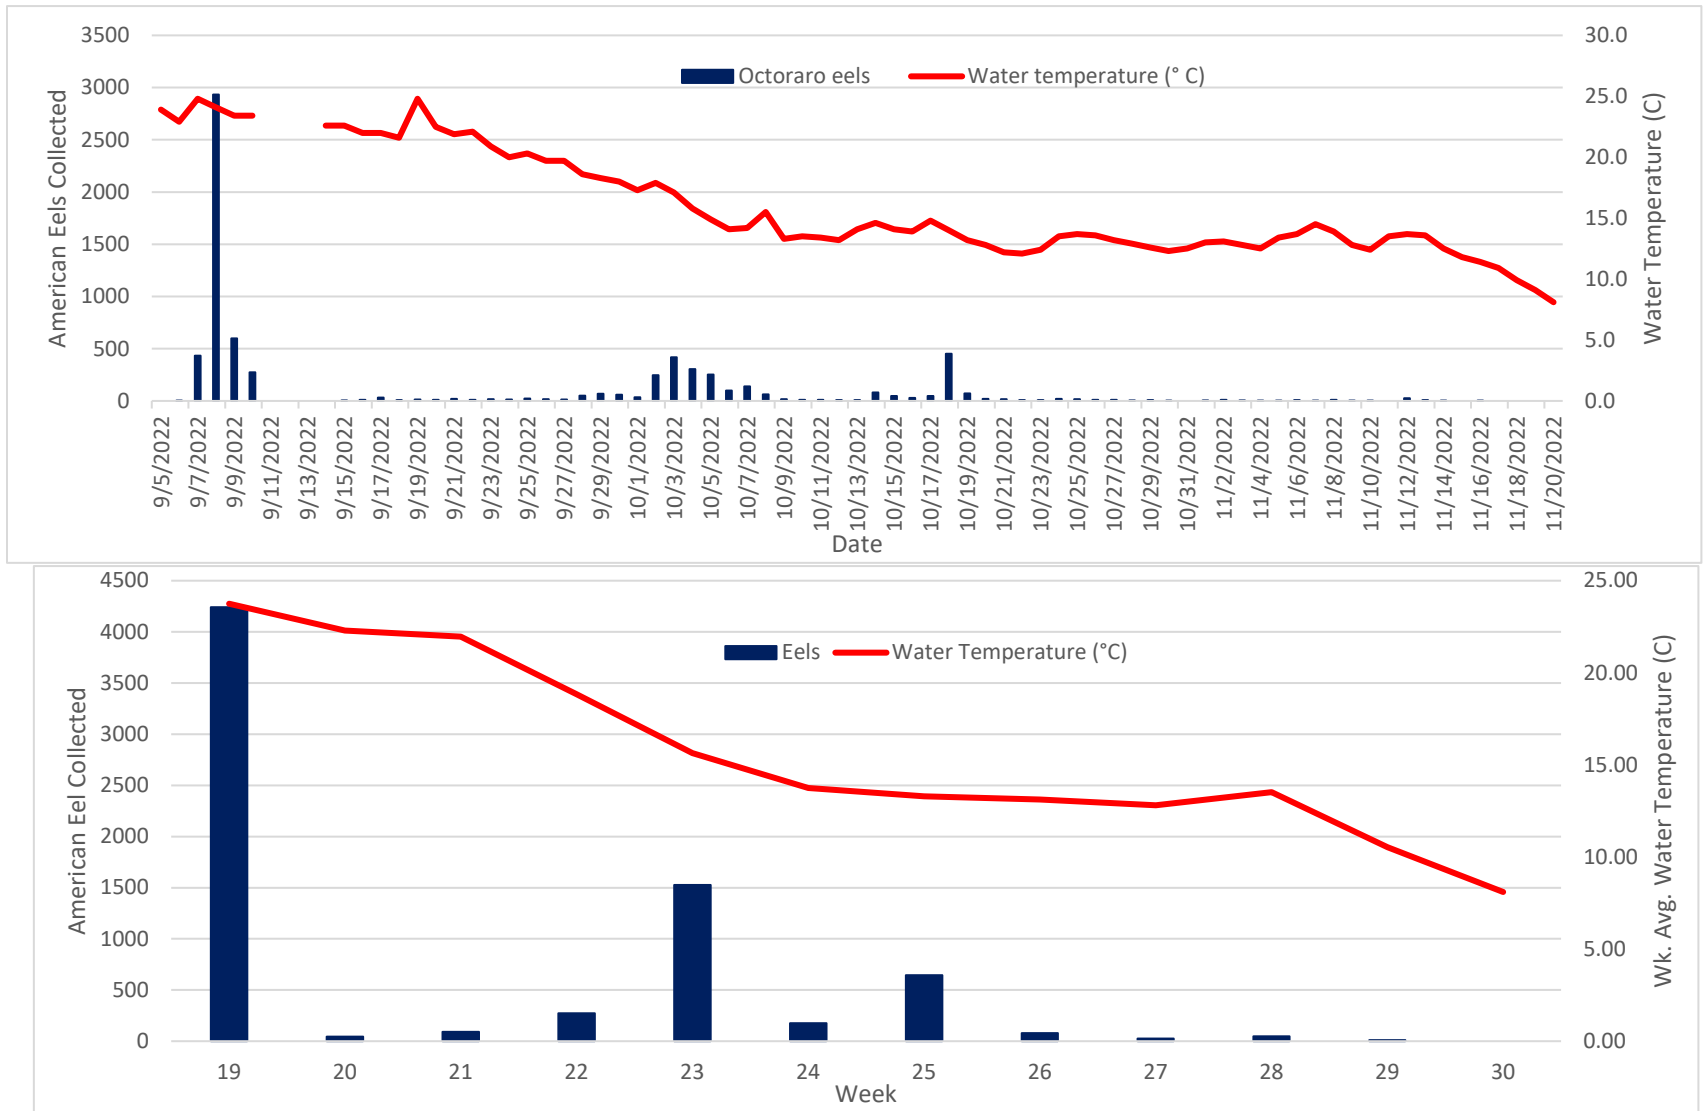
**Figure 4.5-3: Eel Catch to Water Temperature (Daily above, Weekly Average below), Octoraro Creek Eel Facility, 2022**

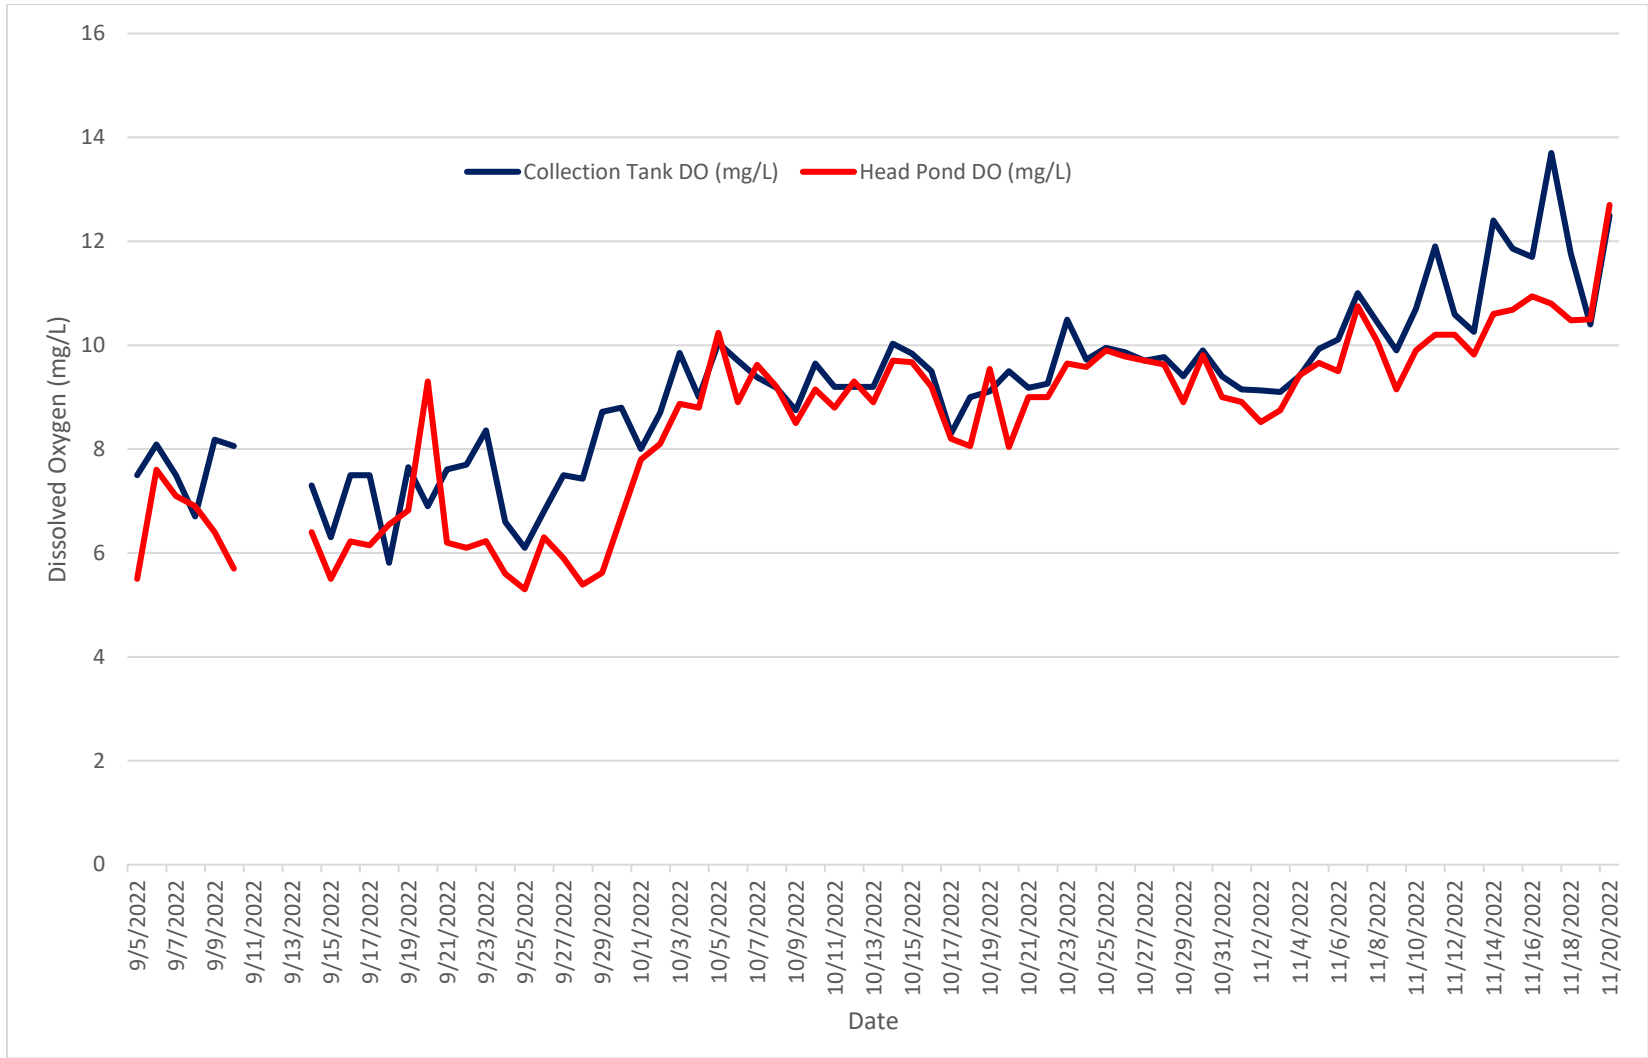
Figure 4.5-4: Comparison of Dissolved Oxygen Readings in Collection Tank and Head Pond, Octoraro Creek Eel Facility, 2022

Eel collection numbers and DO did not appear to be correlated this season. DO was recorded as milligrams/Liter (mg/L). These data indicated that the DO readings were typically lower in the source water in the head pond above the dam than those observed in the collection tank for most of the season ([Table 4.5-4](#) and [Figure 4.5-4](#)). The oxygen supply system was added to the collection tank for the 2022 season and operated daily. Daily DO readings are presented in [Table 4.5-4](#) and displayed in [Figure 4.5-4](#). DO levels in the head pond were lower than the collection tank when the oxygen supply system was operated properly ([Figure 4.5-5](#) and [Appendix B](#)). Dissolved oxygen measurements were usually taken in the early morning when the lowest natural DO level was likely to be observed.

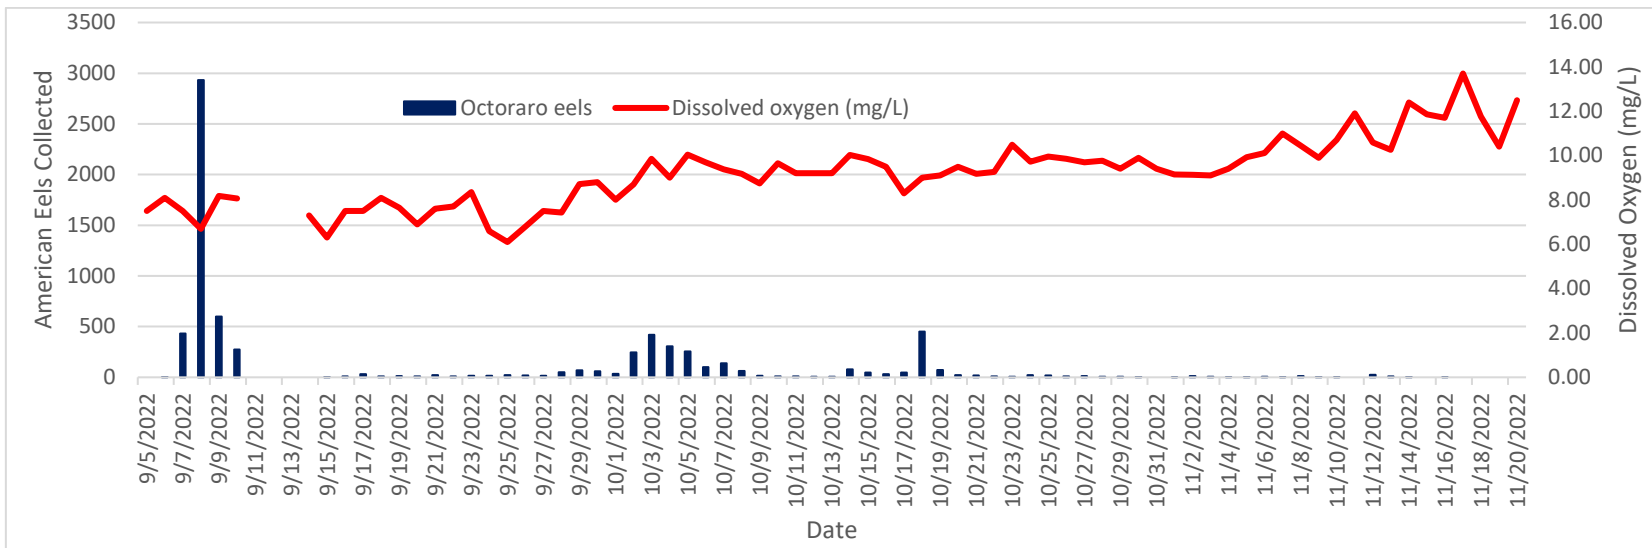
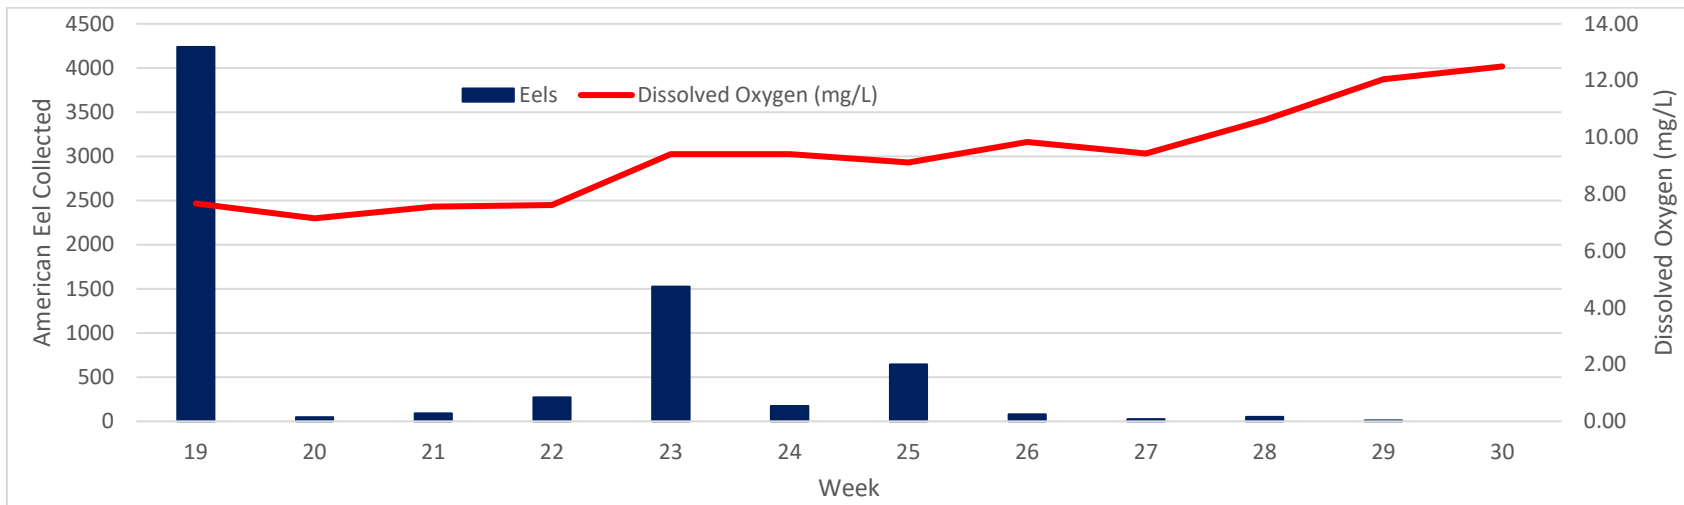
Figure 4.5-5: Eel Catch and Dissolved Oxygen (Daily above, Weekly Average below), Octoraro Creek Eel Facility, 2022

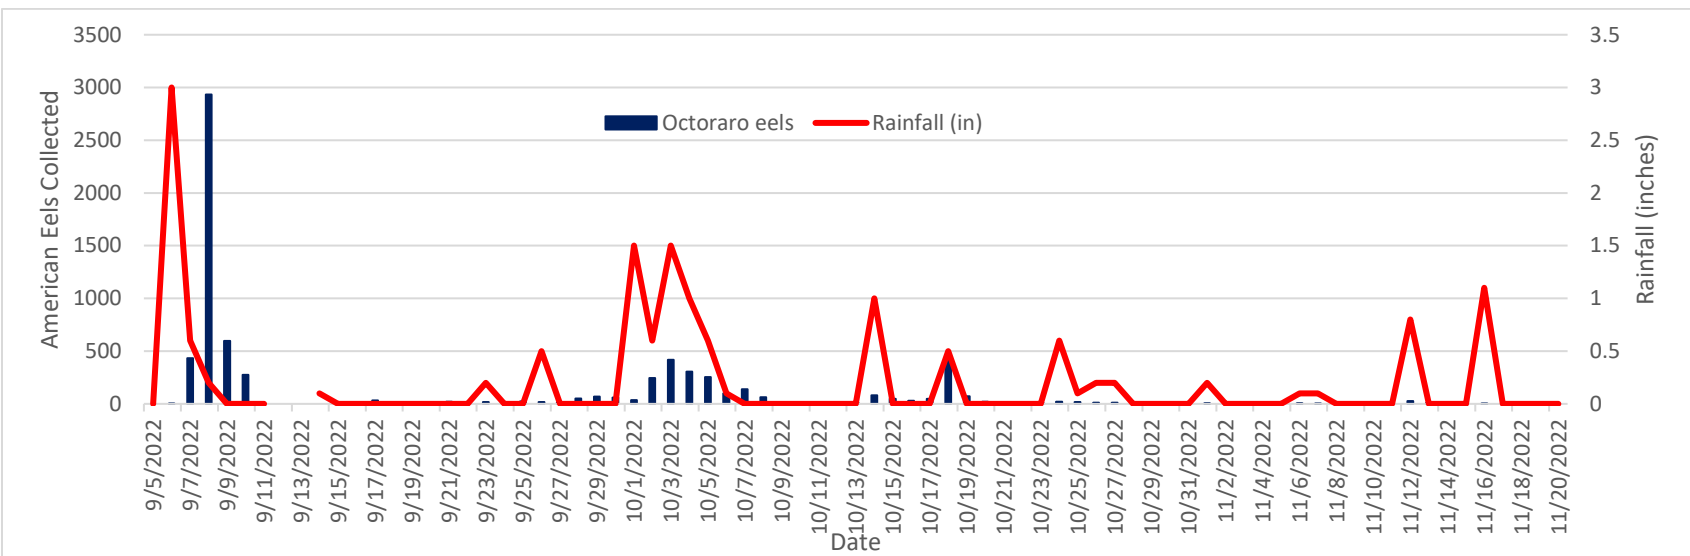
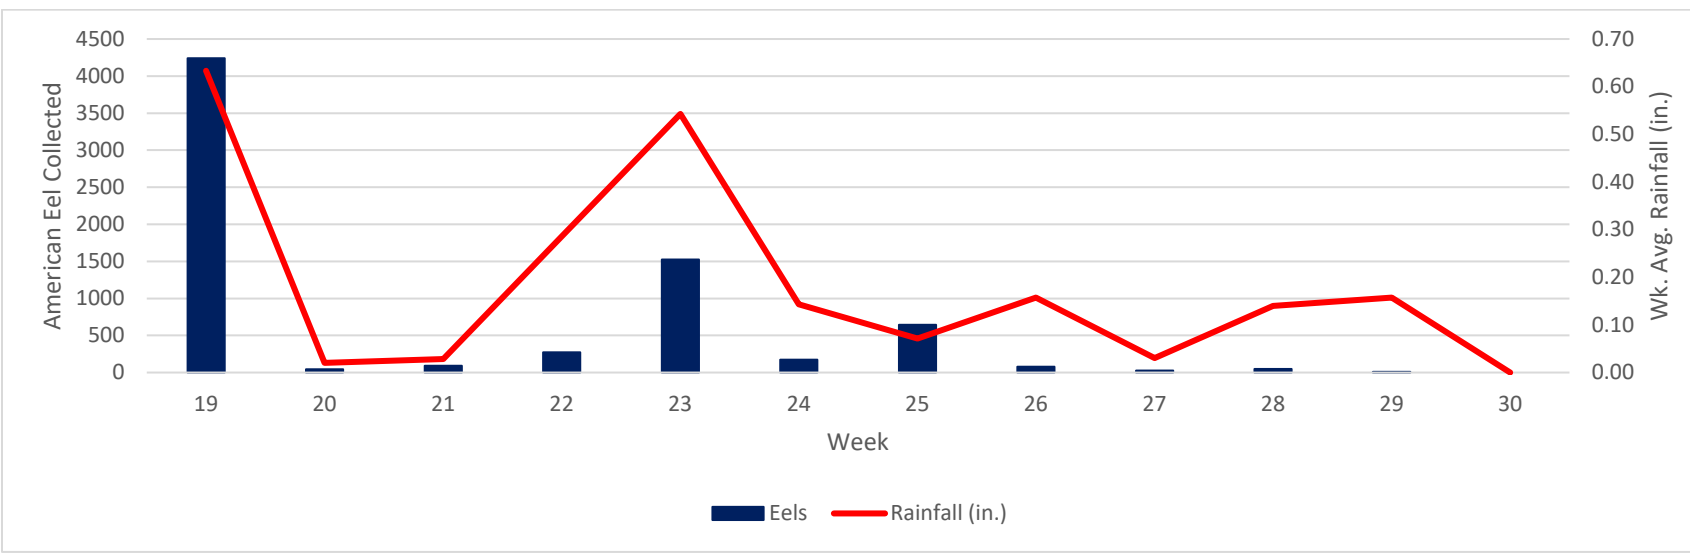
**Figure 4.5-6: Eel Catch and Rainfall (Daily above, Weekly Average below), Octoraro Creek Eel Facility, 2022**

Juvenile eel collection and rainfall did not appear to be correlated during the 2022 season. Rainfall was recorded in inches (in) by a rain gauge affixed to the scaffolding platform. The three largest rainfall events were recorded on September 6, October 1, and October 3, with 3.0, 1.5, and 1.5 inches recorded, respectively ([Table 4.5-5](#) and [Figure 4.5-6](#)). Recorded rainfall amounts over 1.0 inch were observed on six days during the 2022 season: once in September, four times in October, and once in November. During 69.9% of the season (51 of the 73 days), the rain gauge recorded values of 0.0 inches.

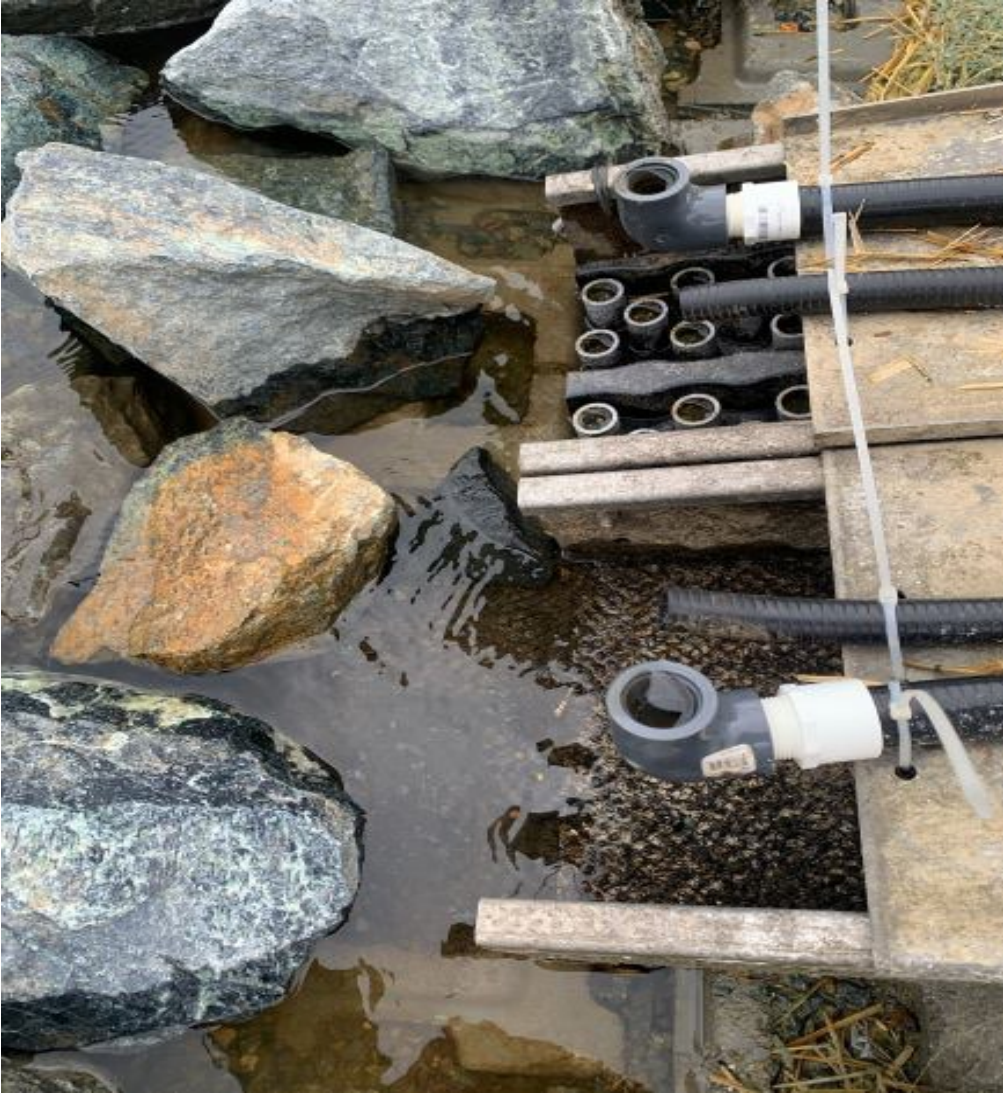
Figure 5.0-1: Ramp Entrance at ACBs (182 cfs ),Octoraro Creek Eel Facility, 2022

[4.5-1](#) and [5.0-1](#)). If the entrance of the ramp was to be located such that it was underwater at all creek flows then the rip-rap would have to be moved causing structural concerns for the integrity of ACBs. If the ramp were to be located such that it would span over the rip-rap, the resulting location of the ramp entrance would be farther away from the shoreline to ensure the bottom of the ramp was in contact with the creek bottom, which would increase the chances of damage to the ramp under high creek flows. The Enkamat substrate extended below the entrance of the ramp and between the riprap and the ACBs into the tailrace at all creek flows in 2022 ([Figure 5.0-1](#)).
