## Muddy Run Pumped Storage Project American Eel Collection Facility in Octoraro Creek, 2022

**FERC Project No. 2355**

**Submitted On:**  
January 13, 2023

**Prepared By:**  
Normandeu Associates, Inc.  
482 Old Holtwood Road  
Holtwood, Pennsylvania 17532

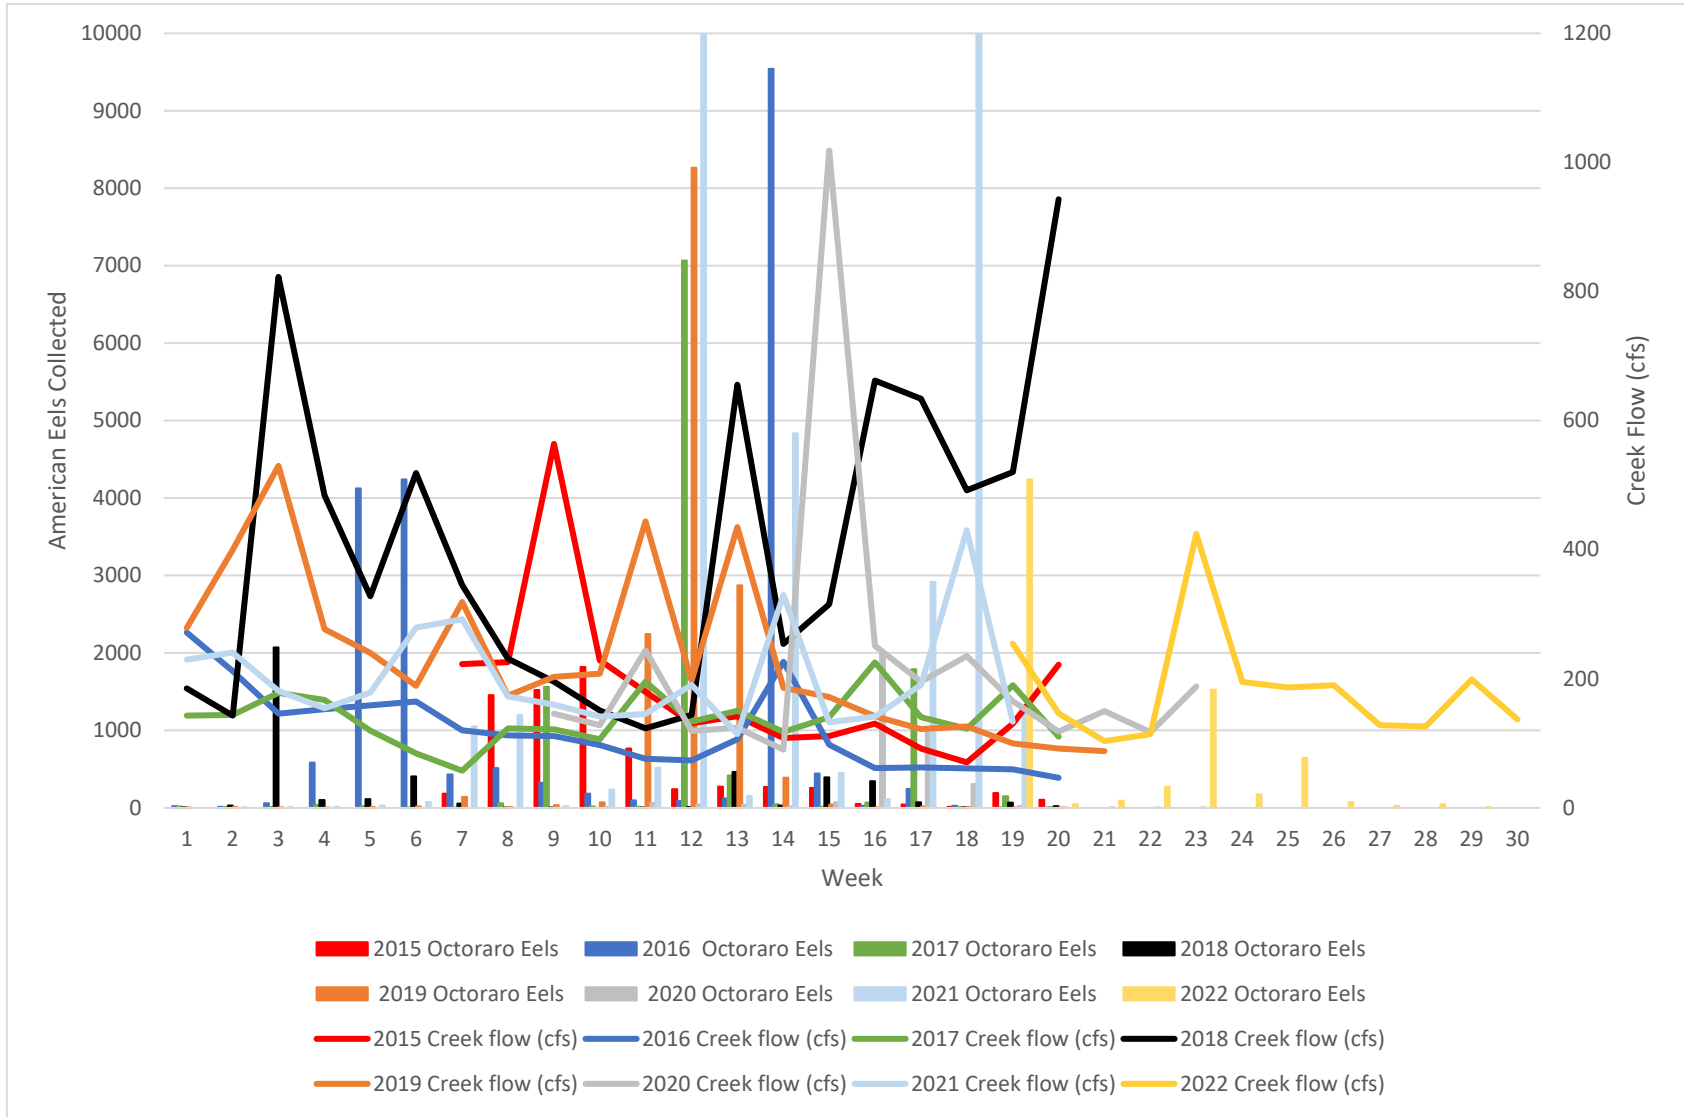
Figure 5.0-2: Weekly Catch and Average Creek Flow, Octoraro Creek Eel Facility, 2015-2022

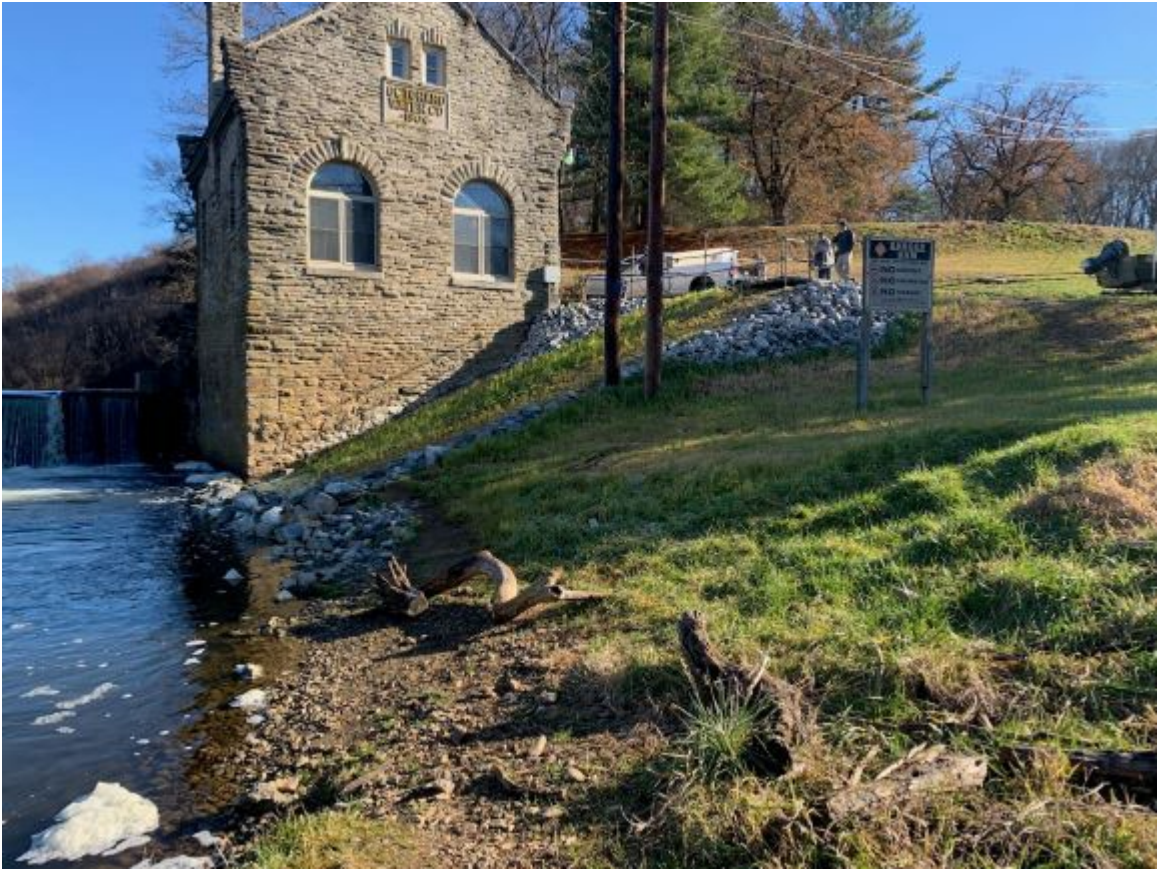
Figure 5.0-3: Bank Stabilization Project with Established Seed, Octoraro Creek Eel Facility, 2015-2022

The newly placed seed along the hillside will be monitored throughout the 2022/2023 winter and spring to ensure the plants become well established ([Figure 5.0-3](#)). In addition, Constellation is planning to enhance/replace the existing working platform with a wooden structure in the future.

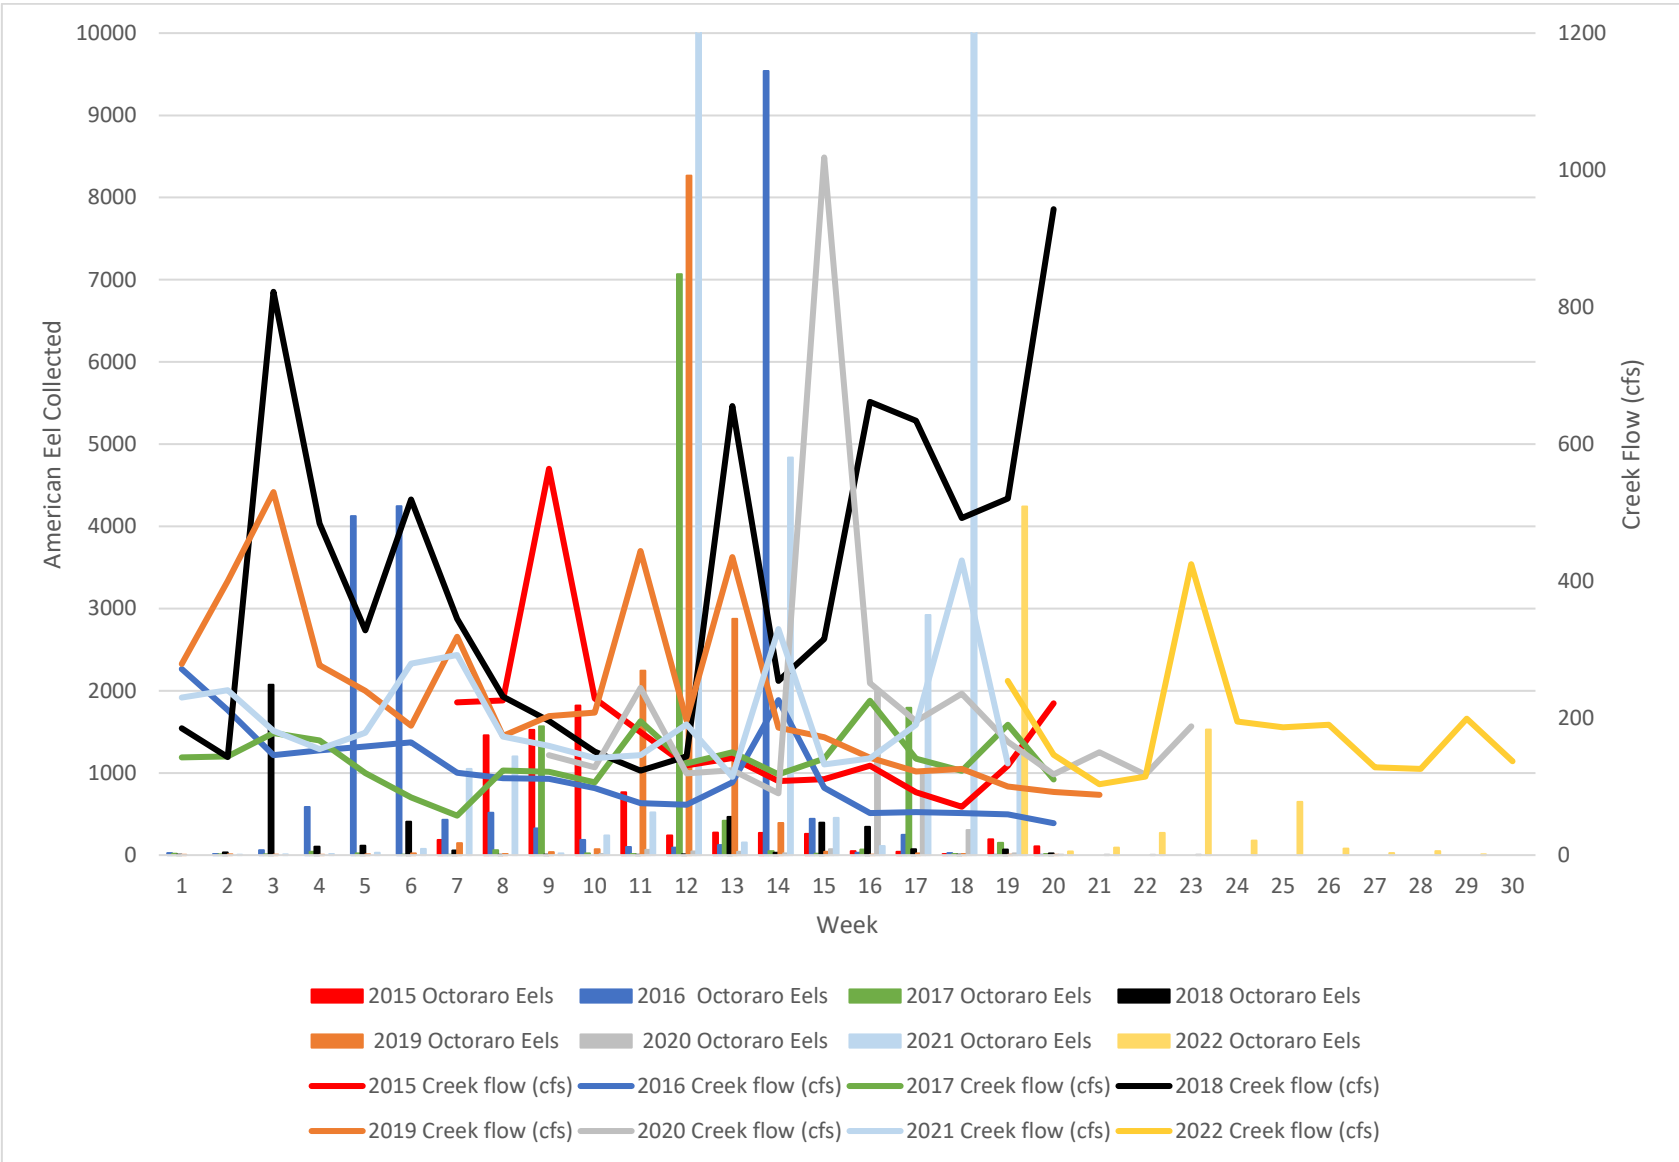
Eel Catch (Collection) to Creek Flow (2015-2022)

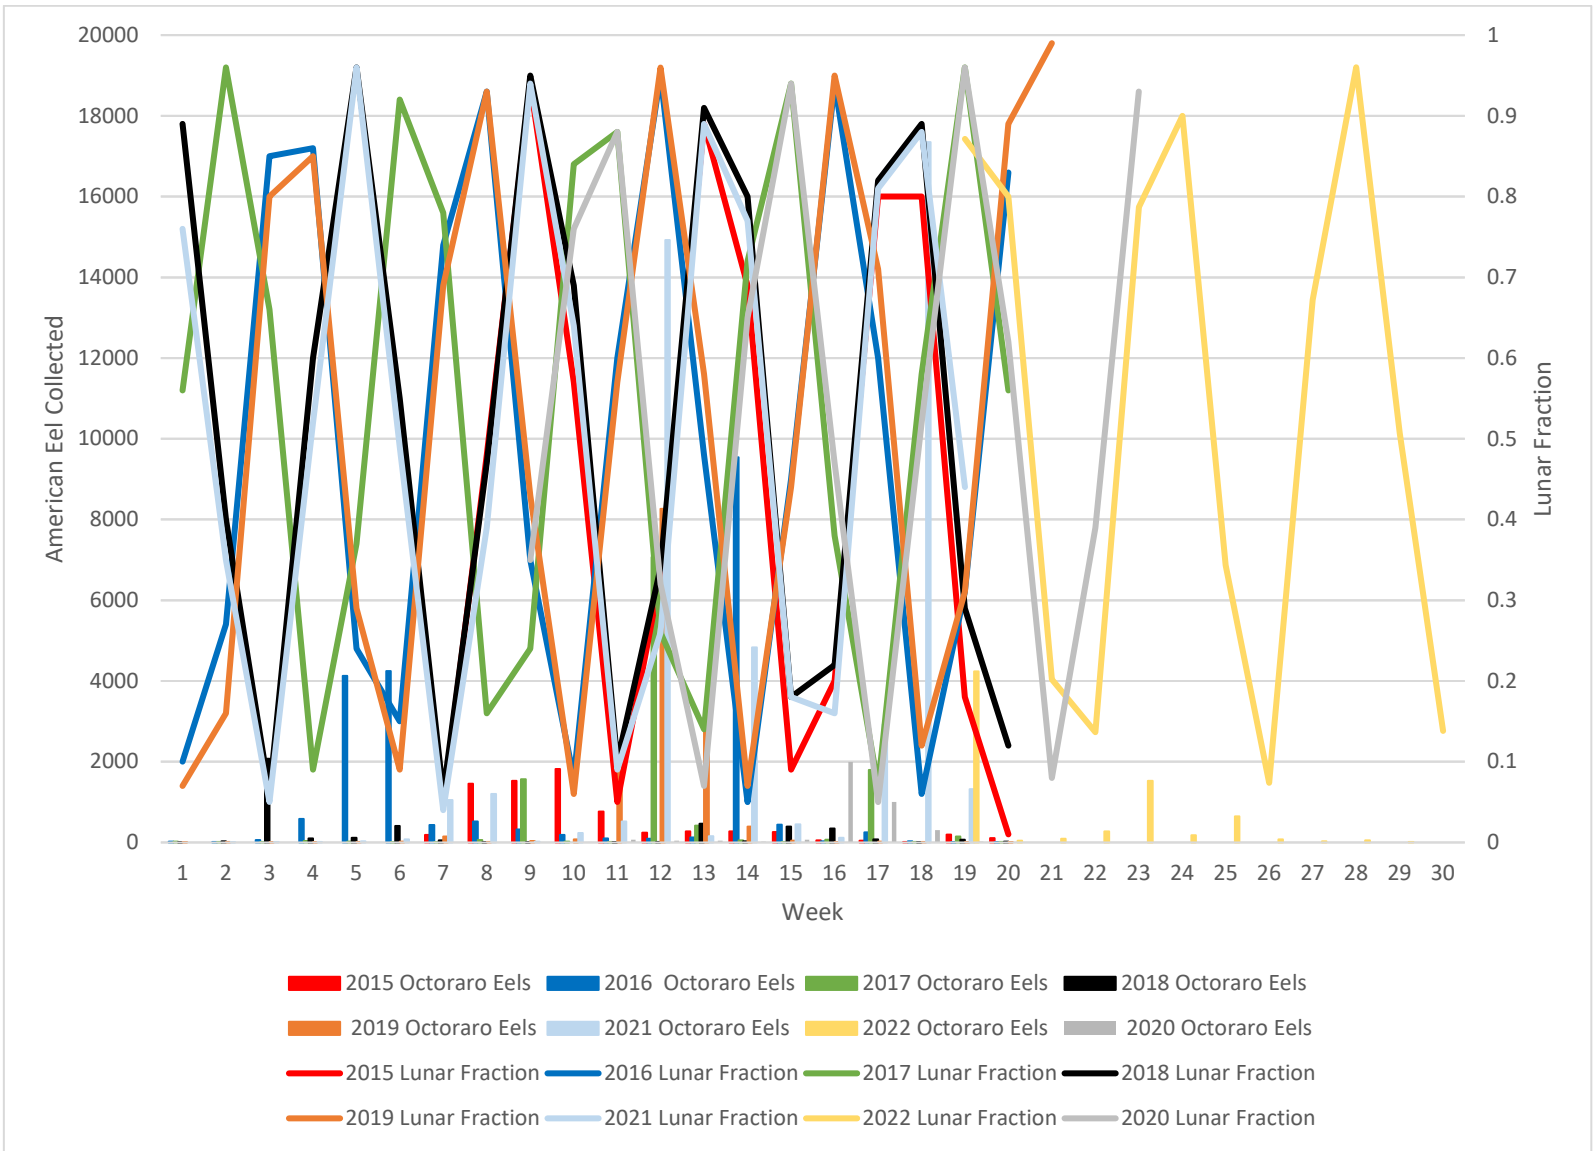
### Eel Catch (Collection) to Lunar Fraction (2015-2022)

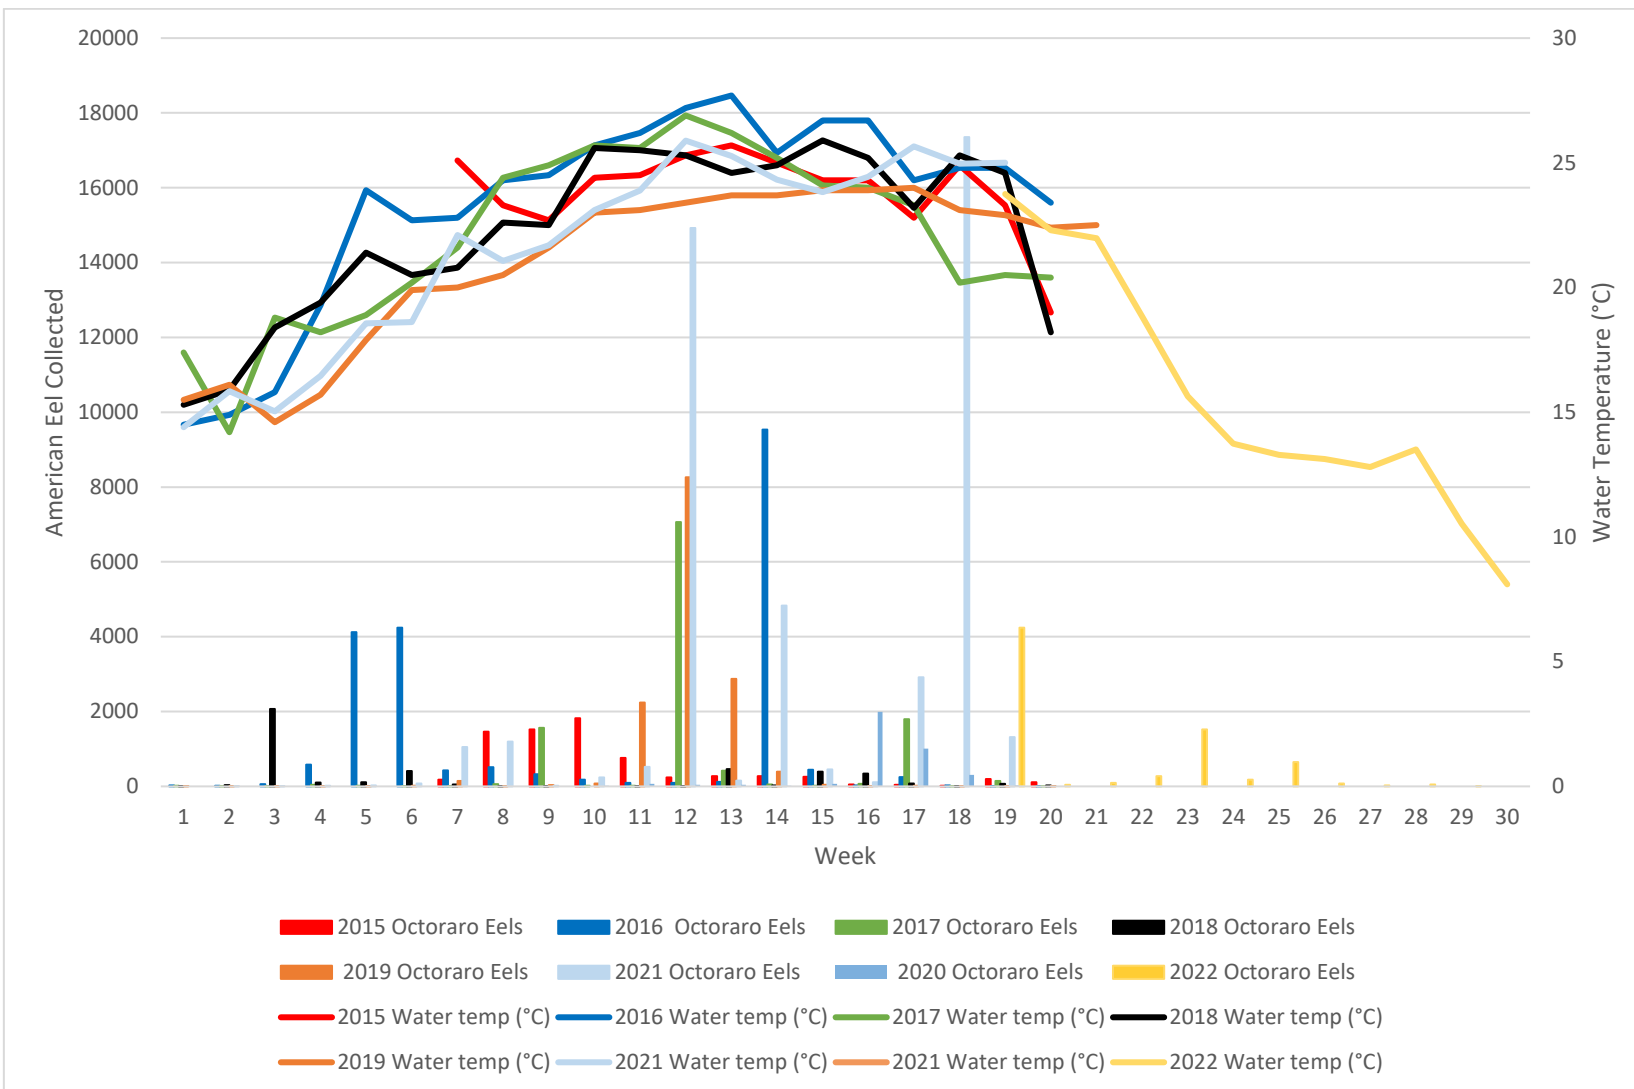
**Eel Catch (Collection) to Water Temperature (2015-2022)**
