Roller Mill Dam Removal Effects on Chiques Creek

Interim Technical Summary: Additional Pre-Dam Removal Sampling in 2024

Publication No. 338

October 2024

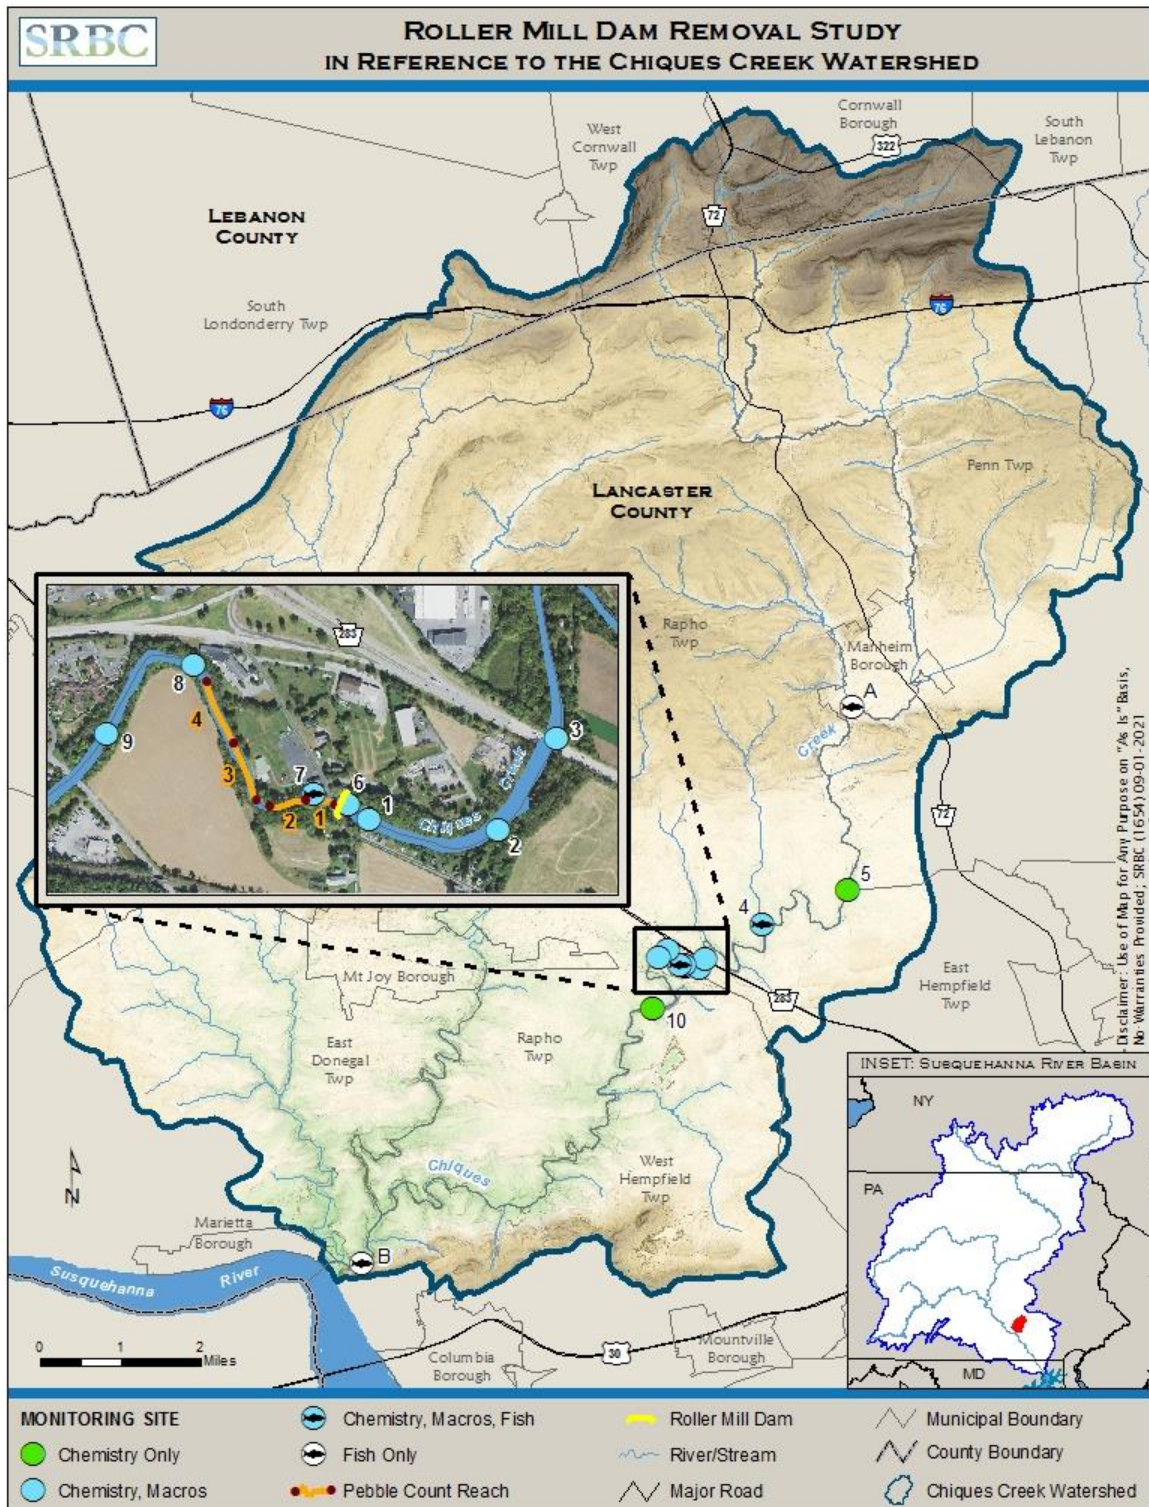
Figure 1. Map of All Monitoring Locations Associated with the Pre-Dam Removal Monitoring on Chiques Creek

In 2020, the Susquehanna River Basin Commission (Commission) established a study area on Chiques Creek above and below Roller Mill Dam to study the effects of a proposed dam removal on stream channel dynamics, water quality, and aquatic communities (Figure 1). The Roller Mill Dam (RMD) was originally slated to be removed in Spring 2021 but has been pushed back annually. The delays were caused by regulatory hold ups as well as continued funding issues. However, permitting is currently underway and work is progressing towards dam removal within calendar year 2025.

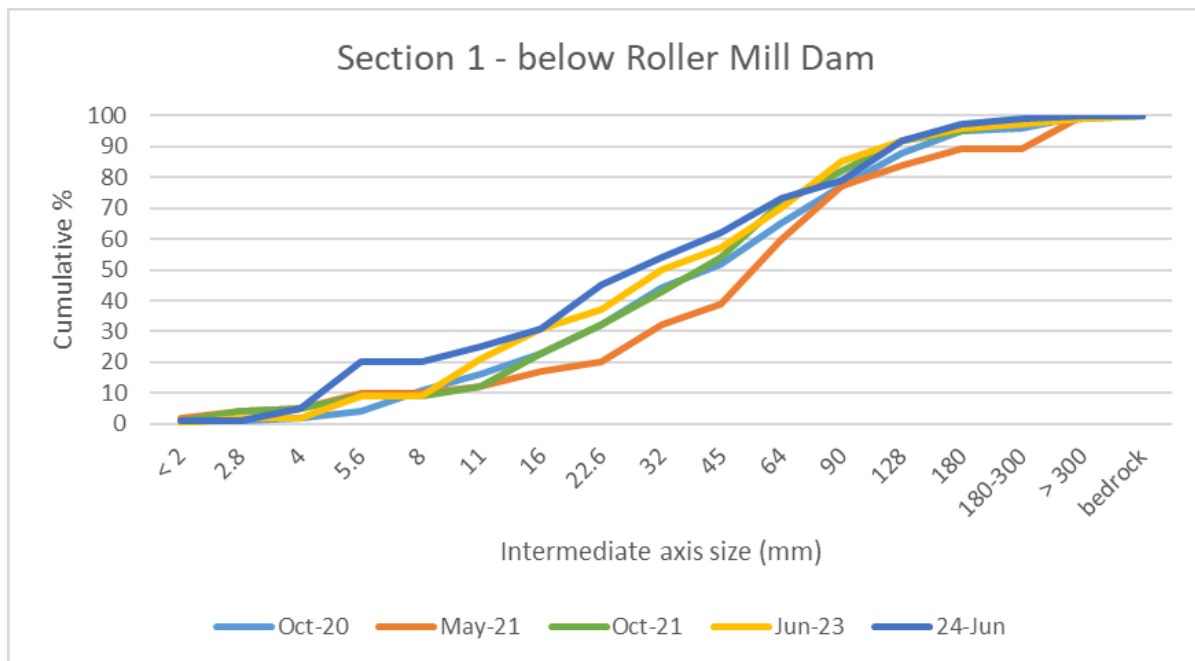
Pebble counts have been completed routinely in the 450 meters below the Roller Mill Dam with the goal of documenting the relative stability of the substrate type and median particle size (Figure 2). Zig zag 100 pebble counts were done using a standard gravelometer. Having a documented pre-dam removal substrate characterization will be valuable for determining how long it takes after dam removal for the stream to return to its pre-removal stable state.

Figure 2. Example of Pebble Count Cumulative Frequency Plot for Section 1, Below Roller Mill Dam, 2020-2024
